CORROSION BEHAVIOR OF FRICTION PLATE SURFACES CONNECTED BY HIGH-STRENGTH BOLTS

S. YAMASHITA¹, T. SHIMOZATO², Y. ARIZUMI², M. TAI³, and T. YABUKI²

¹ Production Planning Group, Miyaji Engineering Co., Ltd, Ichihara, Japan

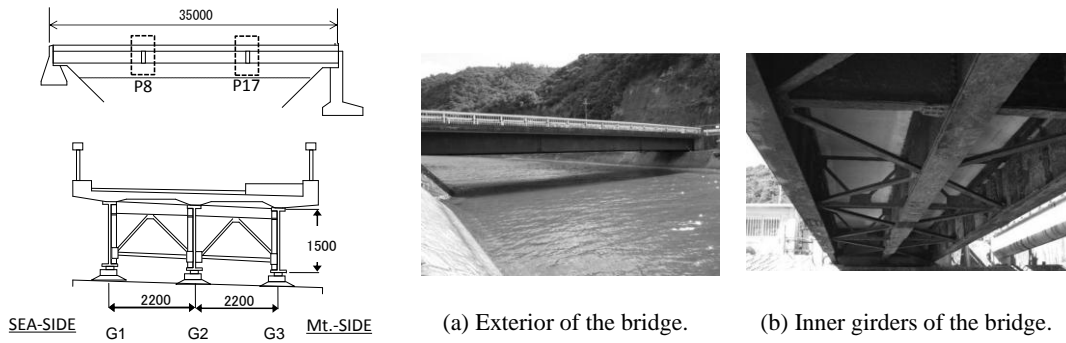
Figure 1. Inspection steel girder bridge.

Fig. 1 shows the steel girder bridge before its collapse. This bridge was fabricated from weathering steel left unpainted, and had three girders with 1500mm girder depth, 2200mm distance between each girder, and 35.0m span. The bridge had been exposed to environmental conditions 50m from the seashore in Okinawa for 28 years, and had been monitored on its corrosive environment and corrosion profiles until its collapse in 2009 due to the severe corrosion of the girder end. It can be seen from the figure that the inner girders in the bridge cross-section are corroded more than the outside girders.

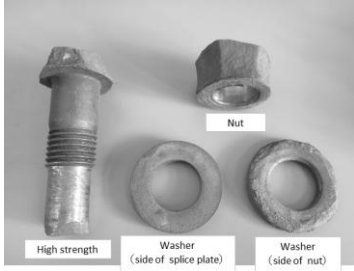
Figure 4. High strength bolts.

Corroded friction joints connected by high-strength bolts were cut from the web plates of the outer main girders, i.e., G1 and G3, as shown in Fig. 1. Fig. 4 shows the corroded high strength bolts which were removed with the core extraction method from the corroded friction joint. The thickness-reduced quantities of the bolt heads and nuts exposed to corrosive factors (e.g., air, aerosol chlorides, and rain water) were severely intense. The washers were also severely corroded except the surfaces in contact with a bolt head and a nut. On the other hand, the bolt shaft parts sealed by a bolt hole have comparatively maintained their integrity.

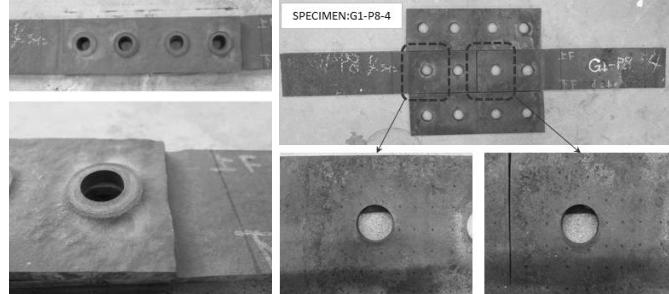
Figure 5. Splice plates.

Fig. 5 shows the corrosion states of the splice plates. It can be seen that the surfaces of the splice plate are uneven due to the corrosion thinning. However, the progression of the corrosion at the surfaces of the splice plate in contact with washers is inhibited. On the other hand, the corrosion of the surfaces around washers have severely progressed in a doughnut-shape with an approximate 10mm width. Furthermore, the end edges of the fastener plates also have progressed with the corrosion thinning. It can be said from this corrosion profile that the joint parts on the edges of the fastener plates and around washers are more corroded because those parts present a condensed condition with dust and water.

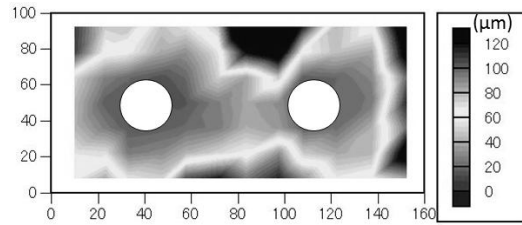
Figure 8. The corrosion thickness.

Corrosion thicknesses were measured at every 10mm on the inner surfaces of the fastener plate with an electromagnetic thickness gage, as shown in Fig. 7. The thickness of corrosion shown is the average value of the triple measurements. The corrosion thicknesses of inner surfaces of the fastener plate are shown in Fig. 8. From this figure, it can be seen that the edges of the inner surfaces are more rusted than the

inner surfaces around a bolt hole. These results show that the progression of the corrosion at the inner surfaces around the bolt hole is inhibited by the tensile force given by the high-strength bolts.

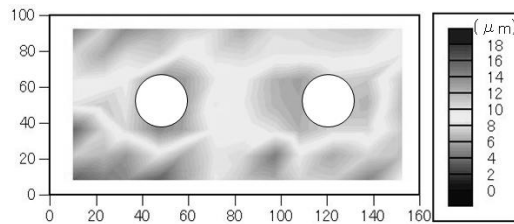
Figure 10. The arithmetic average roughness.

The roughness of the inner surfaces of the fastener plates was measured with a tracer-type surface roughness meter. The arithmetic average roughness (i.e., Ra) that has a relationship with the friction coefficient was applied for this measurement. Fig. 10 shows the contour plots of the arithmetic roughness of the inner surfaces. It can be seen clearly that the edge of the inner surfaces had more roughness than the inner surfaces around the bolt hole, because of the intense rust.
