ANALYSIS OF DETERIORATION IN REINFORCED CONCRETE BRIDGE GIRDERS DAMAGED BY CHLORIDE DETERIORATION AND FATIGUE

H. HONDA, T. SHIMOZATO, and Y. ARIZUMI

Dept of Engineering, Ryukyu University, Okinawa, Japan

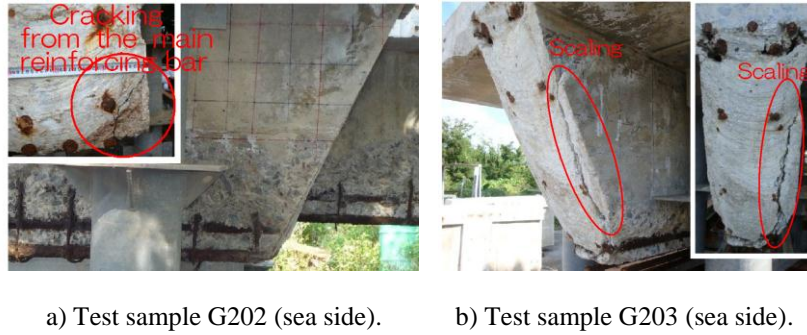
Figure 2. State of damage in girder G2 (sea side).

- On the undersides of the main girders, cover concrete had spalled off, leaving the main reinforcing bars exposed and severely corroded. On the sides, spalling had not gone beyond areas around the main reinforcing bars.

- There was extensive scaling accompanied by cracking on the sea side of the main girder, exposing main reinforcing bars as far as the second layer, resulting in extreme corrosion. On the mountain side, only the lowest layer of reinforcing bar was affected.

Next, Figure 2 shows the cross section of girder G2 close to the sea side, and Figure 3 is a diagram of cracking in main girders. The net cover over the main reinforcing bars was 54 mm on the underside and 69 mm on the sides, so the underside had the least cover. Cracking on the sea side of test sample G202 penetrated to the web face close to the second layer of main reinforcing bar, but had not advanced above that (Figure 3c). The cut surface at the midpoint between supports had some remaining cover concrete, with cracking observed to penetrate from the lowest main reinforcing bar layer, pass close to the second layer of main reinforcing bar, and extend to the surface. Thus, cracking had not originated from the second layer of reinforcing bars.

cover over the stirrups at the center of the web to the surface. The net cover from the sides to reinforcing bars was around 85 mm in test sample G202, but only around 65 mm in G203, in a position 20 mm thinner.

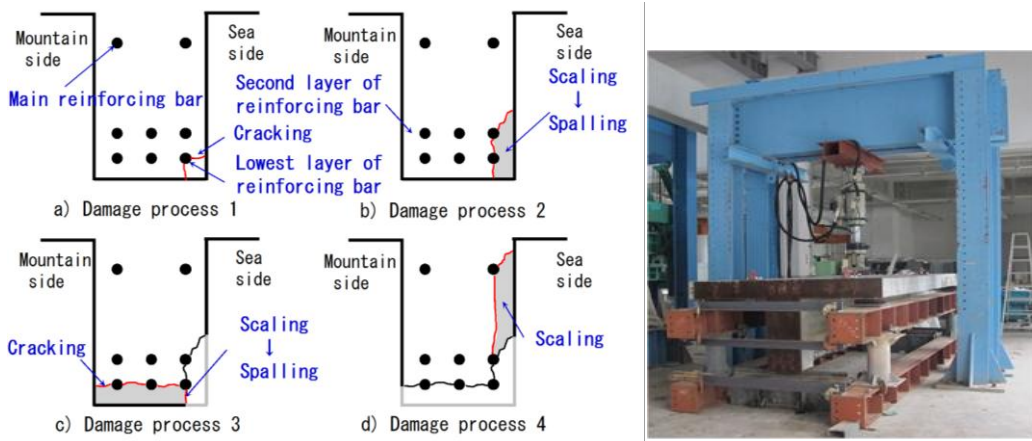
Figure 3. Cracking damage process in main girders.

Cracking on the sea side of test sample G203 penetrated to the web face close to the main reinforcing bars, and to the surface close to the center of the web (Figure 3d). Thus, close to the main reinforcing bar, damage had penetrated from the lowest layer of main reinforcing bars to the second layer, and advanced gradually from the depth of

From the above, the state of deterioration can be illustrated as in Figure 3 for the undersides and sides of main girders, and for the sea sides and mountain sides, in which different damage patterns were observed. The following characteristics of chloride-induced deterioration can be inferred.

- Corrosion and expansion from the lowest layer of main reinforcing bars on the sea side caused cracking, and vertical cracks had extended on surfaces with thinner cover. (Figure 3a)
- Reinforcing bar corrosion advanced further due to windblown salt, and cracking extended from the second layer of main reinforcing bars to the web. (Figure 3b)
- Cover concrete on the sides spalled off (Figure 3b) and main reinforcing bar on the mountain side corroded due to contact with windblown salt. Cover concrete spalled off the underside. (Figure 3c)

- On the sea side, corrosion of the stirrups caused cracking to advance onto the upper web; there was scaling of the cover concrete. (Figure 3d)

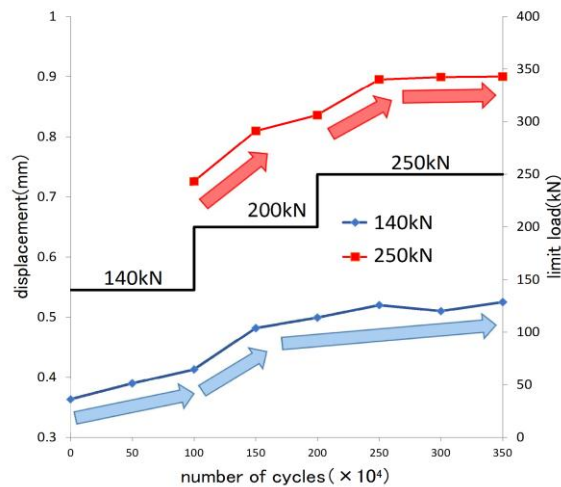
Figure 5. Displacement - number of cycles relationships.

Figure 5 shows the relationship between displacement and loading number of times. As Figure 5 clearly shows, displacement is increased due to an increase in fatigue loading times and when fatigue loading limit load is increased from 140 kN to 200 kN, displacement of the static loading test was greatly increased. However, when fatigue loading limit load is increased from 200kN to 250 kN, only displacement of 250 kN has increased significantly.

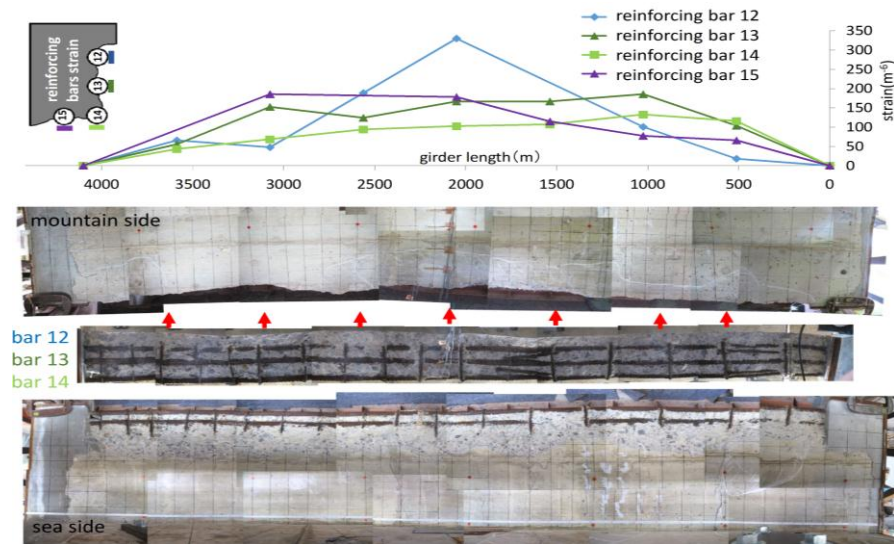
Figure 6. Reinforcing bars strain and the state of deterioration.

Figure 6 shows reinforcing bars strain after 3.5 million times loading. In addition, for comparison of the state of deterioration and reinforcing bars strain, photos of test sample G202 is to be displayed. As Figure 6 shows, reinforcing bar 12 of the mountain side was one point concentrated load loading state of simple beam. Other reinforcing bars did not show a tendency of the “reinforcing bar 12”. Reason as, reinforcing bar 12 that remain of side of the cover concrete are integrated concrete and reinforcing bars. The state of deterioration, such as cracks and reinforcing bars strain is not related.
