BASAL STUDY ON SIMPLE THICKNESS EVALUATION FOR ROAD-LIGHTING POLES WITH LOCAL CORROSION NEAR THE BASEPLATE

TOMOHIRO MITSUNAGA¹, TATSUMASA KAITA¹, and KATASHI FUJII²

In this study, a simple thickness evaluation method was proposed for corroded road-lighting poles based on thickness measurement results of a dismantled road-lighting pole which had been used for about 40 years. The remaining thickness in cross-section of this specimen was measured by using both of Ultrasonic Thickness Gauge (UTG) and 3D portable laser scanner in order to investigate the accuracy of average thickness which could be obtained from only 4 measuring points at intervals of 90 degrees in circular cross-section. In this UTG measurement, the smoothing process, which will be carried out ordinarily by using electric grinder around measuring points, was abbreviated from the considering of labor-saving and additional thickness loss. From the measurement results, UTG measurement under the condition of no smoothing process will overestimate the actual remaining average thickness depending on surface roughness due to corrosion. Finally, an example of simple thickness evaluation, which uses average thickness and stan

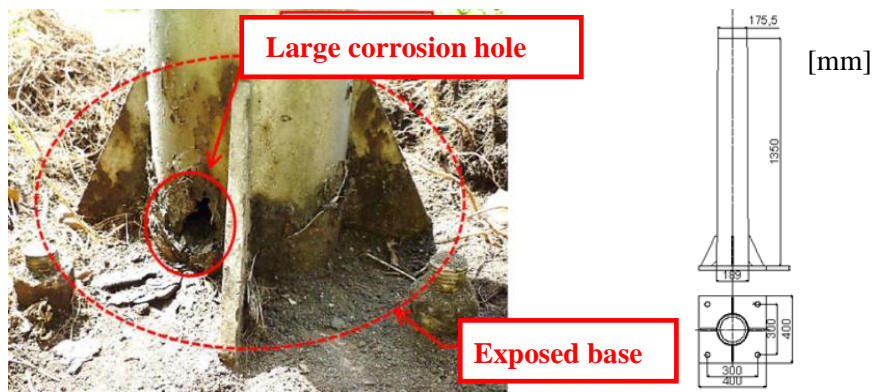
Photo 1. In-situ condition and dimensions of road-lighting pole specimen.

The corroded pole specimen in this study is a dismantled road-lighting pole, which had been used for about 40 years at coastwise road in Yamaguchi prefecture, with severe local corrosion near the baseplate. Photo 1 shows in-use condition and dimensions of this specimen. This pole has 4 stiffening ribs ($t = 12$ mm) on a baseplate, but this baseplate was covered with many clod and weed. The distance from coast of Seto Inland Sea was only 100 m. In Photo 1, a large corrosion hole between 2 ribs could be confirmed near the baseplate. The initial thickness (t_0) of this pole would be 4.5 mm.

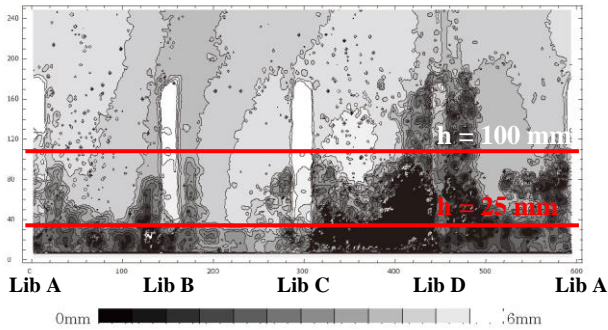
Before the thickness measurement, remaining paints and rusts on steel surface were removed by sandblast. The range of thickness measurement is $0 \text{ mm} < h < 250 \text{ mm}$. At first, the portable 3D scanning system was applied to thickness measurement of specimen. This system can obtain 3D coordinate values of steel surface at the intervals of less than 1 mm by irradiating 2 wide laser beams (measurement accuracy: $50 \mu\text{m}$). Then the remaining thicknesses of specimen were calculated from two-sided 3D coordinate values at 2mm mesh. In this study, the thickness measurement results obtaining by using 3D scanner were treated as the most probable value. In this study, the thickness measurement results by using 3D scanner are treated as the most probable values. The thickness contour map of specimen is shown in Figure 1 as development diagram. From this figure, it will be found that severe corrosion damages progressed

Figure 1. Thickness contour map (3D scanner).

near the baseplate under $h < 75$ mm. Especially, a large corrosion hole between Rib C and D is marked, since both ribs were in a direction towards seaside while in use.

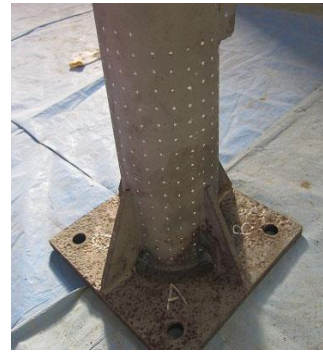
Photo 2. Measuring points for UTG.

On the other hand, UTG measurement was carried out without smoothing process around measuring points at 25 mm mesh as shown in Photo 2. The circular contact probe ($\phi 9$ mm, ultrasonic velocity: 5,920 m/sec, frequency: 5 MHz, measurement accuracy: 10 μ m) and pipe measurement jig were applied for this measurement.

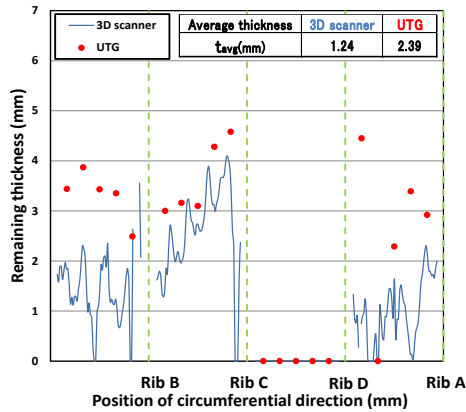
(a) $h = 25$ mm.

Figure 2. Remaining thickness distributions in a cross-section.

Figure 2 shows the examples of remaining thickness distribution obtained from 3D scanner and UTG measurement results in a cross-section of $h = 25$ mm and 100 mm. The number of measuring points per one cross-section are 254 (3D scanner) and 20 (UTG), respectively. In Figure 2(a), it could be noticed that the UTG results (red dots) are greater than that of 3D scanner. And, the average thickness calculated from UTG

results was overestimated about 1.15 mm than actual thickness. However, in the $h = 100$ mm section, which has minor corrosion as compared to the section of $h = 25$ mm, the measuring results obtained from 2 different devices significantly approximated each other, as shown in Figure 2(b). From these facts, it is thought that overestimation of remaining thickness in UTG measurement was caused by surface roughness due to severe local corrosion. In addition, the average thickness and thickness distributions of 3D scanner and UTG are almost the same at the section in the range of $h > 100$ mm.

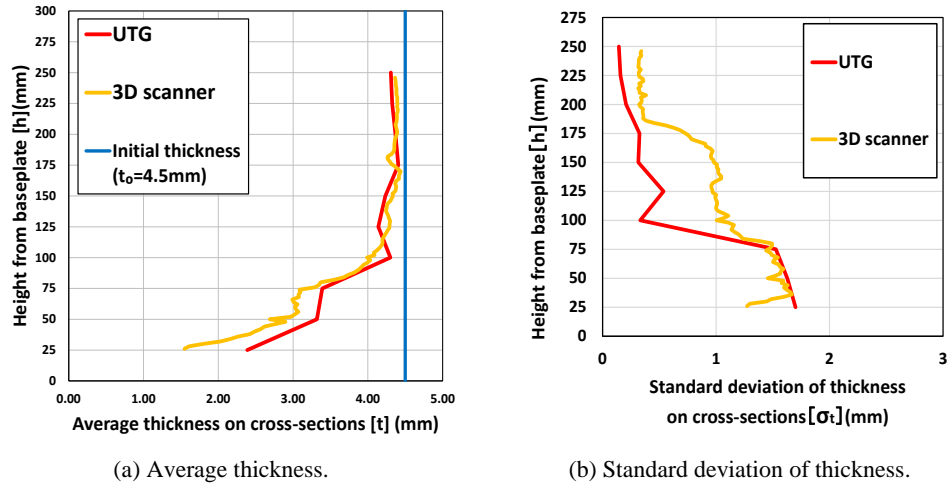
Figure 3. Relationship between h and statistical thickness parameters.

Figure 3 shows the relationship between h and statistical thickness parameters. From Figure (a), the average thickness (t_{avg}) in a cross-section was decreased remarkably in the range of $h < 75$ mm. In this portion, it is thought that the clod and salty weed on baseplate would accelerate corrosion progress. And, it can be confirmed that the UTG measurement is more likely to overestimate remaining thickness when the height from baseplate is smaller. Figure (b) shows the relationship between h and standard deviation of thickness (σ_t). In the range of $h > 75$ mm, because many pitting corrosion which has the diameter smaller than that of UTG probe are distributed widely on steel surfaces, UTG probe cannot measure the corrosion wastage by their pitting corrosion. Therefore, σ_t of UTG results will become smaller than that of 3D scanner. On the other hand, in the range of $25 \text{ mm} < h < 75$ mm, because the large corrosion pits, which may affect to the average thickness, are generated all over the surface, it can be thought that the variation of measured thickness is a little more than 3D scanner.
