Research Article

# DAMAGE OF PUNCH/DIE TOOLS IN STEEL WIRE ROD SHEAR CUTTING

*In this research work, damage of punch/die tools in a steel wire rod shear cutting was investigated. The tools (punch and die) used in a steel wire rod (JIS SCM420) cutting ranging from 50,000 to 150,000 cutting shots were collected for the investigation. Experimental results showed that the main damage of the tools at the sheared zone was tool edge chipping. The edge of the die was chipped severely when passing 150,000 cutting shots. To investigate the cutting characteristics of the wire rod by the damaged tools, the tools were applied for a shear cutting test using a developed shear cutting tool holder. It was found that the damage of the tools did not remarkably affect the cutting load resistance of the wire rod. However, when cutting the wire rod with the higher-cutting-shot tools, the quality of the sheared edge deteriorated. Namely, the sizes of the rollover and the burr at the sheared edges of the wire rod tended to increase.*

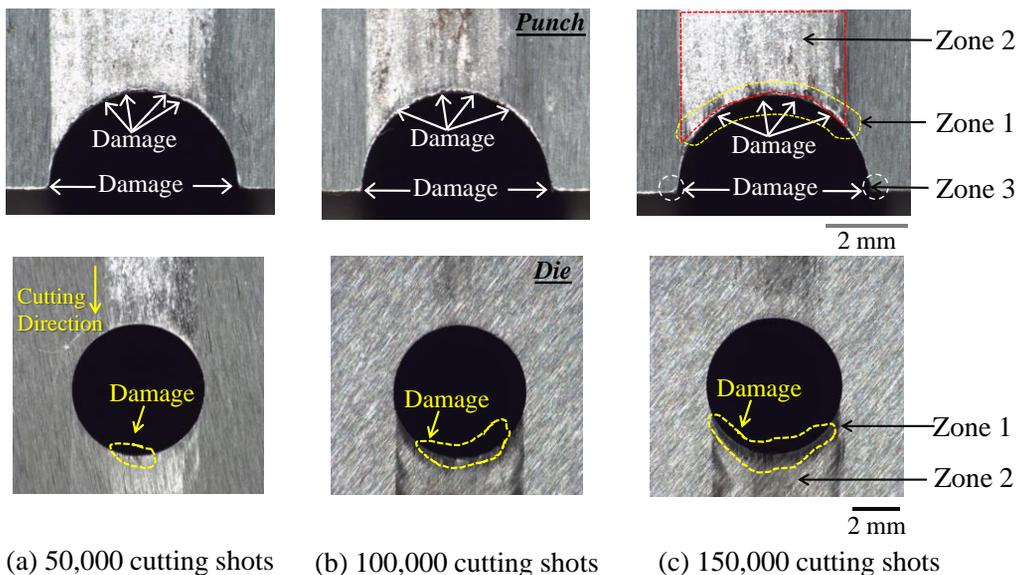
Figure 3 shows the macroscopic photographs of the used punch/die tools. As seen in this figure, three damaged areas were observed on the punches. First, at Zone 1, the damage occurred at the cutting edge of the punches. Since this area was acted directly by the load of shear cutting, the damage could be confirmed to be caused by the shear cutting stress. Then, at Zone 2, scratches appeared on the front surfaces of the punched. This seemed to be resulted by the abrasion between the cut wire rod remained in the die and the surface of the punch. Third, the damage was seen in the edge of the punch (Zone 3). At this zone, an apparent metal loss was detected. Considering the damage of this far area from the sheared zone of the punch, it was not caused by the shear cutting stress. However, vibration of the high-speed moving wire rod during shearing possibly resulted in this damage.

**Fig. 3.** Front-view photographs of the used punches and dies.

At the dies, as seen in Fig. 3, the damage due to the shear cutting stress was detected, at Zone 1. Also, viewing the front surfaces of the dies, the scratches appeared. Based on the overview photographs, when the cutting shots of the tools increased from 50,000 to 150,000, the severity of damage, the tool surface scratch, the metal loss at the punch edges and the damage at the sheared zone, tended to increase.

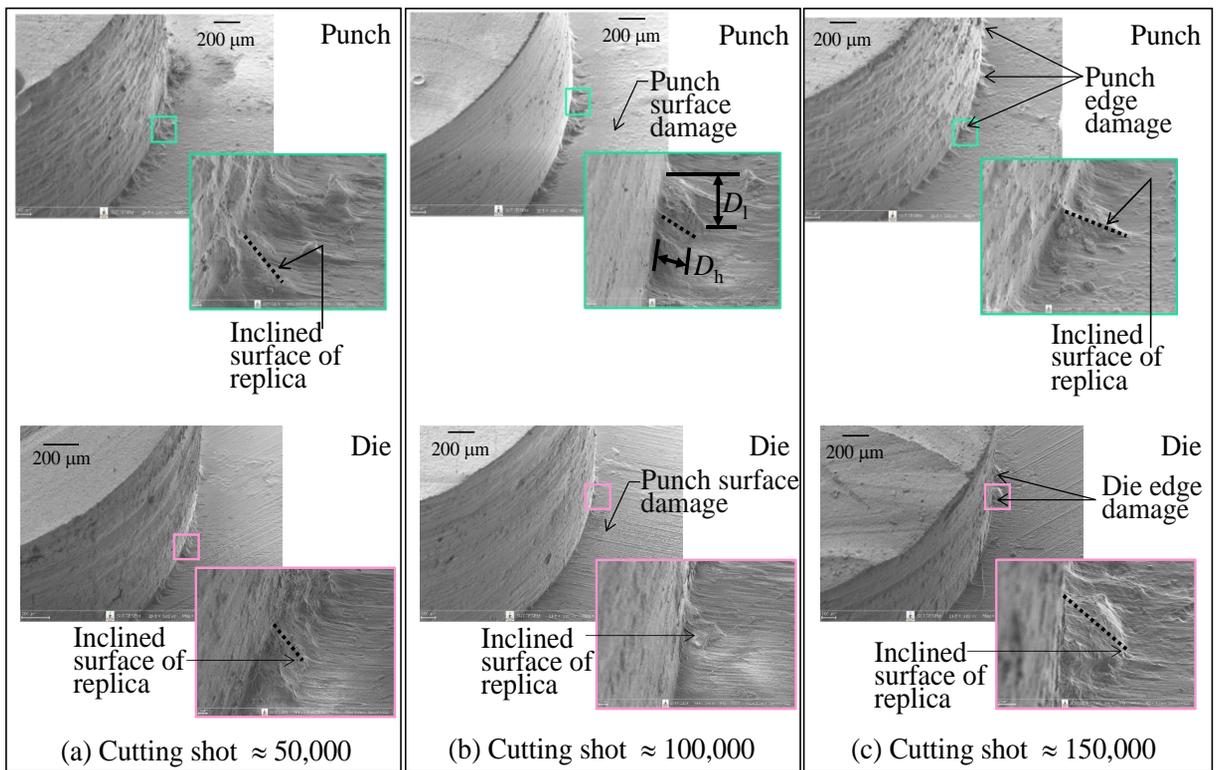
In this work, the authors focused on the examination of the tool damage caused by the shear cutting stress. Since the damage at the sheared zone of the tools occurred at the tool surfaces and splayed inside the tool holes, Two-dimensional micrographs was not usable to clearly see the damage of the tools. So, the authors did the investigation using the replica technique. Figure 4 represents the scanning electron micrographs of the replica samples at the sheared zone. From this figure, it was seen that the damage of the punch and the die due to the shear cutting stress had features of inclined surfaces. Also, this result indicated that the main damage of the cutting tools was edge chipping.

**Fig. 4.** SEM images of replica samples showing damage of punches and dies.

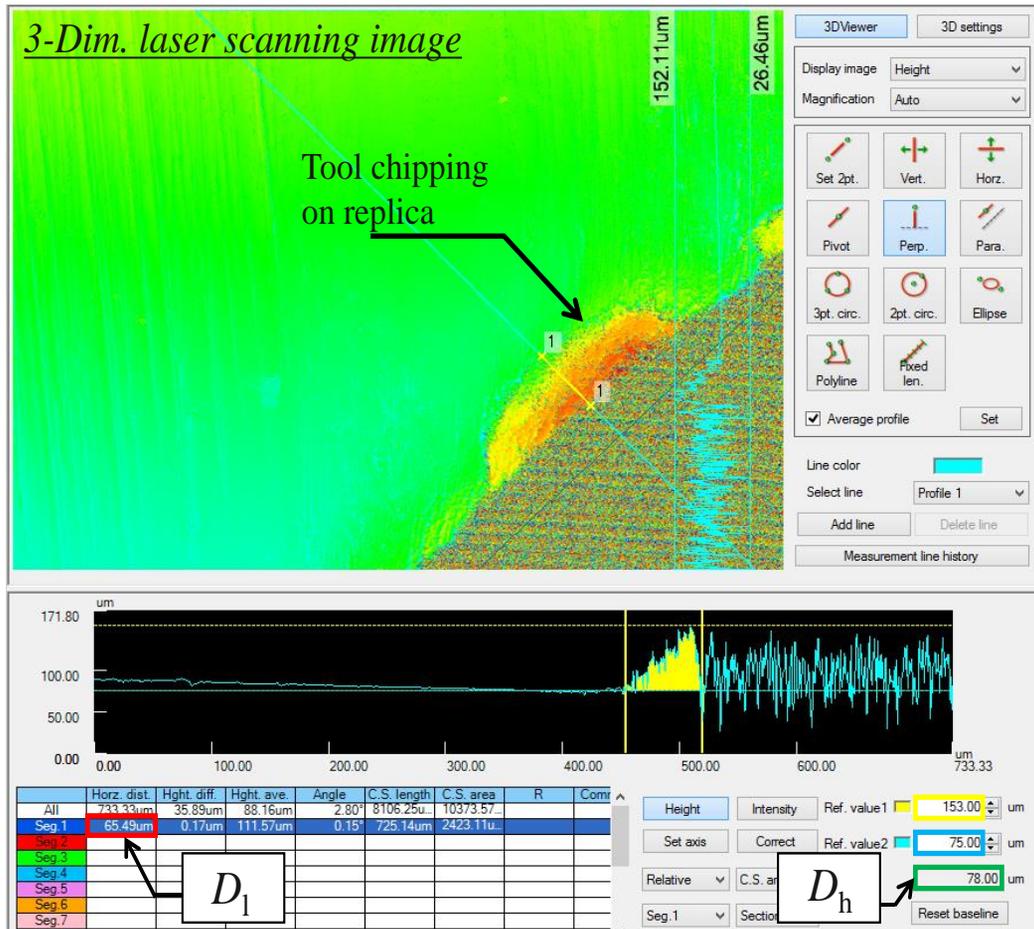
To further investigate the progression of the chipping with respect to the tool cutting shots, the replica samples were subjected to a 3-dimensional laser scanning microscope (Keyence, VK-8710). After scanning, the length ( $D_l$ ) and the height ( $D_h$ ) of the chipping (expressed at the chipping zone in Fig. 4) were measured. Figure 5 shows the measurement of the chipping distances by the microscope.

**Fig. 5.** Measurement of damage distances on replica using 3-Dim laser scanning microscope.

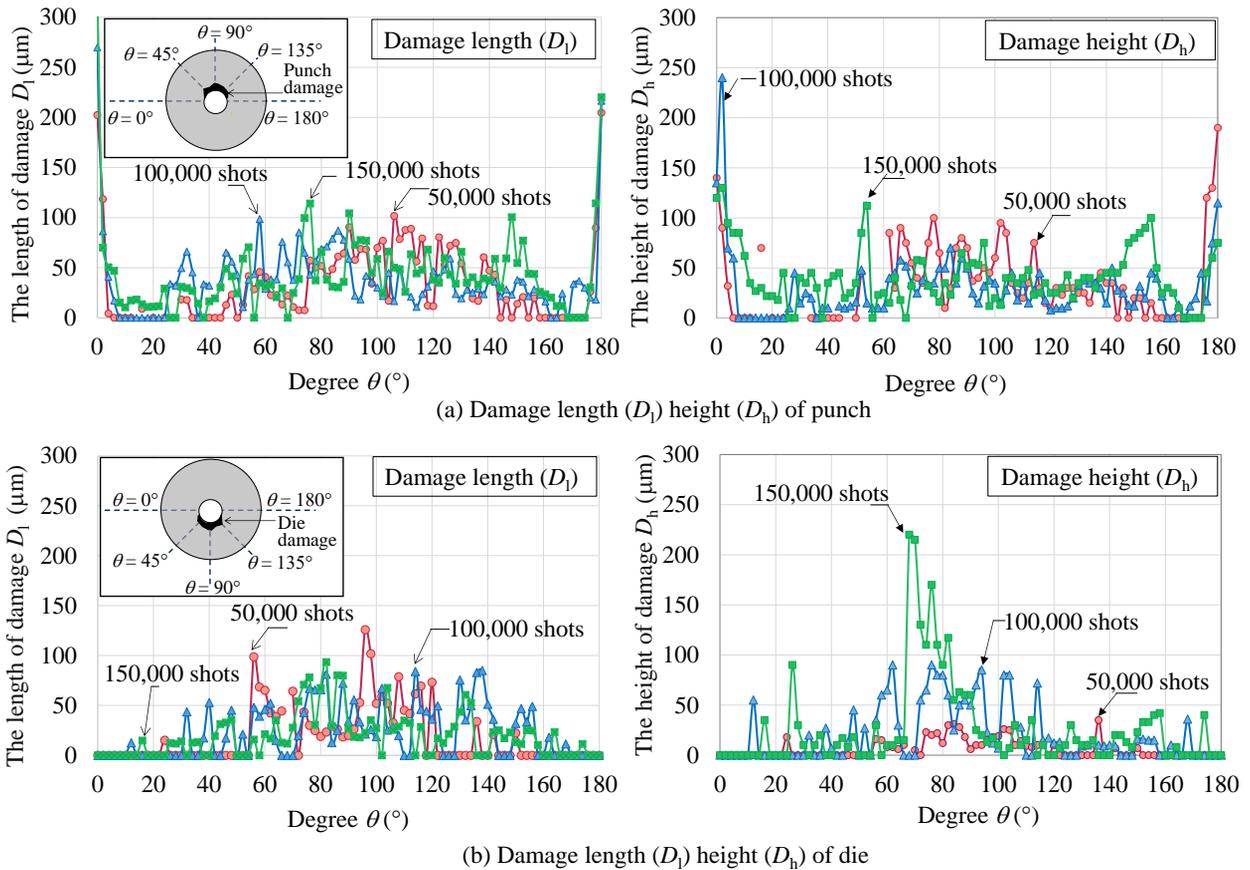
Figure 6 represents the damage length and height measured along the circumferences of the punch and the die cutting edges. As shown in such figure, the 90° angle corresponds to the highest cutting edge of the punch while it corresponds to the lowest cutting edge in the case of the die. From this figure, the following tool damage characteristics were revealed: first, at the edges of the punches (at 0 and 180°), the damage was fairly severe and similar in all cases of the cutting shots. This corresponded to the metal loss at the punch edges, as explained above. Second, seeing the damage distances,  $D_1$  and  $D_h$ , the chipping of the punches and died was drastic at the highest cutting edges of the punches and the lowest cutting edges of the dies (at 90°) and tended to decrease for the faraway positions along the circumferences of the punches and the dies. Third, comparing the damage of the tools under different cutting shots, the chipping of the tool cutting edges except the damage height of the punch ( $D_h$ ) was not significantly different. Finally, seeing  $D_h$  in Fig. 6 (b), the damage height of the die near the lowest edge tended to increase with increasing the tool cutting shots. Here, it was confirmed that when the cutting shots increased, there was the progression of the damage, i.e. at the cutting edge of the die.

**Fig. 6.** Measured damage length and height at punch and die edges.

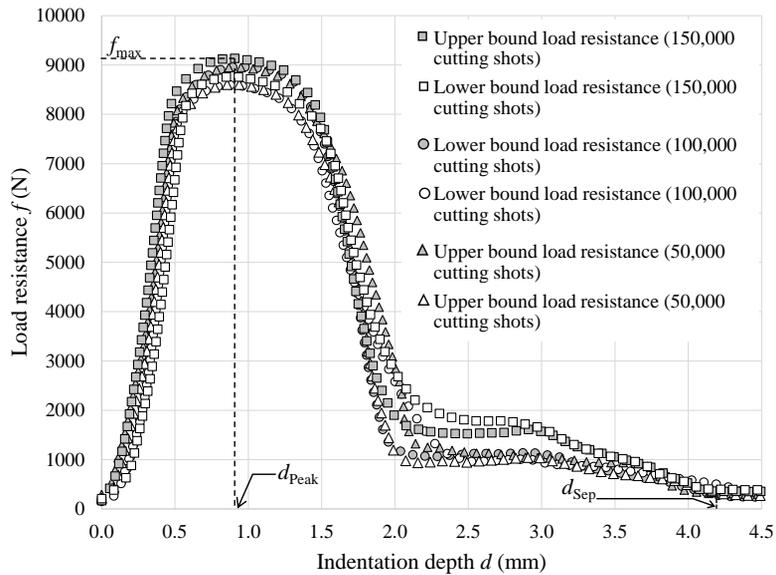
In steel wire rod shearing industry, punch and die are impossible to be replaced, suddenly after their damage. Due to the high productivity of the shear cutting process, a lot of wire rods are cut by the damaged tools. In order to identify the acceptance damage level of the tools to obtain satisfy shear cutting results, the understanding of the cutting characteristics of the wire rod by the damaged tools is crucial. Thus, the authors used the damaged tools (50,000, 100,000 and 150,000 cutting shots) for the wire rod shear cutting test and investigated. Figure 7 shows the cutting load resistance of the 50,000, 100,000 and 150,000 cutting shot tools. Here, it was found that the load resistance of the wire rod was not significantly different when varying the tool cutting shots. In addition, considering the peak point of the load ( $f_{max}$ ) and the peak position ( $d_{peak}$ ) which typically correspond to the crack initiation state of wire rod, they were not noticeably affected by the tool damage. Also, the final separation position of the wire rod ( $d_{sep}$ ) was similar for all cutting shot tools.

**Fig. 7.** Relationship between indentation depth of punch and cutting load resistance of wire rod.

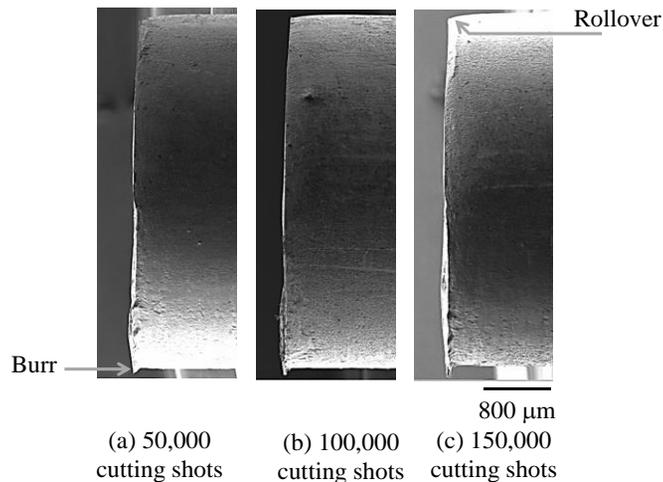
After shear cutting, the sheared edges of the wire rods were examined by the Scanning Electron Microscope. Figure 8 represents the sheared edges of the wire rods cut with the 50,000, 100,000 and 150,000 cutting shot tools. From this figure, rollover and burr at the sheared edges were observed. Their size seemed to be increasing with the tool cutting shots. To examine the sheared edge feature in more details, an image analyser software was utilized to measure the dimension of the burr and the rollover.

**Fig. 8.** SEM images of steel wire rod sheared edges.

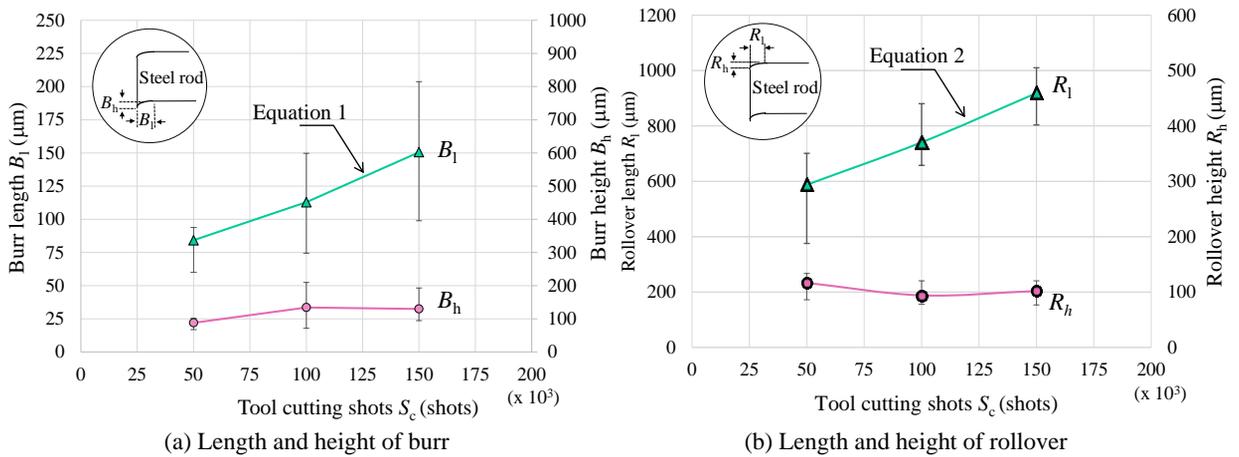
Figure 9 represents the measured length and the height of the burr and the rollover at the sheared edges. As seen in this figure, the following geometrical features were revealed: (i) for the cutting tool shot ranging from 50,000 to 150,000, the lengths of the burr and the rollover linearly increased when the cutting shot increased. Eqs. (1) and (2) explained the relationships. In these equations,  $S_c$  is the numbers of the tool cutting shots. (ii) there were slight variations of the burr and the rollover heights for the investigation range of the cutting shots. When relating the sheared edge geometry with the tool damage explained before, the lengths of the burr and the rollover seemed to be related to the severity of tool damage.

**Fig. 9.** Relationships between cutting shots and dimensions of burr and rollover at sheared edges.
