# Thermal Imaging for Improving Energy Conservation Behaviors: An Infrared Thermography Survey for Residential Buildings

Husein Ali Husein<sup>1\*</sup>

<sup>1</sup>Department of Architecture, College of Engineering, Salahaddin University-Erbil, IRAQ.

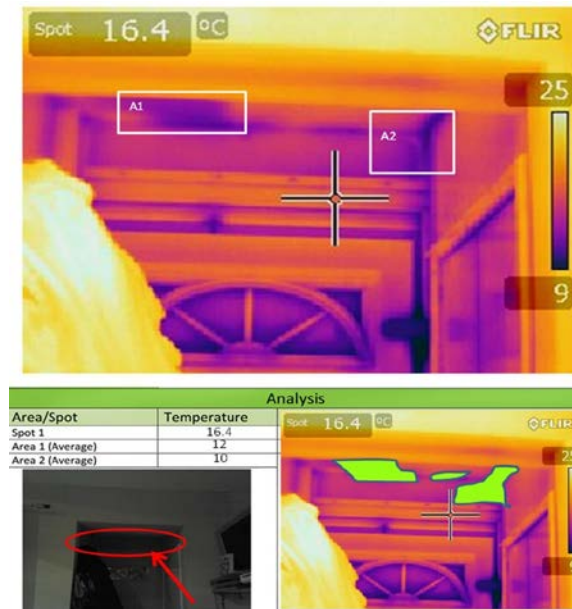
**Figure 6:** Using thermography for the entrance

The green highlighted isotherm in the infrared image shows the area where the surface temperature is below the critical surface temperature which is on average 10°C (Figure 6).

**Area 1** is likely due to the missing /poorly fitted insulation within the pitched roof above the extension.

**Area 2** the junction between the walls shows the cold area which is likely due to missing insulation which allows cold air to infiltrate the residence.

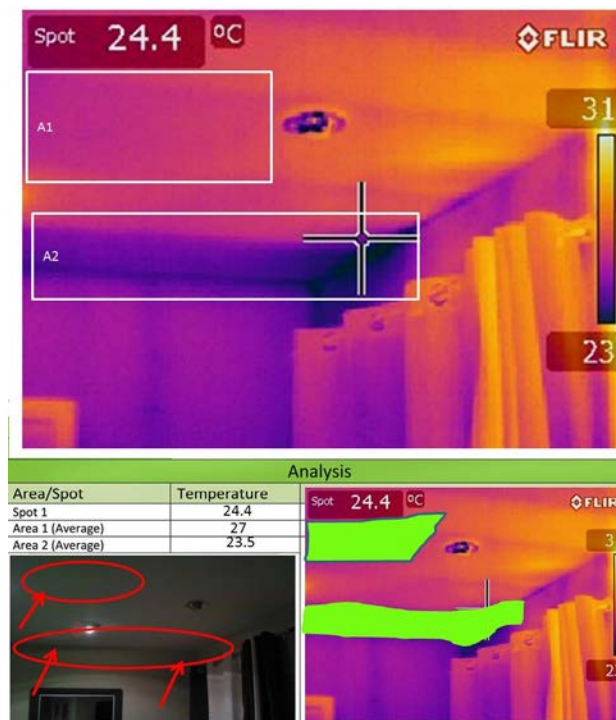
**Figure 7:** Using thermography for the Living room

The green highlighted isotherm in the infrared image (Figure 7) shows the area where the surface temperature is below the critical surface temperature which is on average 23°C. Both area 1 and 2 shows the cold area which is likely due to missing/poorly insulation within the ceiling. The missing insulation and thermal bridging may be a common defect in the new house in the studied area and can also have a significant effect on the energy efficiency of the building fabric. Visual inspection is unlikely to identify defects within the insulation layer once covered over by surface finishes. Therefore, the performance of insulation, which is sensitive to the quality of installation, may be subject to considerable variation. Heat flux measurement and co-heating tests enable thermal transmission to be measured. However, the cost and time taken to conduct these tests are currently a barrier to their more widespread use, particularly during the construction process.

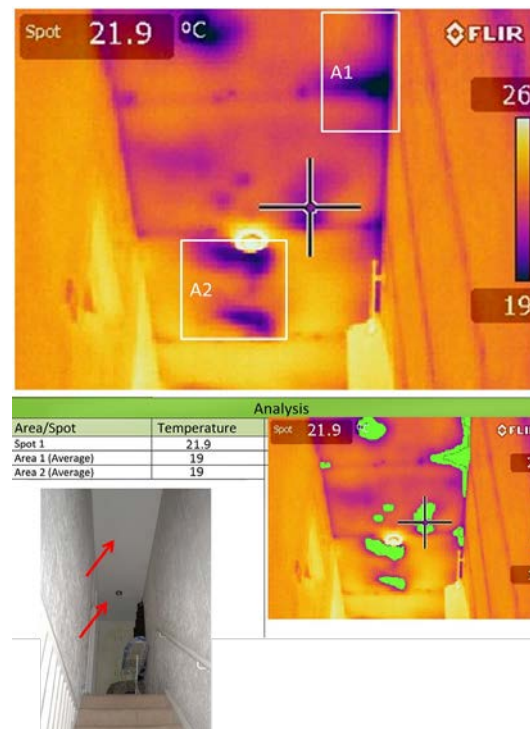
**Figure 9:** Using thermography for the staircase area

The green highlighted isotherm in the infrared image shows the area where the surface temperature is below the critical surface temperature which is on average 19°C.

These areas illustrate the dampness in the ceiling due to the missing insulation also it shows the cold air infiltration which leads to heat loss and eventually reduces the efficiency of the building.

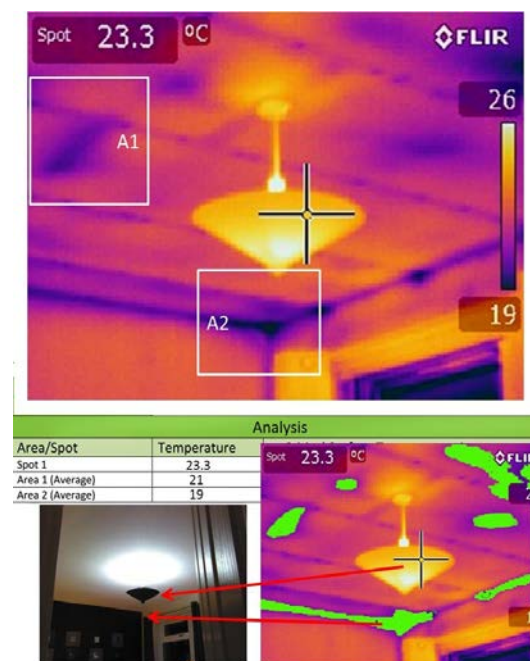
**Figure 10:** Using thermography for the bedroom

The dark blue areas (Figure 10) in the ceiling represent the area where the temperature of the surface is below the critical surface temperature which is on average 23.3°C

**Area1:** These wide spots in the ceiling show the missing of the fitted insulation in the loft.

The missing insulation leads to an increase the air infiltration from and into the room, which has an impact on reducing the heating efficiency in the room due to a large amount of air penetrating the ceiling, especially on windy days.

However, area 2 shows the joint poor/missing insulation which causes air leakage.

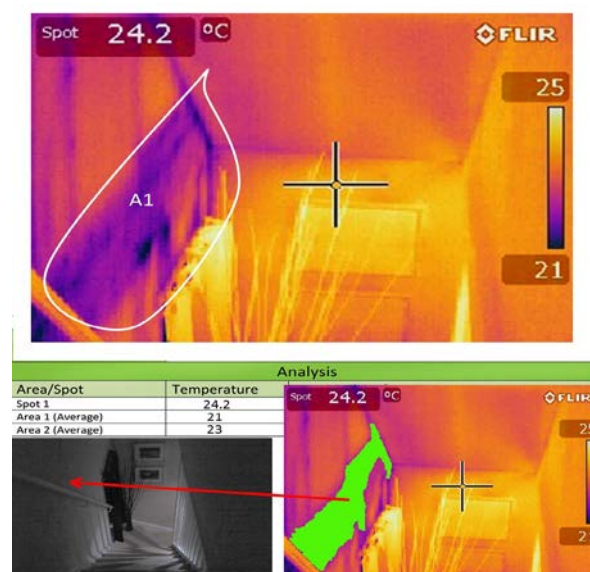
**Figure 13:** the defects on the staircase wall

The green highlighted isotherm in the infrared image (Figure 13) shows the area where the surface temperature is below critical surface temperature which is on average 24°C.

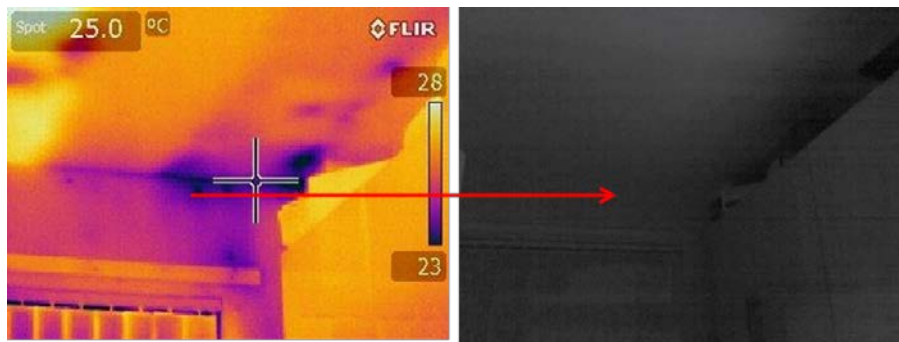
**Figure 15: Kitchen wall under thermography**

Water leakage and also air infiltration lead to heat loss through the cold area shown in the image due to poor/missing insulation.

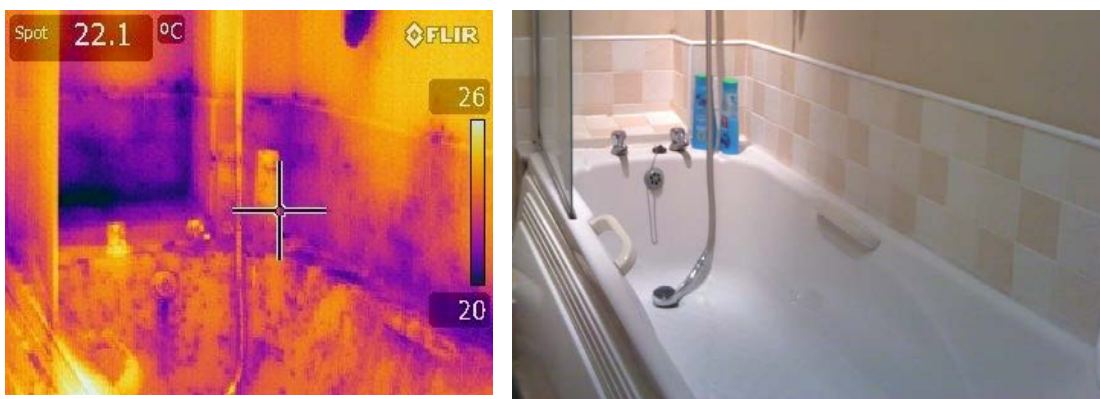
**Figure 16: leakage of the water in the side of the bathroom**

The image (Figure 16) illustrates the leakage of water into the side of the bathroom. This is due to poor insulation being used for the bath.

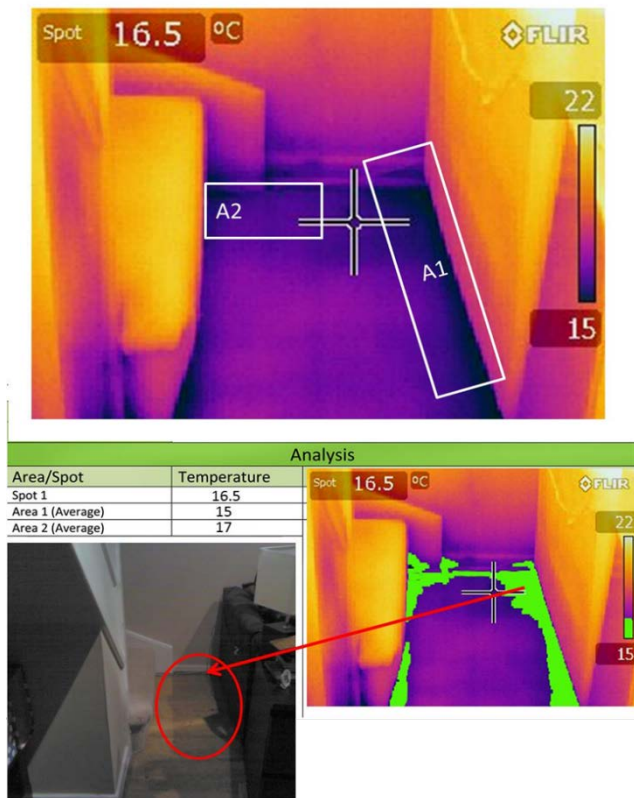
Figure 17: Living room floor under thermography

The green highlighted isotherm in the infrared image shows the area where the surface temperature is below the critical surface temperature which is on average 22°C (Figure 17), and which is on average 20°C (Figure 18).

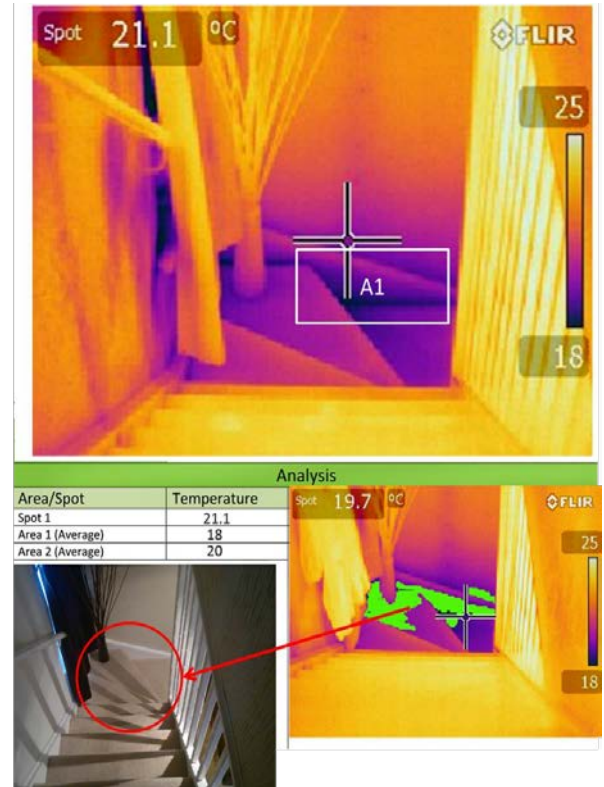
Figure 18: Analysis of staircase walls

The large difference between the floor temperature and another surrounding surface (Figure 18) which is around 7°C illustrates a cold area where the heat is lost; this is likely due to missing insulation.

This cold area causes air leakage and also heat loss (Figure 18) this is likely due to the thermal bridge having been made by the window and missing the insulation.

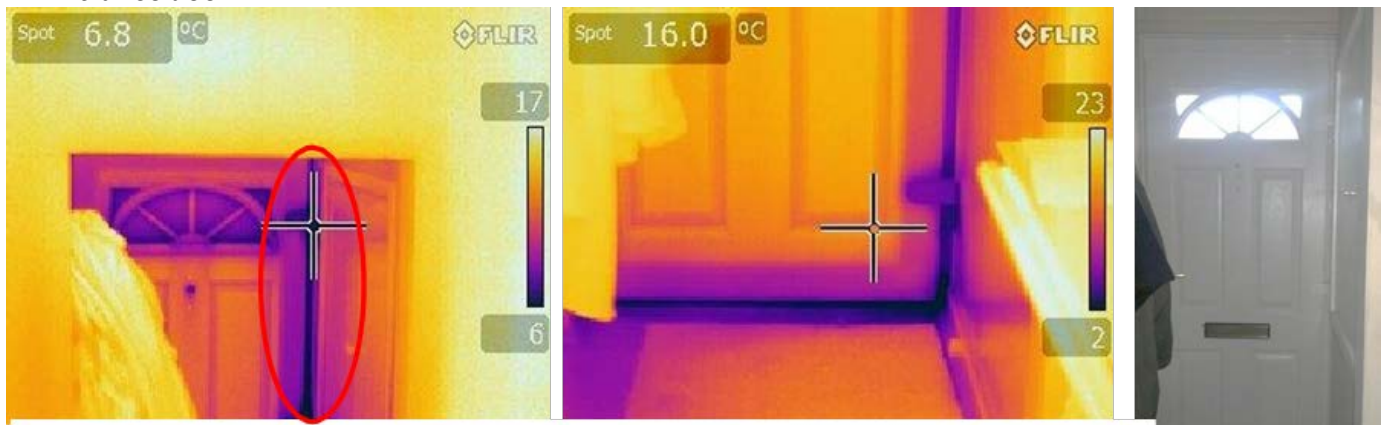
Figure 19: Investigation of entrance door under thermography

The black area (Figure 19) represents the area where the cold area is due to air infiltration, this is related to the defective seals on the top and bottom of the door profile.

By comparing these varying temperatures around the image, it is possible to identify cold air ingress in between the doors, and infer that by weatherproofing, comfort in that part of the home can be improved and energy costs reduced.

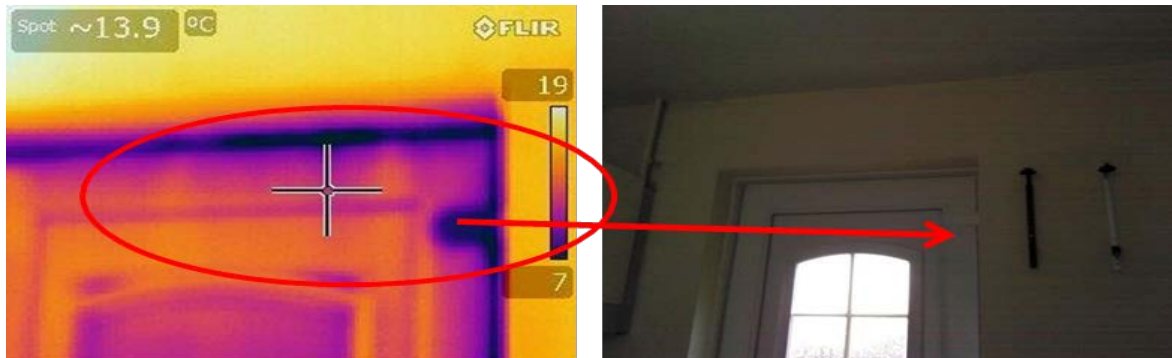
**Figure 20:** Defective seals on the top of the door profile

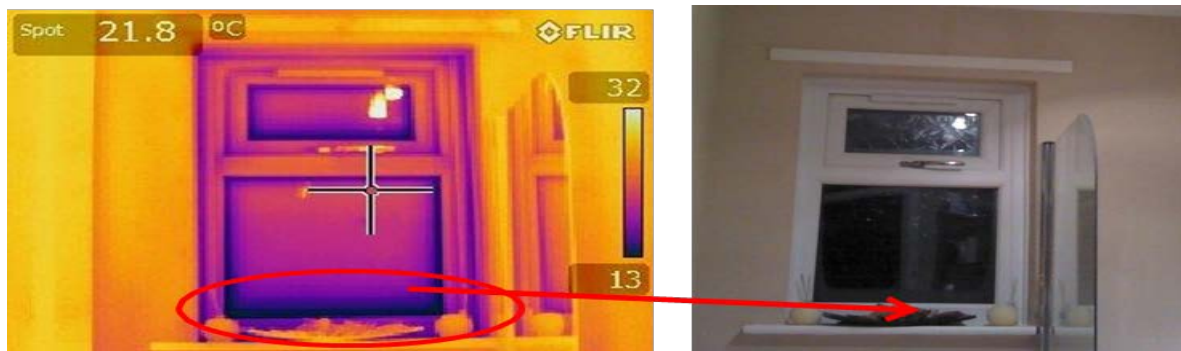
**Figure 21:** Detections around windows at the bottom.

The highlighted area (Figure 21) is cold air with a temperature of less than 14°C. This is likely due to the defective seals around the window frame and opening, allowing cold air to enter the house.

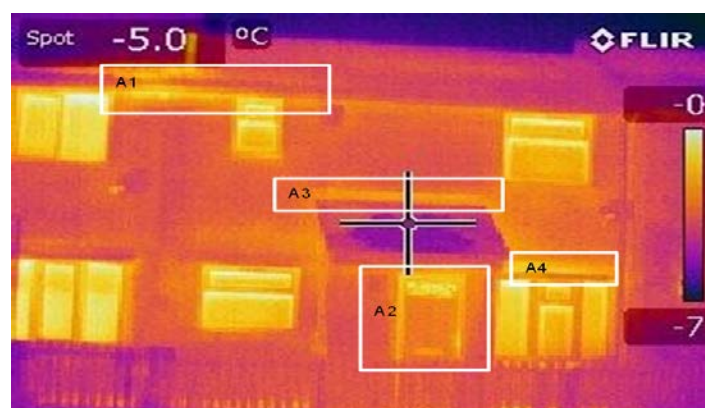
**Figure 22:** Thermography photo of the elevation walls.

**Area 1** shows a comparative increase in surface temperature, due to missing/poorly fitted loft insulation at the eaves of the roof.

**Area 2** is showing an increase in surface temperature around the door frames, possibly due to defective seals around the window openings allowing warm air to escape.

**Area 3** is showing an increase in the temperature above and around the extension area and this is due to poor/ missing insulation in the joints which leads to heat loss.

**Area 4** shows a comparative increase in surface temperature which is likely due to the window lintels creating a thermal bridge.

The temperatures of the windows appear to vary as well. Consider area 6, which looks to be cooler than area 5. Given that the two windows are in the same room and have the same temperature, the variation in infrared radiation is caused by infrared reflection from buildings on the opposite side of the road. They primarily measure infrared radiation, and various factors such as humidity, distance from the item, object emissivity, and reflection of infrared radiation from other sources can all influence the findings.
