## Debris Flow in Peninsular Malaysia - Case Study on Sungai Kupang Debris Flow, Kedah

Amir Mizwan Mohd Akhir\*, Saiful Abdullah, Mohd Farid Abdul Kadir,  
Abd Rahim Harun, Zamri Ramli, Hisamuddin Termidi

*Department of Mineral and Geoscience Malaysia*

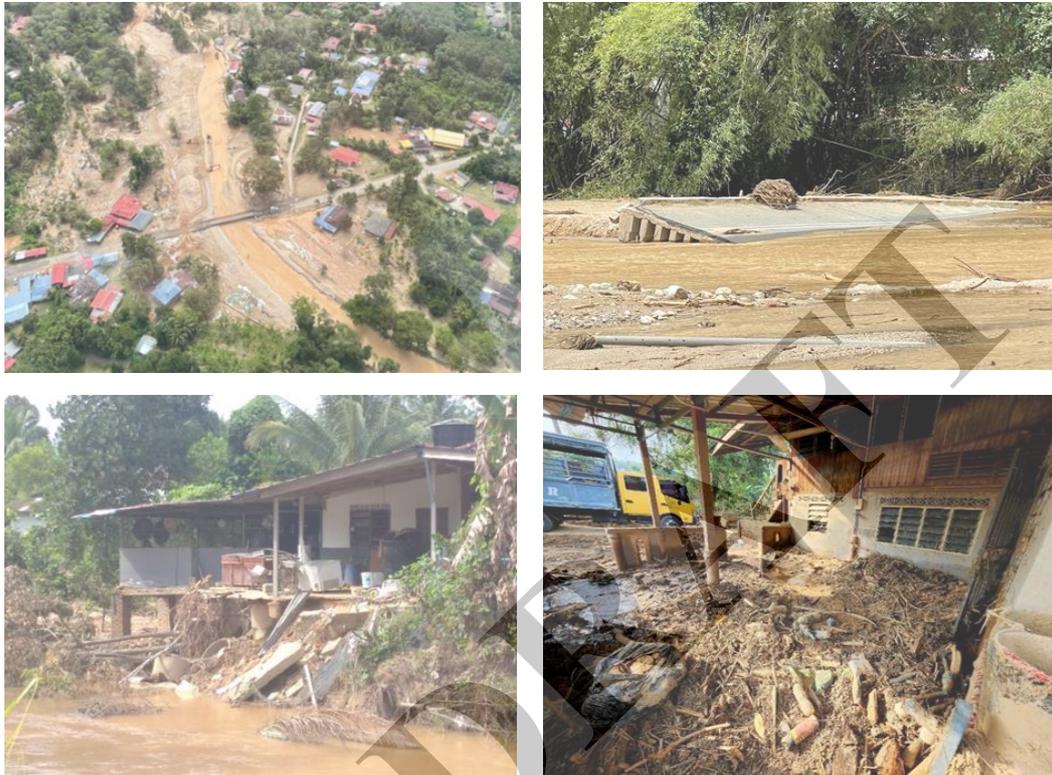
Kampung Iboi, a Malay traditional village and several villages downstream which are located on the banks of Sungai Kupang, Baling, Kedah were hit by the debris and mud flood on 04 July 2022. The disaster claimed 3 people, destroyed 17 houses and affected 3,546 with losses estimated at RM 25.91 million. The disaster with a high destructive power is the main cause of death and destruction of many infrastructure (Fig. 1). This incident happened very quickly, starting around 4 pm and the flood receded only after the next few hours. The debris flow and flood in Kampung Iboi was caused by a combination of several geological processes in the upstream area of Sungai Kupang. Heavy rains have triggered

**Fig. 1:** Photo of Kampung Iboi, Sungai Kupang, Kedah (the most affected area)

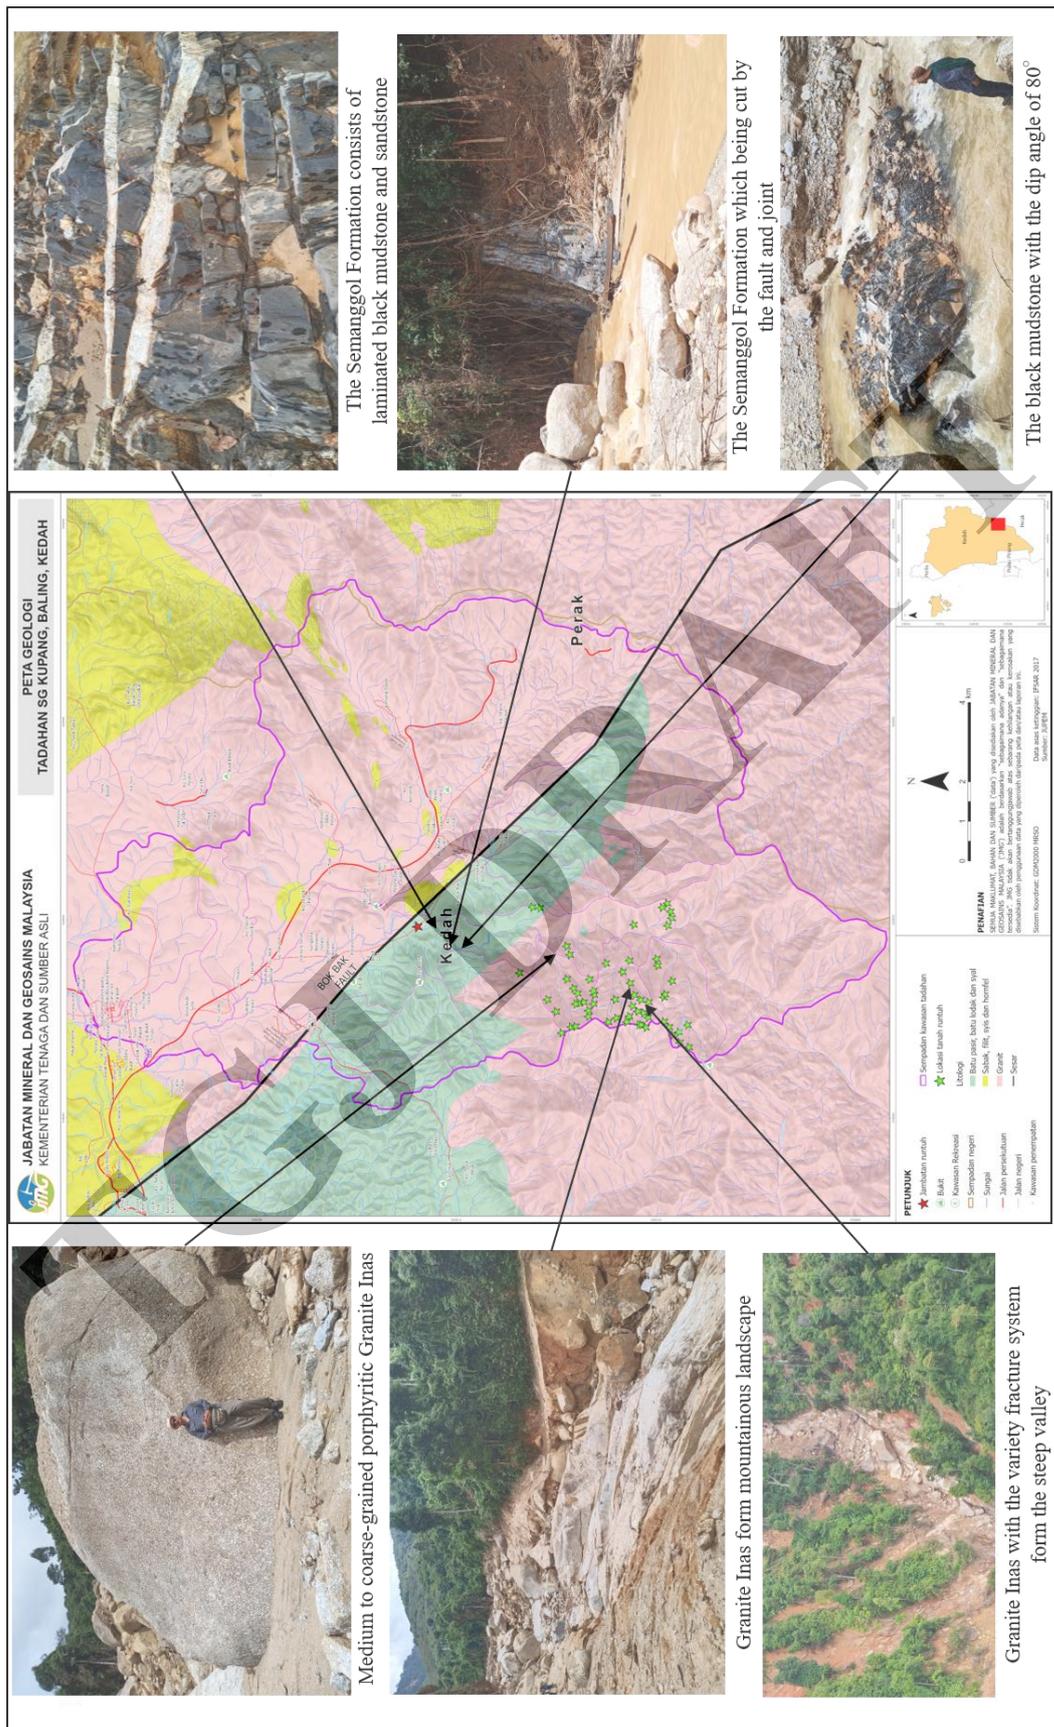
Fig 2: The Geology Map of the Sungai Kupang Basin (Source: JMG, 2022)

The entire Sungai Kupang Basin is underlain by three main rock units, namely Inas Granite in the upstream part of the basin with high topography (ranging from 200 m to more than 1450 m), Semanggol Formation in the middle and Kroh Formation which forms the low and undulating hills at the very downstream (Fig. 2). The Inas Granite in the upstream covers almost 70% of the rock distribution in the Sungai Kupang Basin area. The granite consists of medium- to coarse-grained porphyritic granite formed by quartz, feldspar and biotite minerals. The Semanggol Formation, which consists of laminated black mudstone and sandstone, forms the lowland that underlies almost 25% of the Sungai Kupang Basin area. This formation is separated from the granite by a major fault known as Bok Bak Fault. This fault has formed a clear topographic or slope change from steep in the granite area to

The Bok Bak Fault is oriented in a direction of northwest-southeast (NW-SE) and affects the downstream direction of Sungai Kupang. It also produced a shear zone that created a weak zone between the granitic and sedimentary rocks, producing minor faults (weak zones on the slope) as well as influencing the geomorphology of the Sungai Kupang catchment area.

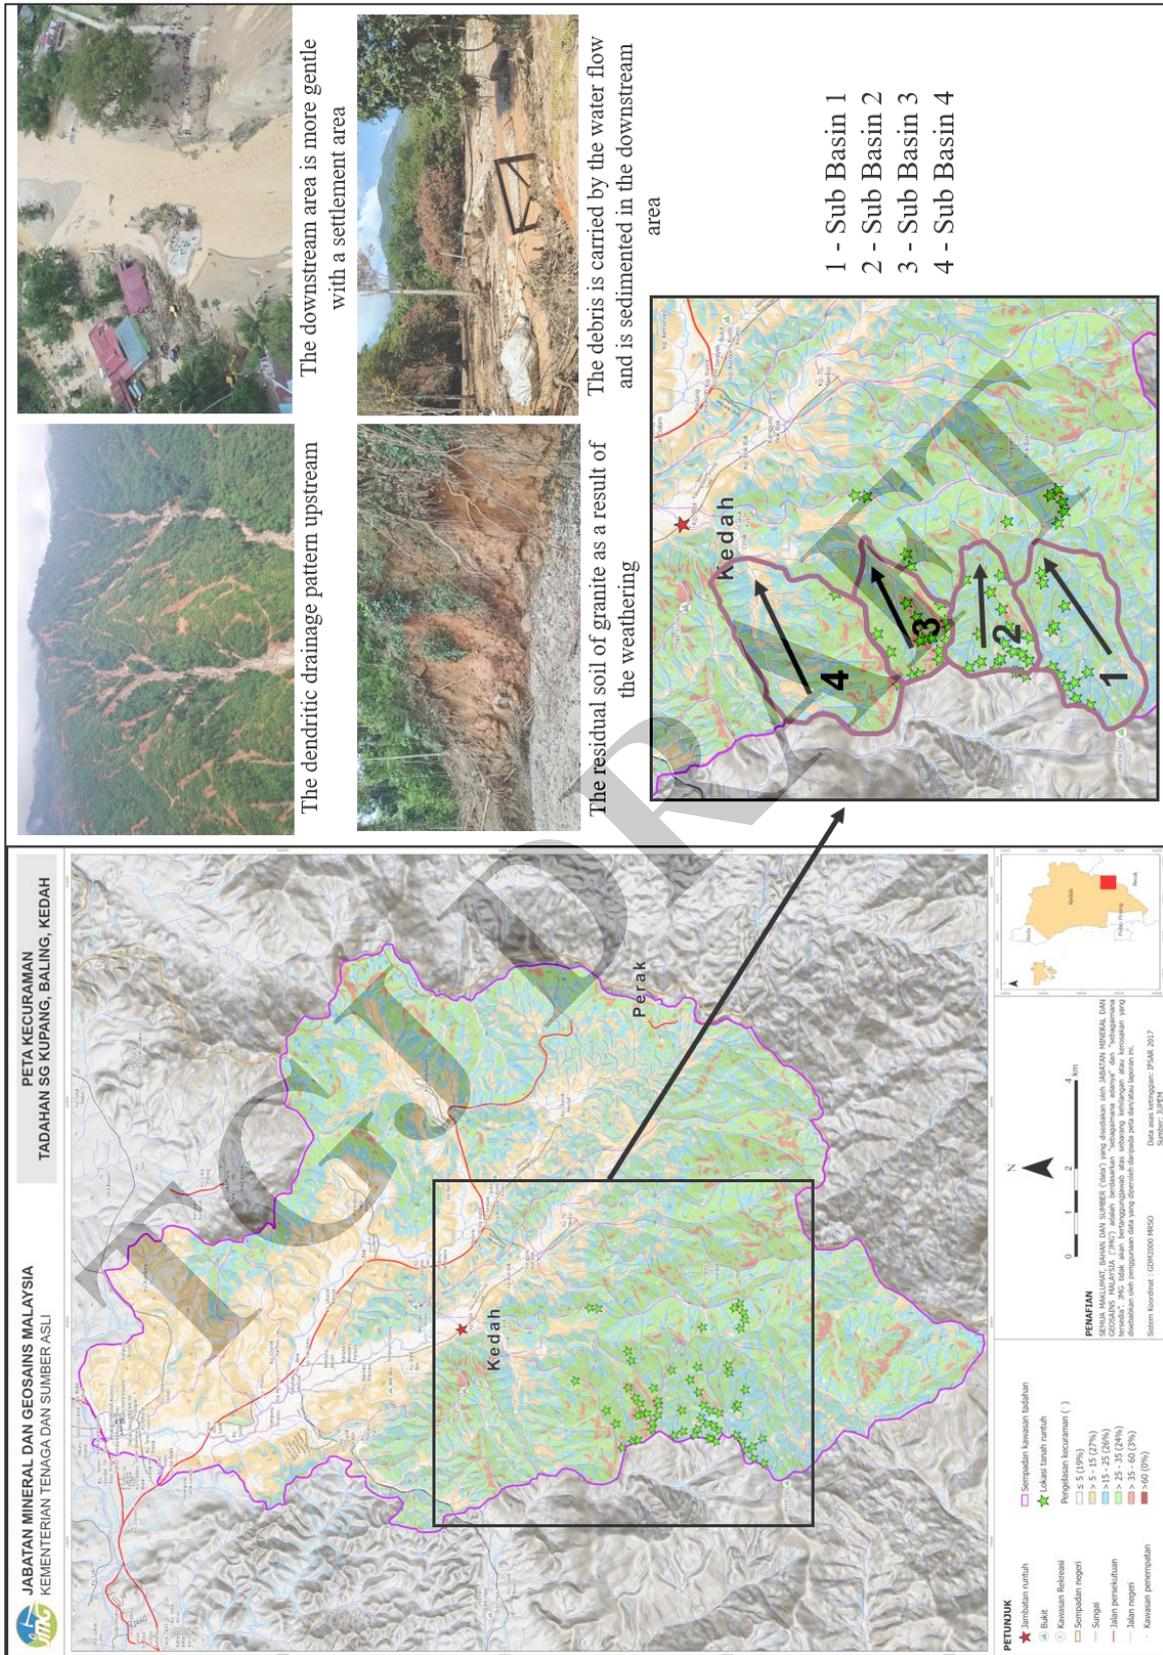
Fig. 3: The Geomorphology Map of the Sungai Kupang Basin (Source: JMG, 2022)

upstream to low-lying area are controlled by the underlying rock and lithological units. Between the peaks and the lowlands, there are river channel with V-shaped that became the transport zones of debris. The dendritic drainage pattern upstream form four (4) sub-basins that eventually merge with the main river forming the Sungai Kupang Basin (Fig. 3).

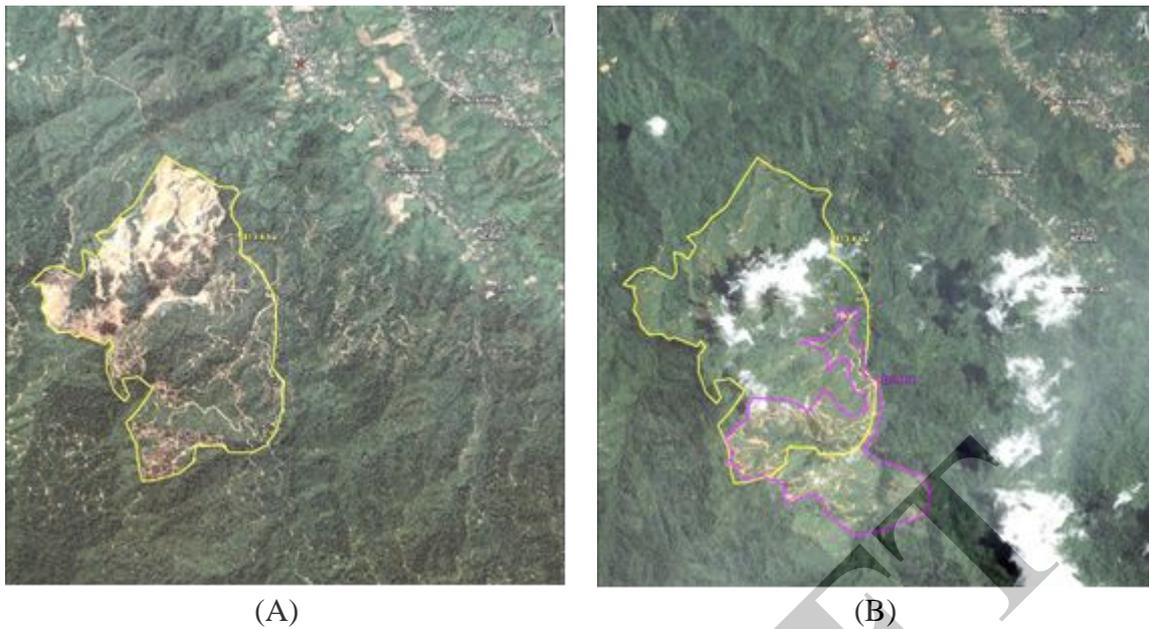
Based on satellite images released by the Malaysian Space Agency (MySA), 813 hectares in Compartment 8 were deforested in 2019, this has led to an erosion rate of 743,895 metric ton/year (Fig.4.A). For the first 6 months of 2022, the area has been deforested and turned into agriculture land with an area of 980 hectares and the annual erosion rate is 57,330 metric ton (Fig.4.B). The rate of erosion

used for the calculation of the load rate that goes into the river channels based on soil erosion and siltation studies by Gharibreza et al. (2013). In summary, within 3 years from 2019 to 2022, the rate of erosion that goes into the river channels in Sungai Kupang Basin is estimated at 1,011,006 metric ton as shown in Table 2.

**Fig. 4.** (A) Cleared Area (yellow line) in 18 Mar 2019 (813 hectares) (B) Cleared Area (yellow & purple line) in 02 July 2022 (980 hectares) (Source: MySA, 2022)

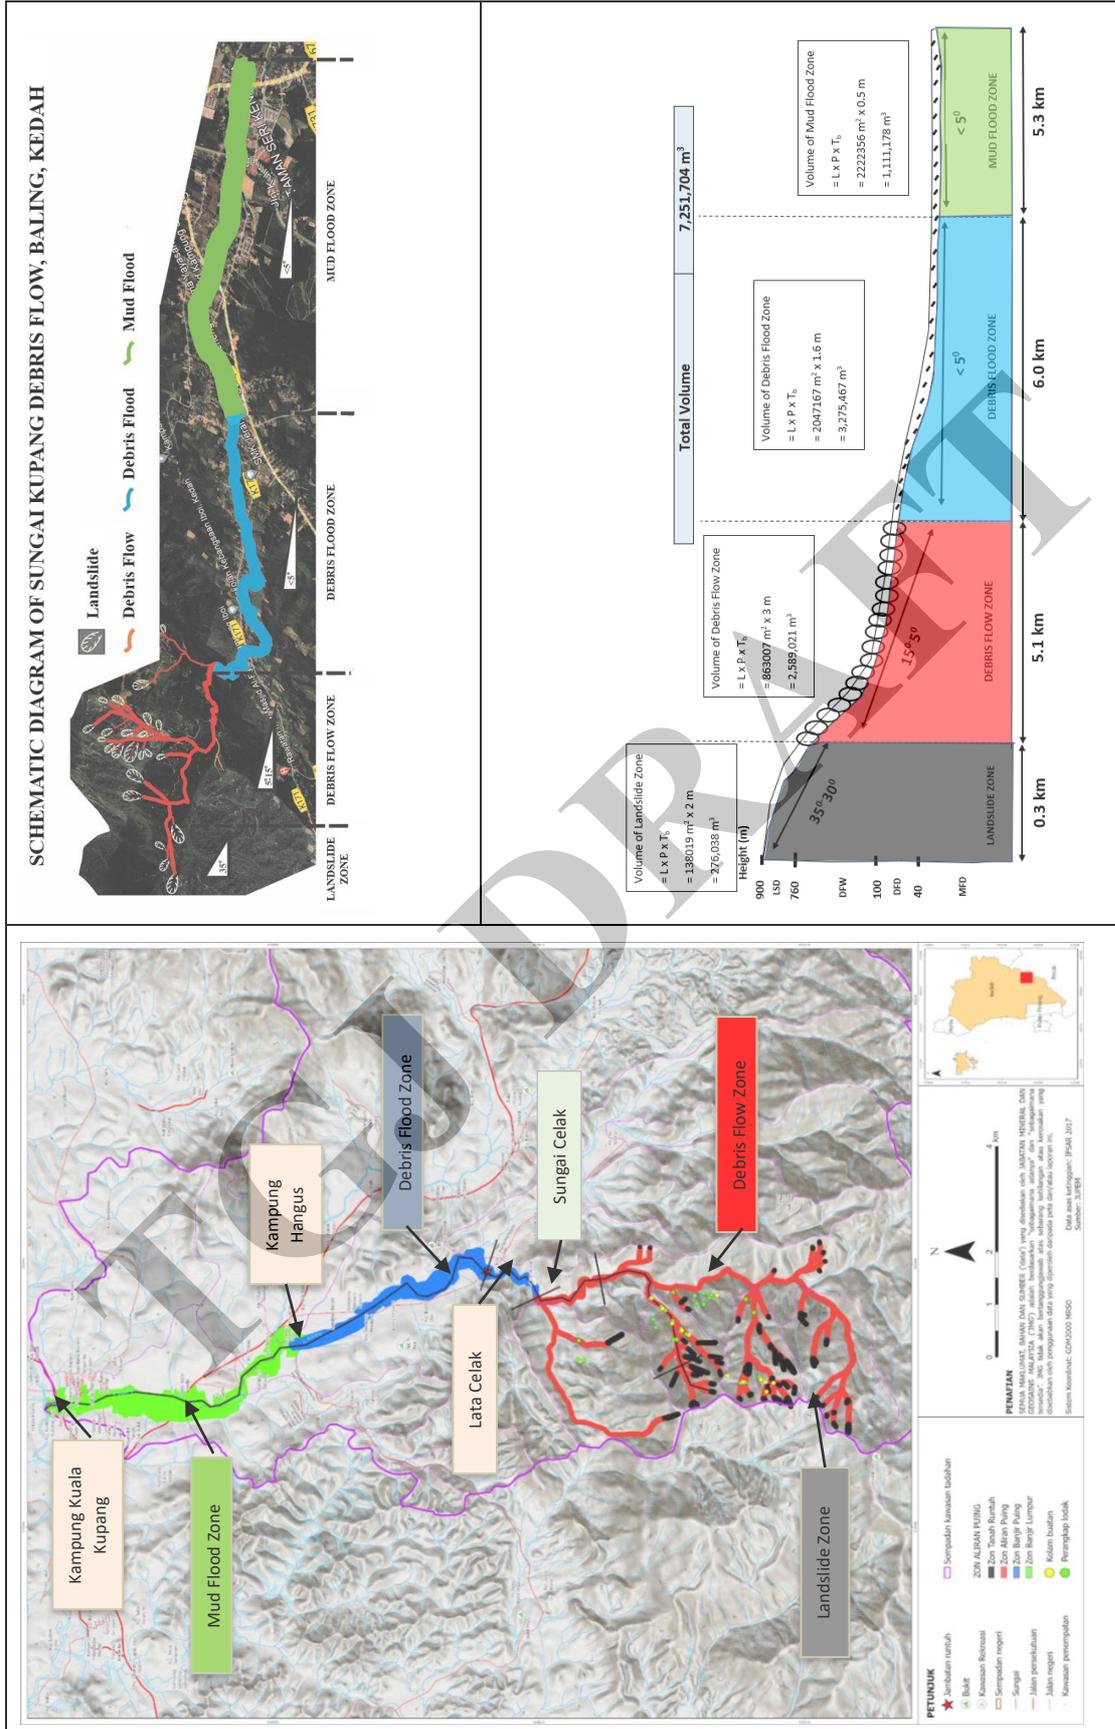
Fig. 5: Sungai Kupang Debris Flow Zone Map (Source: JMG, 2022) (Landslide Zone - Black), (Debris Flow Zone - Red), (Debris Flood Zone - Blue), (Mud Flood Zone - Green)

Site investigation are carried out by walk-over survey along the affected river channels from 16-23 July 2022 and aerial survey conducted on 27 July 2022. Based on the site investigation, the disaster area can be divided into four zones; namely the landslide zone, the debris flow zone, the debris flood zone and the mud flood zone (Fig. 5).

A total of 59 large (>5000 m<sup>2</sup>), medium (1000-5000 m<sup>2</sup>) and small (<1000 m<sup>2</sup>) landslides were identified with a total landslide mass volume of 276,038 m<sup>3</sup>. The landslides occurred at an average angle of 30°-35° at upstream areas in secondary forest. Based on Varnes (1978) classification, landslides were dominated by the translational landslide (slides failure). The landslide is 3-5 m wide, 5-10 m long and is classified as shallow (depth of 1.5 m – 5 m). The landslide zone is 0.3 km long. Most landslides occur on the soil layer of the weathered granite, and the shallow sliding on the plane between weathering soil and fresh rocks.

Field surveys, satellite imagery and UAV analysis showing the debris flow in four (4) sub-basins sizing from 20 m width, flowing to the main stream of Sungai Kupang with an average size of 40 m. The length of debris flow is following the length of the river, and the longest debris flow is reaches to 5 km. The debris flow with thickness of 3.0 m transports the rock blocks (2.0 m to 5.0 m in diameter), tree trunks, sand, silt and mud along the stream with a cumulative volume of 2,589,021 m<sup>3</sup>. Suspended silt and mud in the water can be

As the water content increases and a lot of debris is sedimented, the debris flow turns into a debris flood. The impact of the flooding began at the river mouth of Sungai Celak, about 1.2 km upstream of Kampung Iboi. Field findings show that Kampung Iboi received the main force from the impact of transported debris up to 800 m wide and weakened in the area of Kampung H Angus with a width of 450 m. The debris flood brought a lot of tree trunks, sand, silt and mud. Debris flood zone does not involve many geomorphological mechanisms (the slope angle is less than  $5^{\circ}$ ), reaches up to 6.0 km with an average thickness of 1.6 m and volume of  $3,275,467 \text{ m}^3$ . Within this zone, a total of 4 bridges located between Lata Celak

After the debris containing sand and tree trunks are stranded, the floodwater contains only high volume of silt material. Depending on the height of the water level, mud flood can overflow on the flood plains extensively. The recorded mud flood level ranges from 0.2 m to 2 m with the width ranges from 150 m to 680 m and estimated volume of  $1,111,178 \text{ m}^3$ . Mud flood zone was detected as far as 5.3 km from Kampung H Angus to Kampung Kuala Kupang and affected 36 villages along Sungai Kupang. The distribution of these zones is very wide and involves damage to public facilities and causes discomfort to the affected residents.

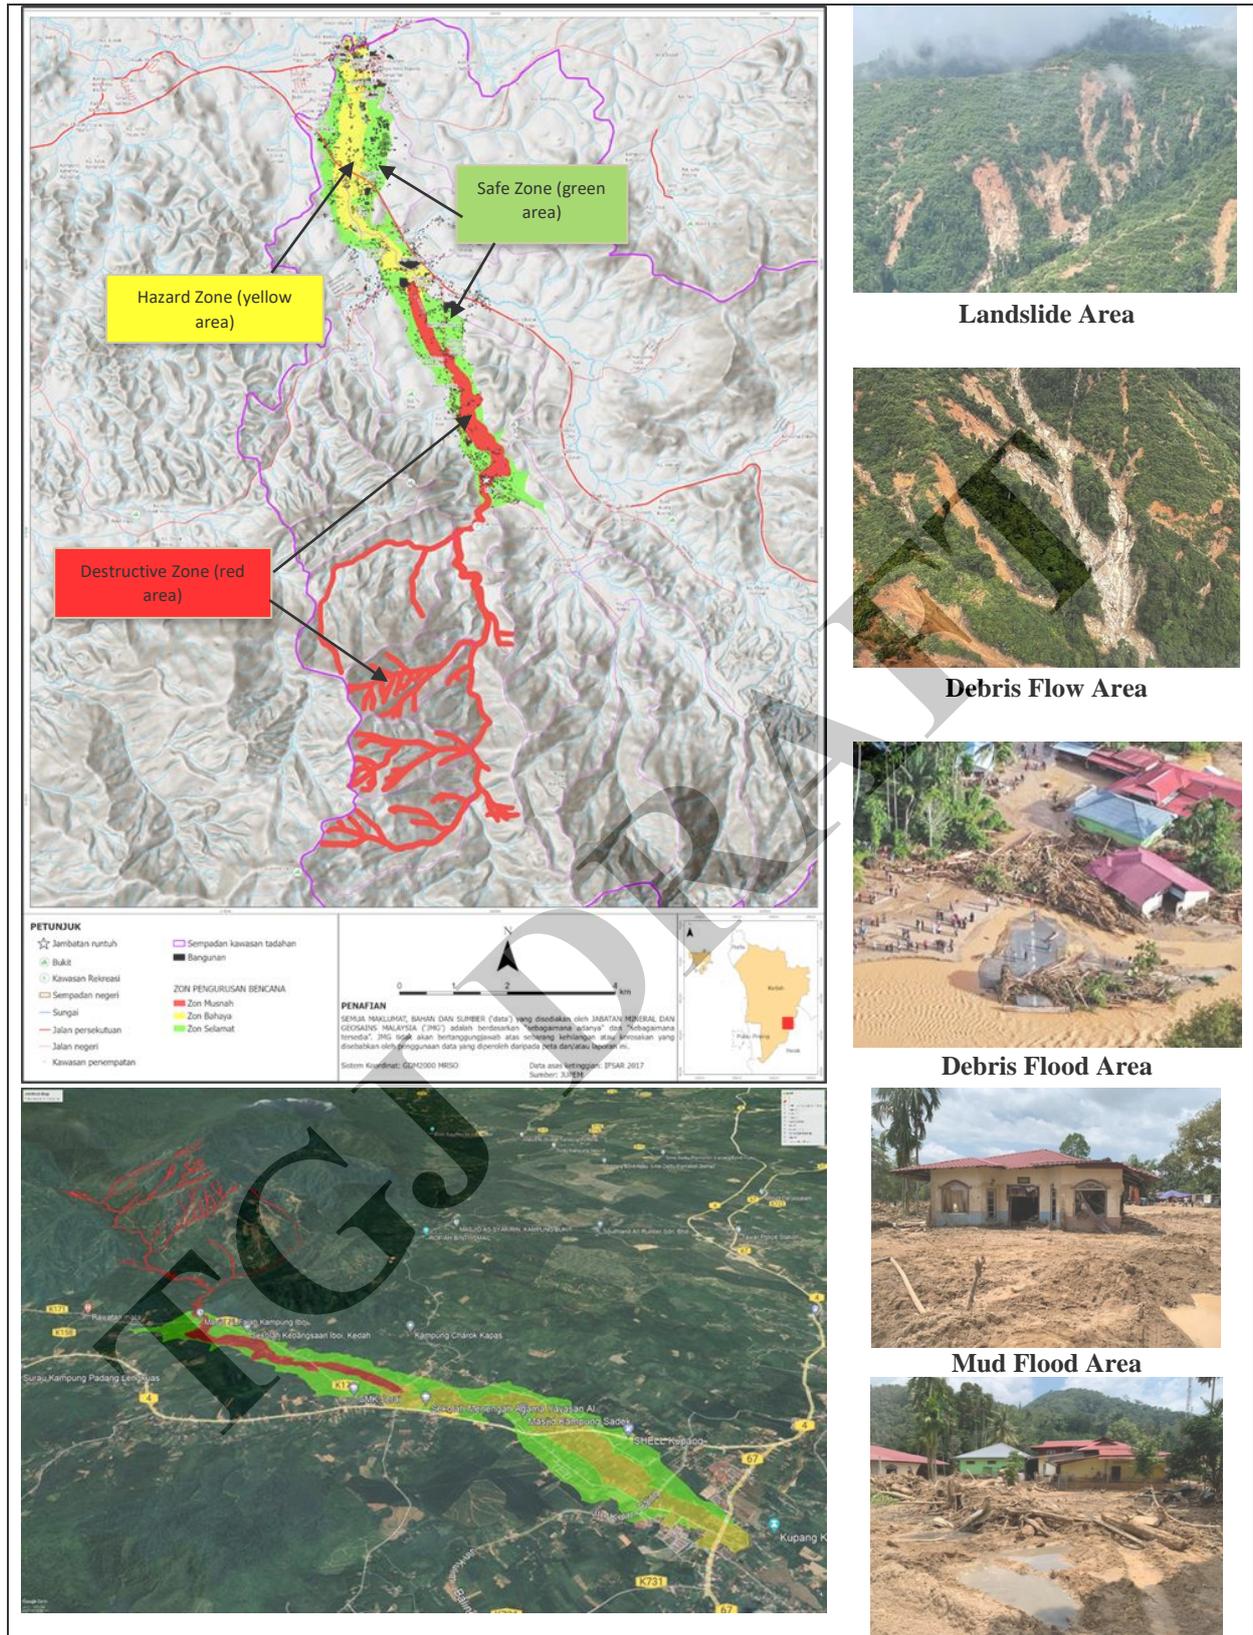
**Fig. 6:** Sungai Kupang Debris Flow Geological Hazard Map (Source: JMG, 2022) (Destructive Zone - Red), (Hazard Zone - Yellow), (Safe Zone - Green)

Based on field investigations and geomorphological analysis, a Debris Flow Geological Hazard Map is provided. This map is intended to be used as a post-disaster development planning guide in areas where the debris flow disaster has occurred. This hazard map takes an approach which the disasters that have occurred can recur in the future and the rebuilding process should take the current experience into account. For this hazard map, three post-disaster management zones were introduced, namely the Destroy Zone, the Hazard Zone and the Safe Zone (Fig. 6).

The Destructive Zone involves areas affected by landslides, debris flows and debris flood. Based on current surveys, any infrastructure in this zone can be destroyed if the repetitive debris flow occurs at the same intensity or more. Houses can be destroyed, while residents who are inside houses will be difficult to save. For disaster management purposes, all elements of infrastructure remain unsuitable for development in this zone and should be placed as a buffer zone, agricultural area or recreation site with an appropriate disaster early warning system.

The Hazard Zone involves areas affected by mud flood. Based on field surveys, most of these areas experienced mud flood at the level of waist-down (2 to 3 feet). Most losses involve property damage and discomfort, without building destruction or death. This zone can still be occupied or build permanent infrastructure, if risk factors and mitigation are considered in planning and construction.

The Safe Zone in the basin is an area that is not affected with the debris flow at all and the repeating impending debris flow. This zone is suitable if reconstruction activities need to be carried out, in particular for the evacuation of houses or settlements that are

- i detail debris flow mapping within 6 months after the incident, collecting data for follow-up planning to reduce risks to local communities.
- ii installation of early warning system including automatic rain gauge in real time. Rainfall information is crucial as the main 'early warning system' to reduce the risk of landslides, debris flows, debris floods or flash floods.

- iii evacuation of residents from the Destroy Zone and Hazard Zone to a safe area. During these few months, the river water will remain murky, while flooding will be easier to happen due to shallow river conditions.

- iv river deepening and continuous cleaning of debris to reduce the risk of post-disaster flooding.
- v planting a deep rooting trees, shrubs, and ground cover plants in open areas to reduce the rate of erosion.
