# An Expanded Polystyrene Foam (EPS) Road Robust to Successive Great Kumamoto Earthquakes in 2016

**ABSTRACT:** This paper describes a case in which no complete demolition was observed in a geofam (expanded polystyrene foam EPS) embankment. Used for local roads situated over active faults at a mountainous site in Mashiki Town, Kumamoto, Japan, the EPS withstood two successive strong earthquakes that struck Kumamoto and Oita prefectures in 2015. The EPS blocks of this EPS embankment were markedly shifted sideways both horizontally and vertically because earthquake-caused landslides occurred behind the EPS fills. Nevertheless, only a part of the EPS embankment collapsed, causing no damage to the temple nearby. Thereafter, the road surface was remediated temporarily immediately after the earthquakes and was maintained for the opening of traffic. This case demonstrates that EPS presents great benefits: most importantly, the partly collapsed EPS road was put into practical use as a temporary road supporting the daily life of local residents. This report describes an engineering perspective of why the road was not collapsed completely. Future issues to be considered by local governments

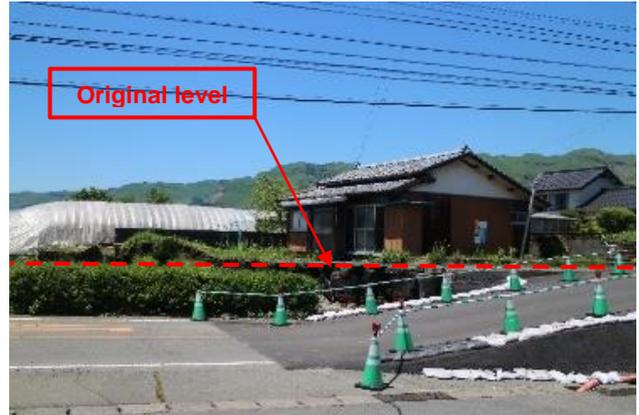
Several grabens of approximately 50 m width occurred in the Aso Volcano caldera. However, the mechanism for this event remains unclear. It is now under investigation (Yasuda et al., 2018).

Figure 5 Land subsidence caused by grabens 9 at Aso

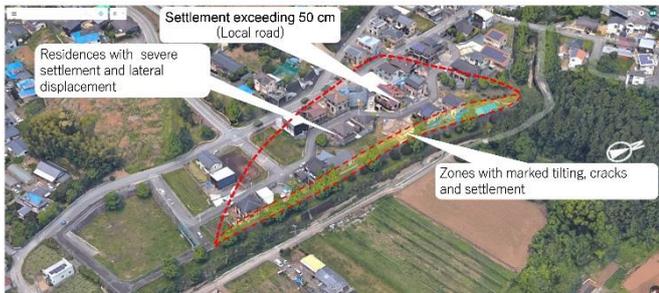
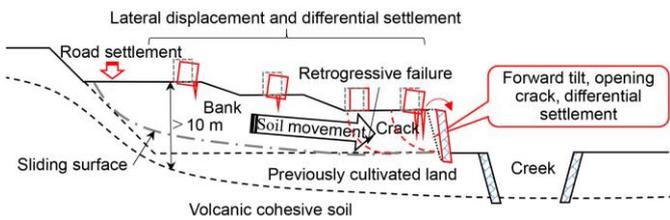
- i) Soil embankments used as residential foundations lost strength and stiffness, leading to collapse, severe settlement, and deformation
- ii) Predominant nonlinearity and amplification of ground motion degraded the stiffness and strength of volcanic ash cohesive soils, leading to large lateral displacement

Figure 3 A damage feature in 2016 Kumamoto earthquake: (a) Damaged residences and adjacent retaining walls and (b) Sketch of the damaged embankment for residences

One example of damage to residential areas is shown in Figure 3(a). A key sketch is presented in Figure 3(b). The authors

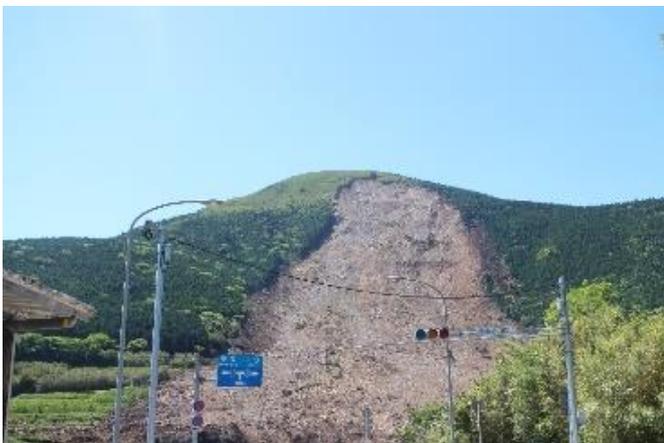
Figure 4 Large-scale landslide in the Minami Aso village

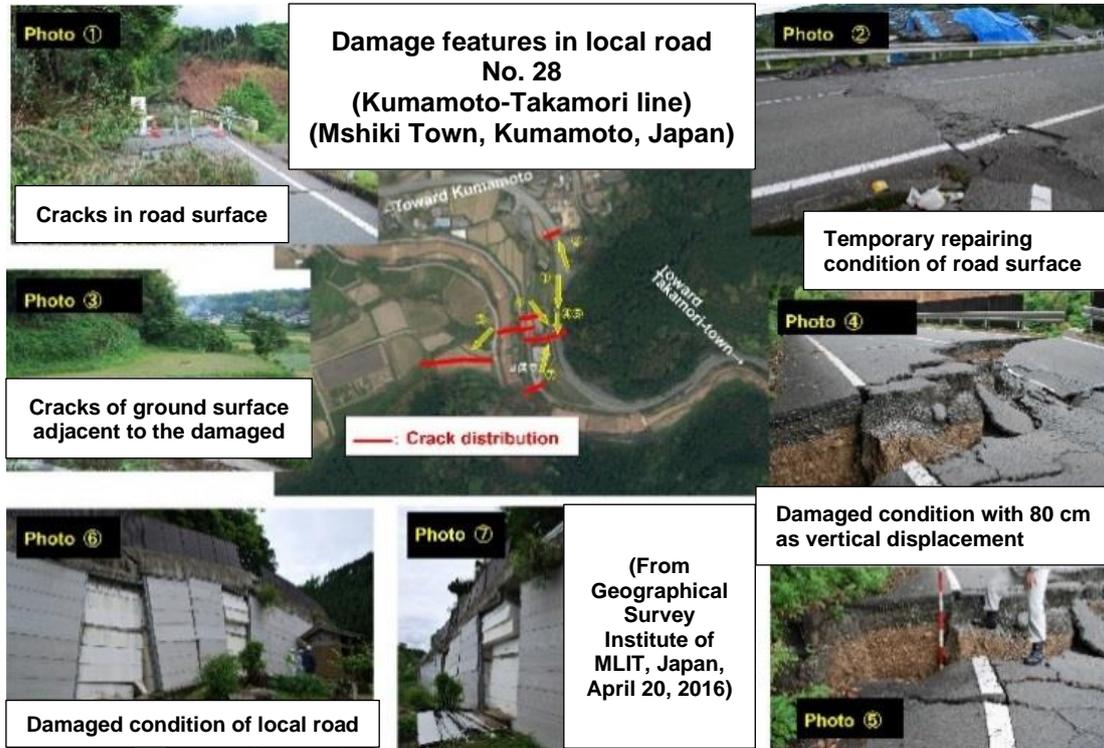
Figure 7 shows damage features at the road reinforced with EPS in images taken from various angles. Although the mountainous steep slope behind the EPS embankment collapsed and the retaining wall protected the foundation from collapse, the road was not completely destroyed, as stated previously.

Figure 7 Damage features of local road (Route 28) with EPS embankment

- 1) The road width is restricted to one lane, as was shown in Figure 7, with a speed limit.
- 2) The road shall be closed during heavy rains.
- 3) Traffic is restricted immediately after the earthquake.
- 4) To support daily life for local residents, roads opened for traffic under the following conditions after temporary remediation against unexpected events by placement of large sand bags resisted against severe weather (Figure 12).

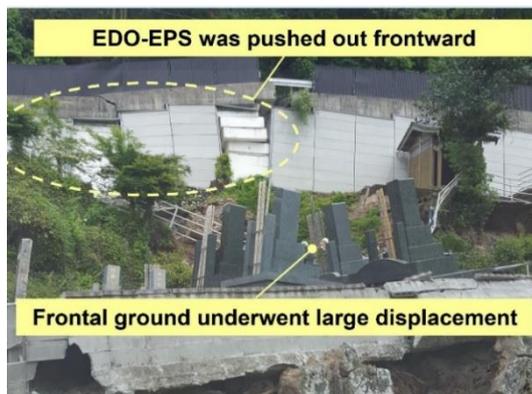
The protective wall on the vertical surface of the EPS road was damaged as the ground moved because of the two successive earthquakes. The EPS blocks were shifted by landslides from the back. They protruded out at the front of roads with EPS (Figure 8).

Nevertheless, the EPS blocks were mutually supportive and maintained the form of the embankment. Joint metal binders (JMB) linking EPS blocks moved, but they kept the EPS blocks mutually connected (Figure 8). A concrete slab in the embankment between EPS blocks broke: a large crack of 1 m width appeared on the road surface (Figures 9 and 10). However, the road level remained even; it did not fail completely. In fact, the roads were temporarily opened for traffic after the earthquakes to support the daily lives of local residents. In addition, the partly damaged EPS road was able to minimize the effects on the neighboring temple.

Figure 8 Damage to the frontal side of the road

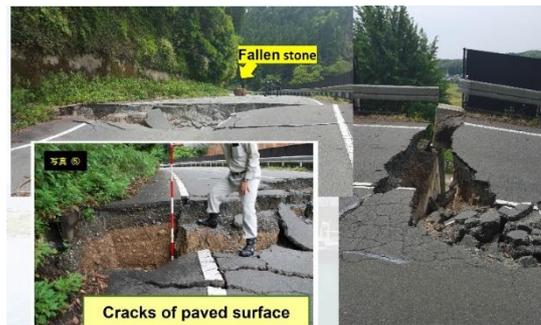
Figure 10 Damage of road surface

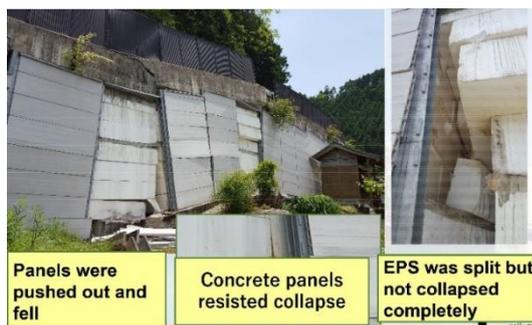
Figure 9 Details of damaged EPS frontal side of road

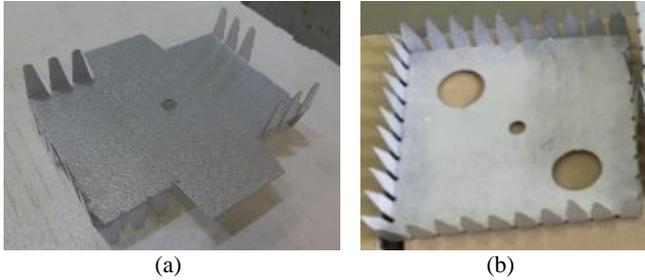
Among the reasons stated above, the most important factor is the role of JMB, as shown in Figure 11. Experiences for local roads during the Kumamoto earthquake examined in this case study

indicated that conventional binders like those shown in Figure 11(a) are not sufficiently strong to resist strong earthquakes of M7 although the EPS embankment for local roads avoided complete failure. Therefore, the conventional binders are expected to be converted to new ones like that shown in Figure 11(b). This is described further in the following chapters.

Figure 11 Metal joint binder connections of EPS blocks: (a) present type and (b) newly developed type

Conventional JMBs are rectangular with asymmetrical spikes, but eccentric motion from seismic forces might affect the mutually connected EPSs. For this reason, the shape should be changed to a square, as was shown in Figure 11, but with an increased number of spikes. Direct-shear box tests were conducted by attaching old and new JMBs to EPS blocks. Results confirmed that the newly developed JMB has 1.5 times the shear strength of the conventional JMB (Taneichi et al., 2018a).
