Forensic Investigation of A Subway Tunnel Construction Failure

ABSTRACT: In this paper, the forensic evidences and investigation of a subway tunnel construction failure occurred in Kaohsiung, Taiwan are presented. The studied construction failure occurred during a cross passage excavation of a shield tunnel construction work of the Kaohsiung Mass Rapid Transit System, and resulted in severe tunnel collapse and extensive ground failure that even reached to ground surface 30m above the tunnel depth. Valuable photo images obtained during and post event, as well as results of special geophysical testing methods were presented and compared to verify proposed failure scenario. Information presented in this paper is hoped to be helpful to improve engineers' knowledge for preventing similar construction risks.

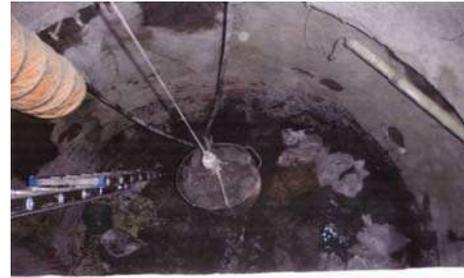
In the afternoon of December 4th 2005, when the sump excavation reached a level 4.95m from the floor of the crosspassage, a chunk of wet soil tumbled out from the southern wall of the sump at the bottom around 3:30pm. The small collapse was followed by steadily increased outflow of mud water as shown in Figure 6. At the beginning of the seepage, sand bags and shotcrete were adopted in an effort to stop the flow. However, the amount of water increased with time despite more dry cement and coagulating agents were dumped into the sump. At 4:50pm, water inside the sump started to whirl turbulently showing the signs of collapse of the side wall of the sump. The top cap of the sump was then sealed with anchor bolts, more sand bags, and vertical posts as shown in Figure 7. At 6:00pm, collapse of the sump led to the undermining of the already completed shield tunnels. Water started to spit out between ring lining segments, and chunks of concrete were found to be detached from the edge of ring segments of the shield tunnels (Figure 8). At 6:30pm dislocation of the ring lining segments was clearly identified (Figure 9) and all engineers and workers were forced to evacuate. At 9:30pm nearly 6 hours after the occurrence of the incident, ground above the up-track (south side) tunnel started to settle by 200mm to 250mm. The settlement area soon developed into a big sinkhole within a very short time as depicted in Figure 10, and ruptured several lifeline pipes including two tap water mains of 300mm and 600mm in diameters (Figure 11). By the morning of December 5th, the sinkhole developed to a size of 80m in length and 20m in width (Figure 12). In the meantime, another ground collapse in a size of 20m long and 10m wide was quickly developed on the north side where the down-track tunnel sit below (Figure 13). These two huge cave-ins on the ground surface led to the threat of large scale collapses of the shield tunnels and the crosspassage. These ground cave-ins were finally backfilled and stabilized near the midnight on December 5th, over 30 hours efforts. In addition to the ground failures, the existing vehicle underpass above the failed tunnels was also found to have been seriously damaged by the accident (Figure 14).

Figure 6 Muddy water started to flow into the bottom of the sump (4:15pm, December 4th, 2005)

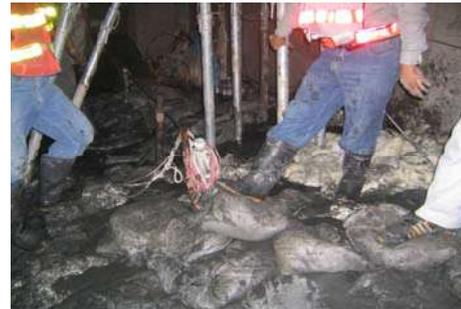
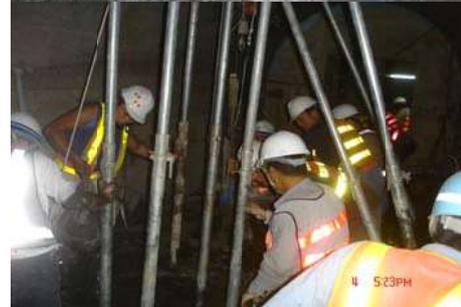
Figure 7 Effort made to seal the top of the sump (5:23pm, December 4th, 2005)

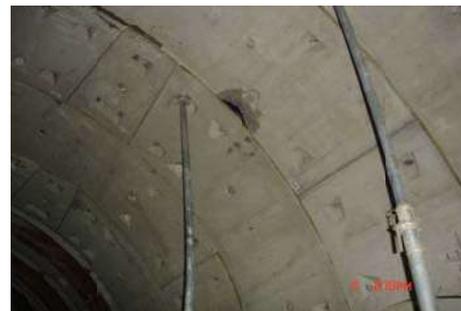
Figure 8 Concrete chunks detached from the ring segments of the up-track tunnel (6:30pm, December 4th, 2005)

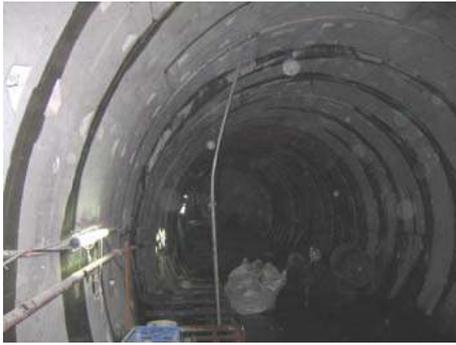
Figure 9 Serious water inflow and dislocation of lining segments inside the up-track tunnel (6:50pm, December 4th, 2005)

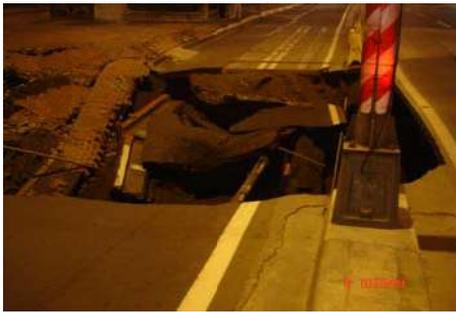
Figure 10 Sinkhole appeared on the ground above the up-track tunnel (10:05pm, December 4th, 2005)

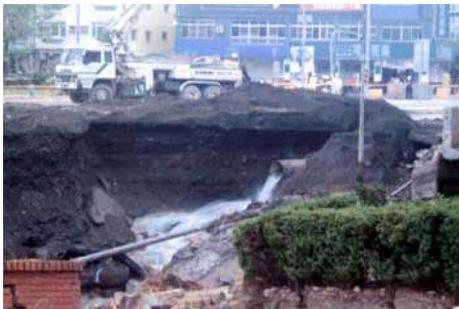
Figure 11 Rupture of the water main (morning of December 5th, 2005)

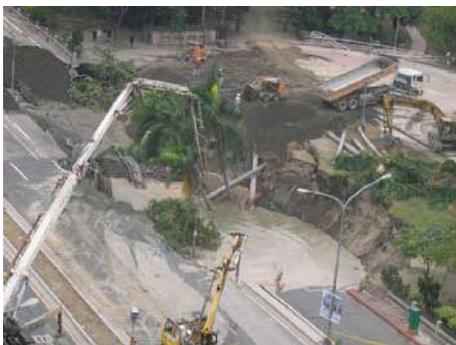
Figure 12 The large sinkhole on the south side and emergency backfill works in progress (daytime of December 5th, 2005)

The first stage of immediate retrofit work mainly focused on backfilling the sinkholes. A total volume of 12,000m³ sand and aggregates, 2,326m³ concrete, as well as 1,150 bags of dry cement,

were dumped from ground surface to fill the sinkholes developed from the deep seated tunnel failures within two days. In addition to backfilling works, remediation grouting and curtain grouting were also applied from both the north and the south boundaries of the vehicle underpass trying to stabilize the existing underground structures and to further confine damaged ground. Figure 15 shows the layout and the total injection volume of grout in cubic meters for the immediate work. In the meantime, four concrete walls sandwiched with sand bags were also constructed at tunnel portals (both up-track and down-track) of O7 and O8 Stations in an effort to retain debris from flowing into the adjacent station areas, as shown in Figure 16. Moreover, in order to stabilize the seriously disturbed ground, water were injected into the tunnels after completion of these retaining walls. This measure was in an attempt to maintain hydrostatic condition of ground, especially at the depth of damaged tunnels. The wall construction and water injecting process was in operation for about seven days before the targeted stable ground water table was reached and maintained (TCRI, 2006). While the retrofit work was in process, ground water table was closely monitored by automatic piezometers installed at different depths at different locations. In addition, settlement survey was conducted on a hourly basis to monitor ground surface settlement closely. Both the settlement and the ground water table measurements were adopted as vital information for safety monitoring and effectiveness of the retrofit works.

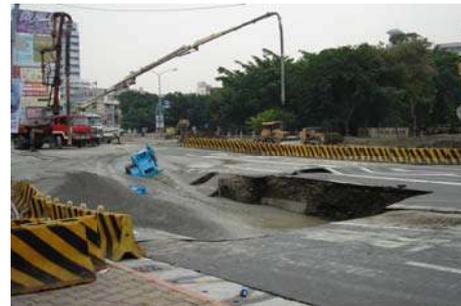
Figure 13 the sinkhole development on the north side above the down track tunnel (4:30pm, December 5th, 2005)

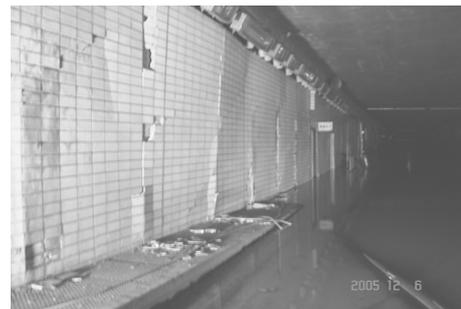
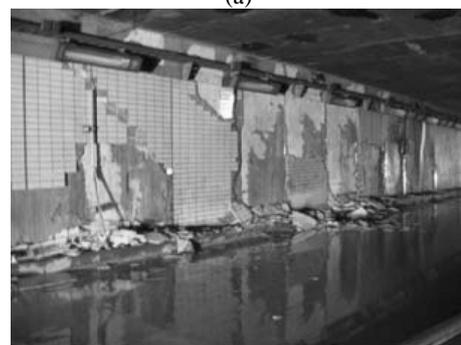
Figure 14 Damaged vehicle underpass

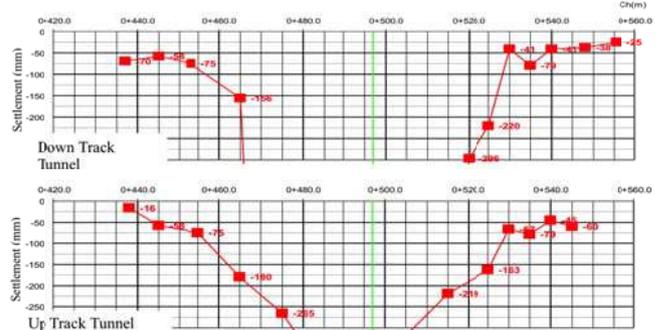
Failure investigation was first conducted by drilling boreholes along the original tunnel alignments. The drilling rod was lowered down to the failed ground in an attempt to reach the pre-casted ring segments of the shield tunnel lining. This borehole probing method was used as a direct inspection measure to assess the damaged condition of the shield tunnels and to estimate the length of collapsed and distorted tunnel portions. Borehole probing results of both the up-track and the down-track tunnels are shown in Figure 17 (Lee and Ishihara, 2008b). The cross passage where the incident occurred was located between mileages 0+495m to 0+500m. As shown in the figure, the section between mileages 0+465m to 0+520m of the up-track tunnel had collapsed due to the failure and could not be located by the probing rod. Near 120 meters of the up-track tunnel was seriously dislocated. For the down-track tunnel at

the south of the failed cross passage, the section between mileages 0+475m to 0+515m had collapsed and was out of reach by the probing rod. Similar to the up-track tunnel, near 100 meters of down-track tunnel was seriously disrupted. The result of this borehole probing revealed that ground failure might have destroyed the crosspassage and have destructed nearly 120 meters long up-track and down-track shield tunnels.

Figure 17 Borehole probing results of the up-track and down-track tunnels

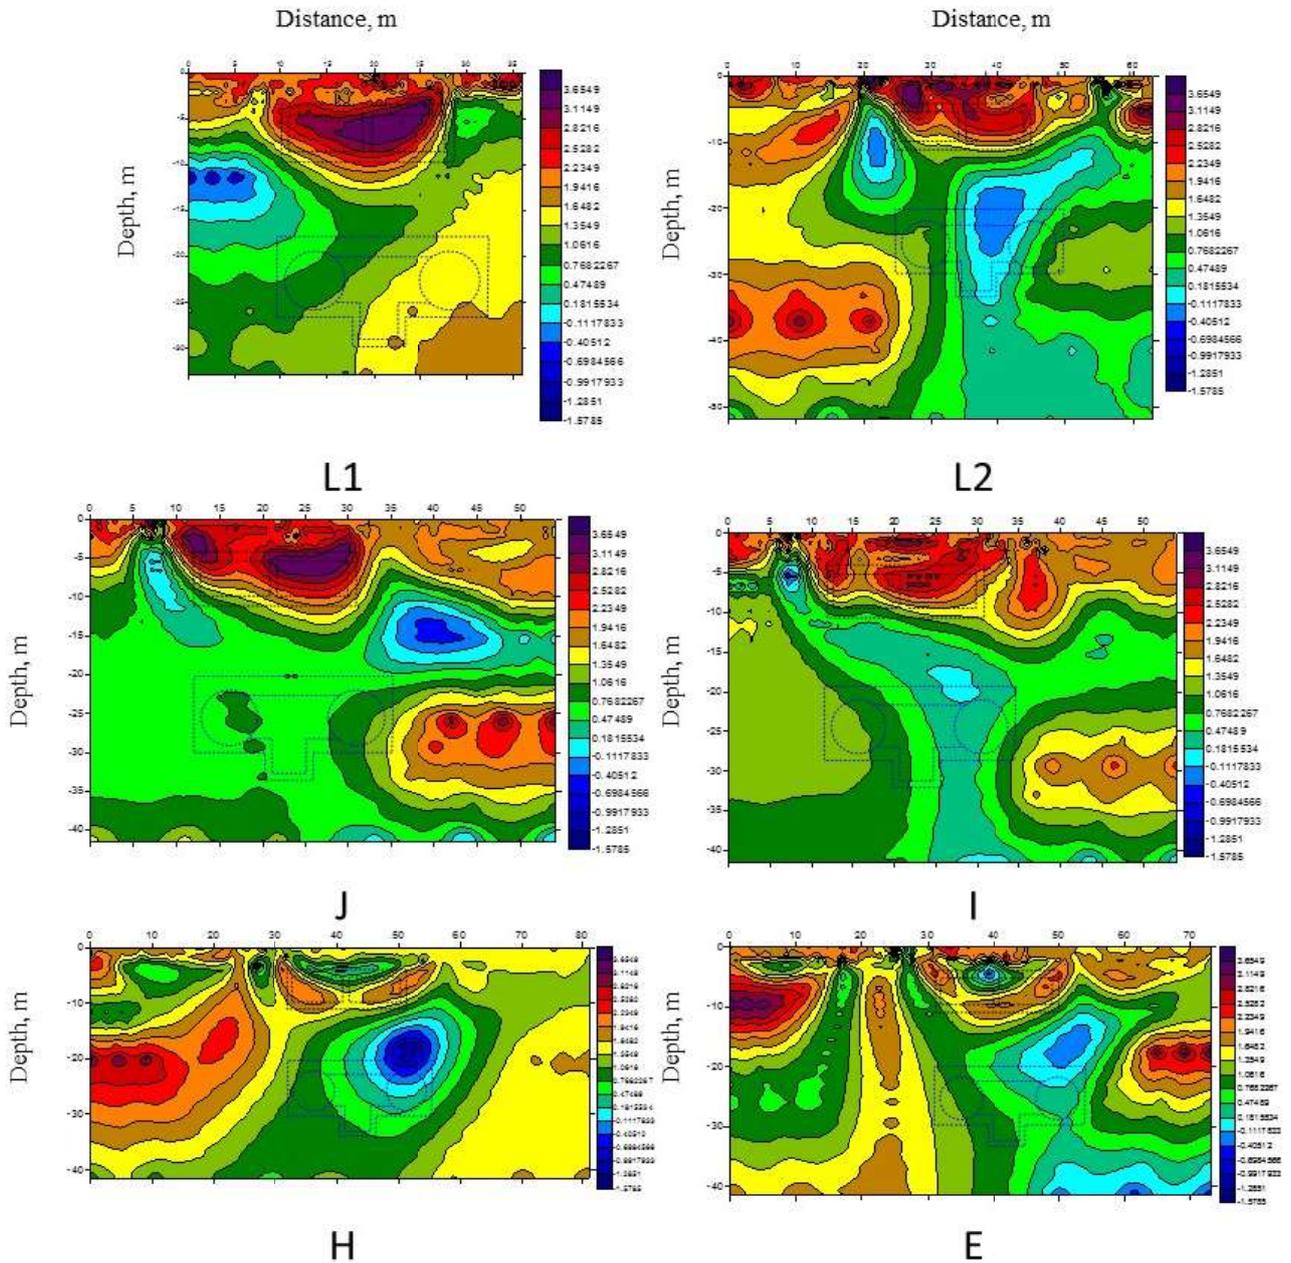
Figure 23 shows the results of 2D RIP test along the selected survey lines marked in Figure 21(b). In these figures, Calibrated values of resistivity are scaled on the right to each profile. As shown in the image profiles, cold colours, from green to deep blue, represent material with relative low resistivity such as disturbed ground with high ground water content or voids. On the contrary, warm colours, from yellow, orange, to red and brown, represent material with relative high resistivity such as dense soil, injected grouts or concrete. In this case, images obtained by the 2D RIP test tend to be slightly distorted upward because only ground surface probing posts were installed to record response resistivity (Lee and Ishihara, 2008a). However, resistivity profiles shown in Figure 23 still clearly indicate that the area in between the vehicle underpass and the cross passage were in serious distressed condition. Profiles L2, H, and E, identify that ground in between the vehicle underpass and the cross passage in south contained high water content and in a loose state at the time of testing. Similar ground condition was also observed in the ground under the sinkhole on the north as shown in Profiles L1, L2, I, and J. In addition, ground failure area on the south where the up-track tunnel was located was found to be more serious than that on the north where the down-track tunnel is.

Figure 23 Results of 2D RIP tests

The 2D RIP results also indicated that damaged areas were larger than two sinkholes appearing at ground surface, and further verified the results of borehole probing that near 120m long tunnels in both directions were destroyed by the piping ground. At the locations of profiles L2, H, and E, which were the east and the west boundaries of the soil improvement work for the damaged cross passage, soil beneath the subway tunnels was also found to be severely agitated by possible soil piping or boiling failures. As shown in these image profiles, the shapes of the agitated soil layers are in funnel shapes. This observation indicates that ground failure was initiated at bottom of water sump and then spread upward through the up-track tunnel first to cause large sinkhole on ground surface. Ground failure then migrated to the soil surrounding the down-track tunnel to cause another sinkhole on December 5th, the second day of the accident. Moreover, no clear image of the cross passage or soil improvement block installed before tunnel construction was found in 2D RIP results; this indicates that the cross passage and the shield tunnels attached to it should have been all broken by the huge soil piping pressure. The 2D RIP results also show that immediate remediation and grout treatments had effectively reached the perimeter of the ground failure to possibly stabilize the ground, as the warm colour areas shown in profiles L2, J, I, H, and E.

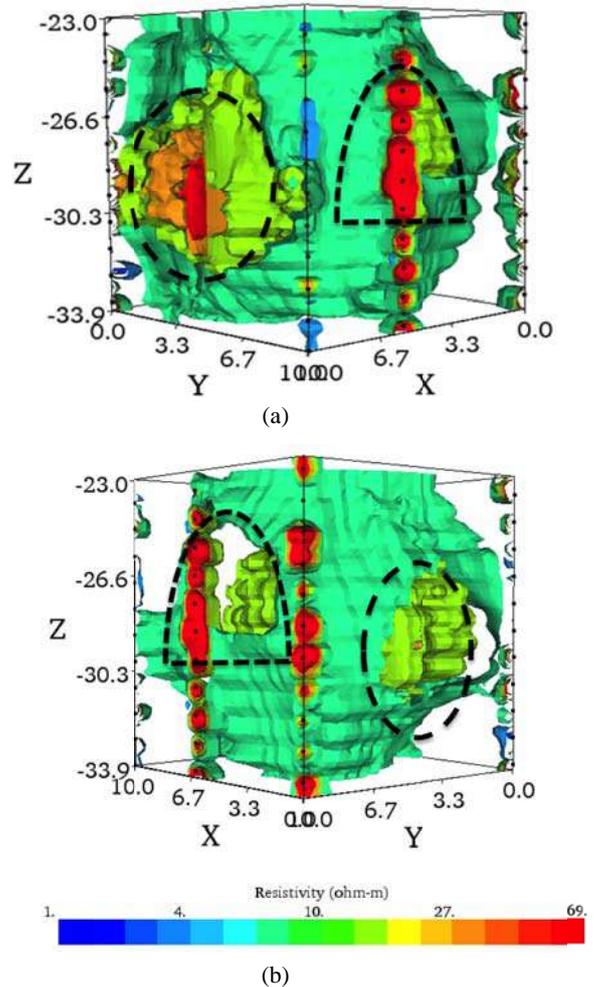
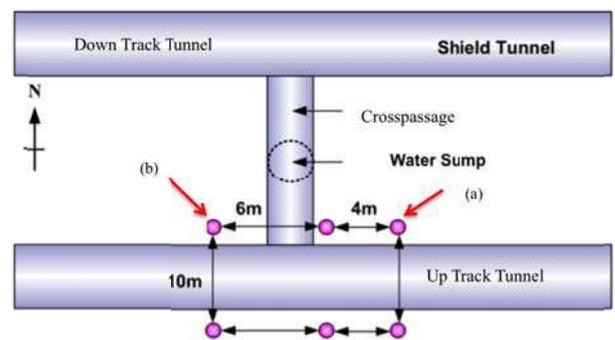
Figure 24 shows the results of the 3D RIP test. As the results of 3D investigation contained fairly complicated stereo information, images shown in the figure have been processed by carefully differentiating assorted materials underground. The light green or blue portion shown in the figure indicates the most of jet grout material applied prior to the construction of the cross passage and the shield tunnels. Reinforced concrete portions of shield tunnels and the cross passage are probably in bright green to yellowish colour. The exposed steel truss and rebar of the cross passage are in orange to red colours with least electrical resistivity. As shown in Figure 24, the integrity of the shield tunnel and the crosspassage was barely observed. The east portion of the shield tunnel was found to have an offset of at least 1m from the cross passage, and the west portion of the shield tunnel was found to be out of shape with an offset over 2m. There was very low resistivity response in both images indicating that the cross passage might have been seriously damaged to expose steel truss components. The results of 3D RIP test denote that piping failure induced from the water sump had probably destroyed the connections of the shield tunnel to the cross passage. The results of both 2D and 3D RIP tests have further verified the results of borehole probing shown in Figure 17. Moreover, it has provided visualization images describing the failure extent and the actual ground condition. This information is valuable for both forensic investigation as well as retrofit design.

Figure 24 Results of 3D RIP tests

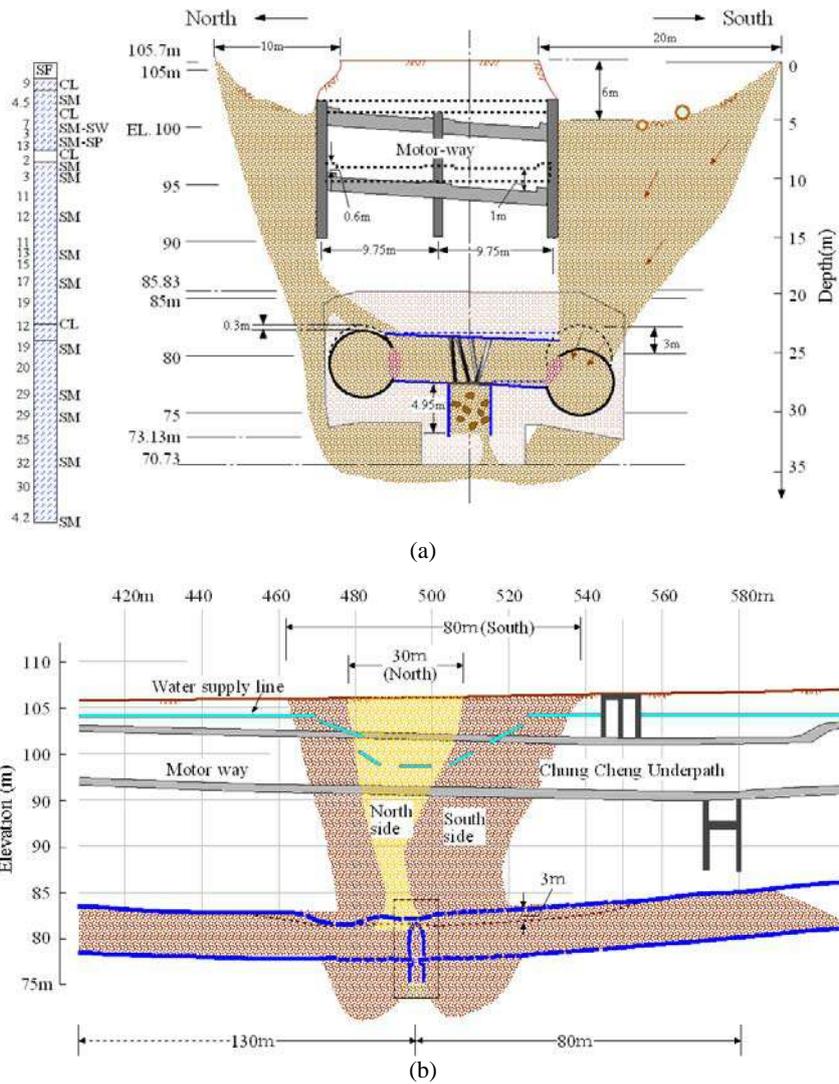
Ishihara and Lee (2008b) first proposed the failure hypothesis of the studied incident (Figure 25) based on the investigation data including workmen testimonies, emergency retrofit work records, as well as the forensic testing results presented in this paper. They described that the failure started from the bottom of the water sump highly likely via a vertical piping crack (Ishihara and Lee, 2008). The invasive hydraulic pressure near 300kPa caused by such a piping failure forced debris to flow into the crosspassage from the collapsed water sump. In the early stage of failure, the jet-grouting block installed for crosspassage construction was fairly strong; it was not broken until the hydraulic pressure caused by piping and flown-in debris had ripped off the ring lining segments of the shield tunnels outside such a jet-grouting block. Ground failure was enlarged when the debris flowed into the tunnels and created large voids underground. The failed ground was in a state near liquefaction due to the high hydraulic pressure and strong downward seepage. The shattered ground soon expanded upward to ground surface forming a huge sinkhole above the up-track tunnel on the south and widely spread to the down-track tunnel on the north

creating similar failure. The vehicle underpass sitting above was thus damaged by distressed ground underneath and all ground as depicted in Figure 25 (Ishihara and Lee, 2008). Moreover, Figures 26 and 27 show the wreckages of the cross passage and the shield tunnel excavated during the retrofit works. As shown in Figure 26, the cross passage inclined to the south and sunk over 2m at the edge connecting to the shield tunnels. The shotcrete lining and the inner truss of the cross passage was found to have been severely broken by the debris flown in. Figure 27 shows clearly that the ring lining segments of the shield tunnel had been ripped off and sunk as revealed in the investigation using borehole drilling and RIP tests. Where the cross passage connecting to the two shield tunnels had the most serious settlement and thus damages included dislocation and collapse to lining segments of the shield tunnel as shown in Figure 27. The proposed failure scenario was further verified by such forensic recovery work.

Figure 25 Failure scenario proposed, (a) cross sectional view, (b) longitudinal view (after Ishihara and Lee, 2008)

A forensic investigation committee was formed to study the possible causes of failure. Comprehensive investigation and analysis were conducted including information presented in this paper. The reasons why such dreadful vertical cracks occurred at the bottom of the water sump were probably a combination of design layout, constructability, unique features of local soil, as well as quality control of ground improvement (TCRI, 2006). There were also some facts found that contributed to such massive ground failure. However, piping created by high hydraulic pressure and internal erosion prone local soil are believed to be the major causes of failure. Near 300kPa pressure difference between the constructed tunnel and the confining soil caused the collapse of water sump and led to even severe failure. The estimated seepage hydraulic gradient exceeded 12.5 (TCRI 2006; Ishihara and Lee, 2008).

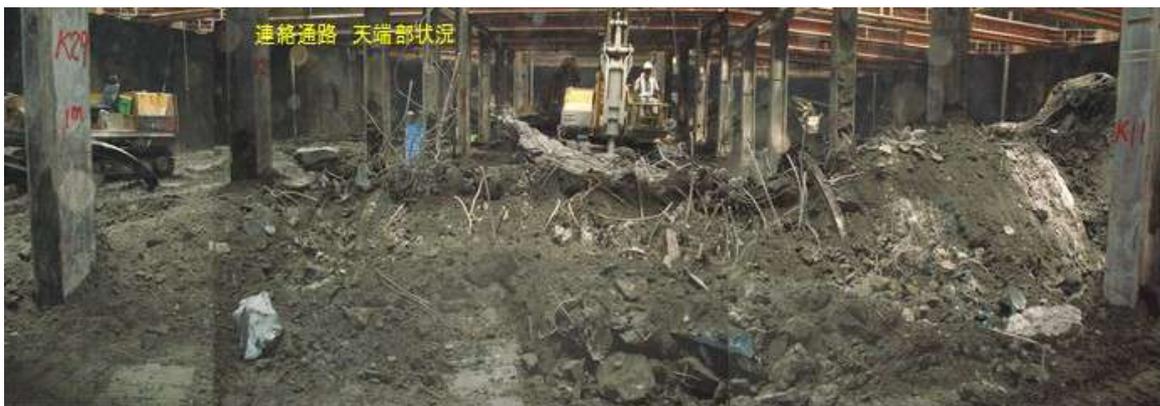
Figure 26 Wreckages of the crosspassage.

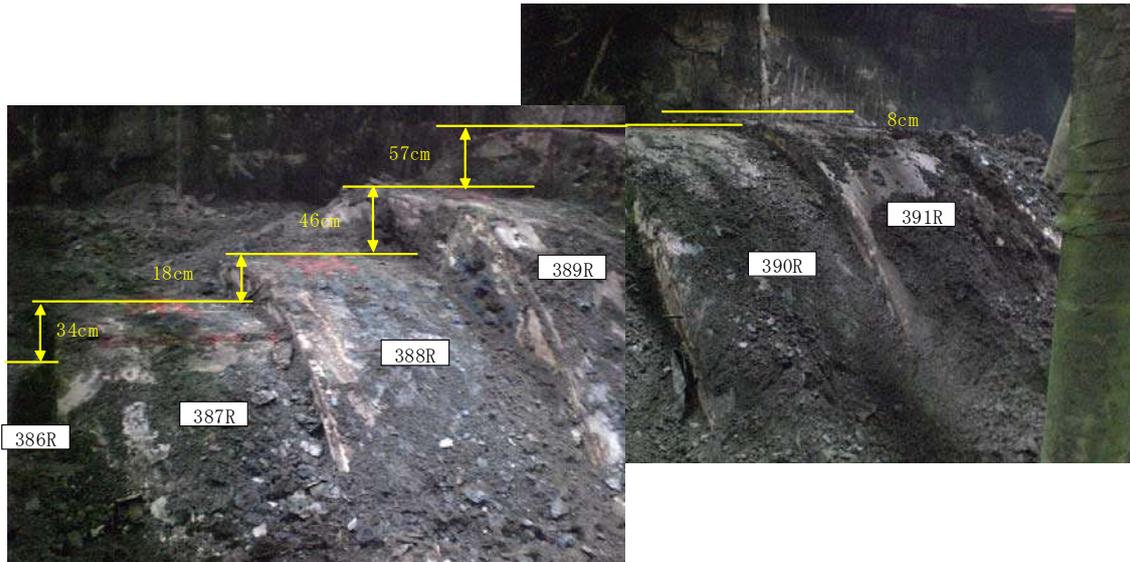
Figure 27 Damaged shield tunnel excavated during the retrofit works
