Geological Investigation and Sliding Mitigation in Jiufen Area

Lee-Ping Shi¹, Jen-Cheng Liao², Sheng-Hsiung Hung³ and Chien-Shui Huang⁴ ^{1,2}Taiwan Construction Research Institute, New Taipei City, Taiwan ³Agriculture Department, New Taipei City Government, New Taipei City, Taiwan ⁴P.E. of Applied Geotechnical Engineering, New Taipei City, Taiwan E-mail: lepnhsu@tcri.org.tw

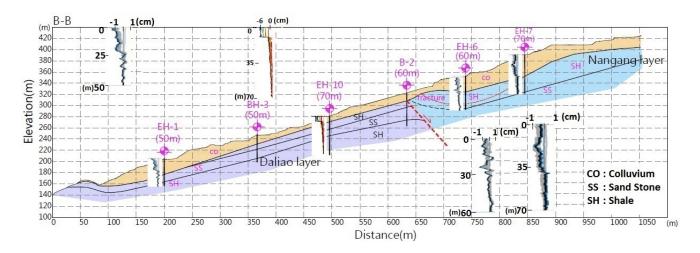
Figure 3 B-B cross-section of Figure 2 and four ground displacement records measured by inclinometers

Four displacements recorded by inclinometers can be seen in Figure 3. Figure 4 shows the monitoring data of groundwater and

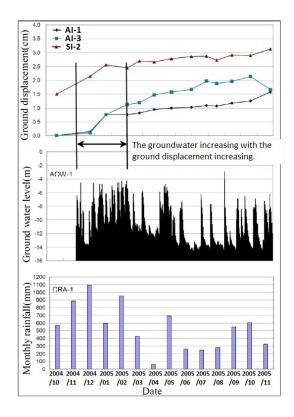
Figure 4 Ground displacement and ground water level vs. rainfall

ground displacement recorded more than one year. It can be seen that the ground displacement increased with the heavy rainfall quantity. Comparing to the monitoring rainfall results in Juifen area and the nearby Keelung rainfall station data of Central Weather Bureau during the Nanmadol typhoon, it is noted that the groundwater level rose about 9.02m and the increasing groundwater volume not only from the rainfall in Juifen area but also from the underground flow of surrounding area as shown in Figure 5. Since the groundwater associated with the stability of Juifen landslide area, it was very important to investigate the underground flow distribution and constructed the drainage well.

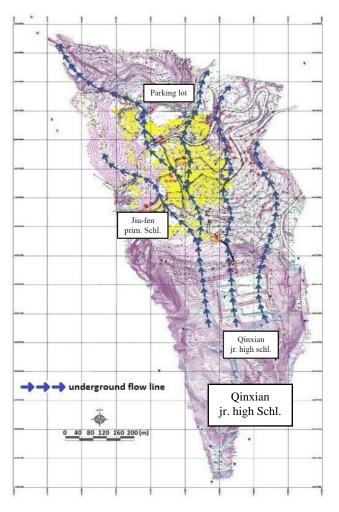
Figure 9 The underground flow lines located both from RIP and SP survey results

the area as shown in Figure 7. The relative voltage contours from SP surveys are shown in Figure 8. Figure 9 shows that the underground flow lines were located both from the RIP and SP survey results. There are four underground flow lines and the main line passed through the middle part of the area. The direction was from the south to the north.

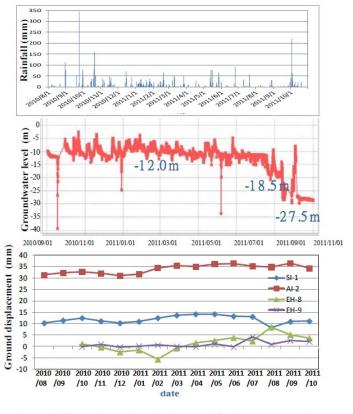
Figure 12 Groundwater level and ground displacements vs. time after five wells completed

Analyses were conducted at several different cross sections. The slope stability analysis results of B-B section is shown as Figure 10. It is found that the safety factor is 1.02 in the high groundwater level during typhoon. In order to increase the slope stability, it should lower down the groundwater level. Five groundwater drainage wells were constructed according to the four underground flow distribution as shown in Figure 11. There are two construction stages shown in Figure 11. After the first stage completed, the groundwater level lowered from 12 m to 18.5 m below ground surface. Following the second stage completion, the groundwater level further lowered from 18.5 m to 27.5 m as shown in Figure 12. The ground displacements also decreased. The safety factor increased to 1.41.
