Overview of the Geotechnical Damages and the Technical Problems Posed after the 2011 Off the Pacific Coast of Tohoku Earthquake

M. Kazama¹, T. Noda², T. Mori¹ and J. Kim¹

ABSTRACT: The 2011 Off the Pacific Coast of Tohoku Earthquake which occurred on March 11, caused serious damage to the infrastructural facilities in Tohoku and Kanto districts due to the strong motion of the earthquake and the subsequent tsunami. This paper includes a brief outline of the earthquake, the earthquake damage to various facilities, and the main geotechnical engineering problems which have emerged after this disaster

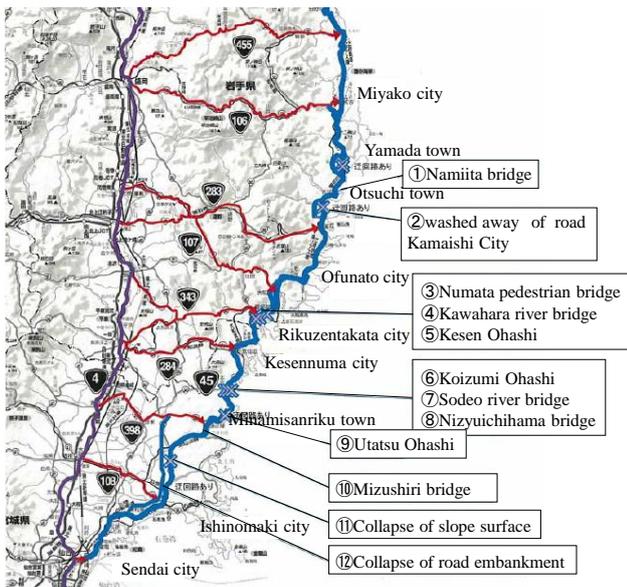
Figures 6 and 7 show the damaged parts of road facilities on National Route 45 and National Routes 4 and 6, respectively. The main forms of damage were the erosion of embankments at bridges (1), road embankments washed away by the tsunami (2), bridge decks washed away (3)-(10), the collapse of slope surfaces (11), the collapse of road embankments and slope collapse (12)-(14), etc.

Figure 6 Damage to roads in the north part of the Tohoku district

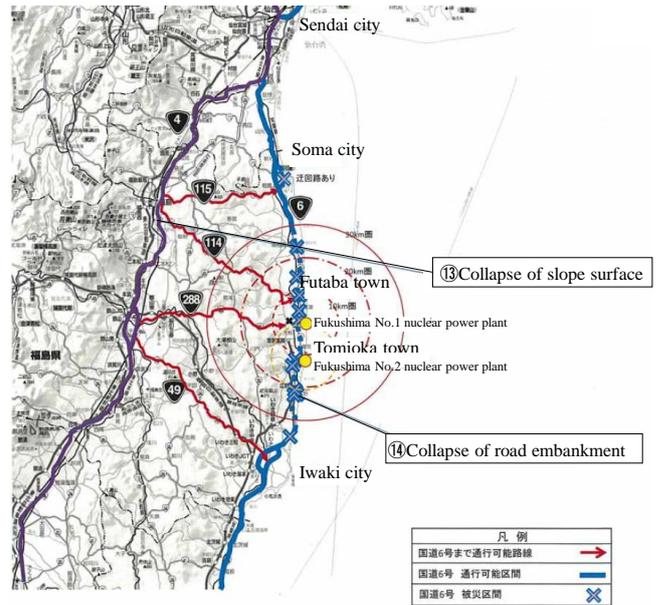
Figure 7 Damage to the roads in the south part of the Tohoku district

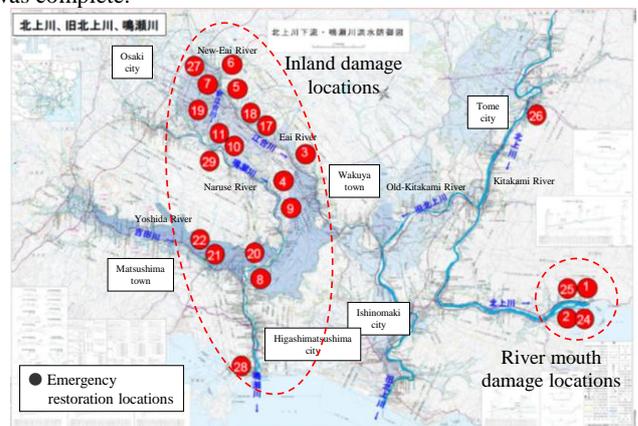
Figure 8 Damage to river embankments in the Tohoku district

The causes of the damage in almost all cases were the tsunami at the mouths of the rivers and liquefaction in inland areas. Figure 8 shows the positions of the major damage locations along the Kitakami River and the Naruse River in the Tohoku Region. Also, almost all the damage in the Kanto Region was caused by liquefaction (see Figure 9). In addition, it was reported that in areas where countermeasures were taken against liquefaction, there was either no damage or the damage was slight.

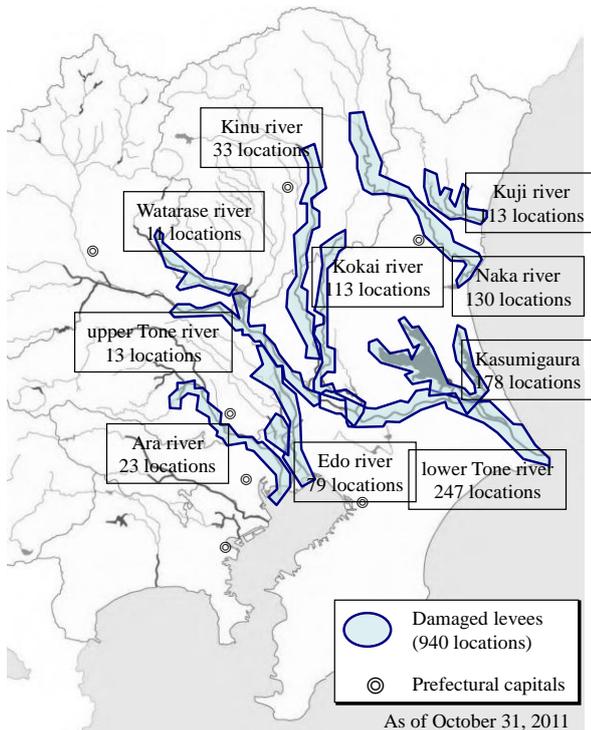
Figure 9 Damage to river embankments in the Kanto district

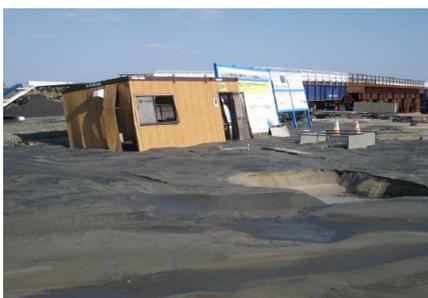
Photo 1 Re-liquefaction evidence caused by 2011/4/11 aftershock at Onahama Port, Fukushima prefecture.(by Tohoku Regional Development Bureau, MLIT)

Normally, traces of liquefaction on coasts that have been subjected to the effects of a tsunami are wiped out by the tsunami, so traces of sand boils cannot be used as evidence of whether liquefaction occurred or not. However, it is known that liquefaction occurred to a certain extent based on the many photographs and images taken of sand boils caused by liquefaction before the tsunami and the liquefaction that occurred during the aftershocks. Photograph 1 shows the (re)liquefaction at Onahama Port caused by the earthquake that occurred at Hama Dori in Fukushima prefecture on April 11.

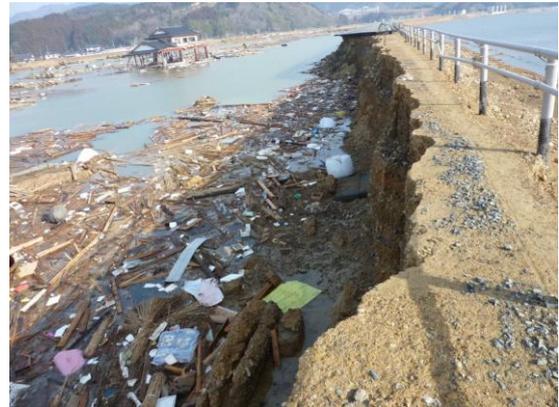
In this disaster, both the earth structures located along the coast and the river dikes were heavily eroded by the tsunami, which resulted in spills into the inland areas. Photo 2 shows one of the examples. On the other hand, the embankment of Sendai east express way stopped the tsunami from infiltrating into the Sendai plain, which dramatically decreased the amount of damage to areas inland from it. Now, as a multiple protection policy against tsunami damage, the use of a prefectural road with a padded embankment to provide protection against another tsunami event like this one is being considered. However, in foundation engineering, the technical requirements required to provide earth structures with tsunami-proof and erosion-proof performance have never been investigated, especially for the over flow case. There is much room for research.

Photo 2 Damage of the river dike caused by scouring at the mouth of the New-kitakami river

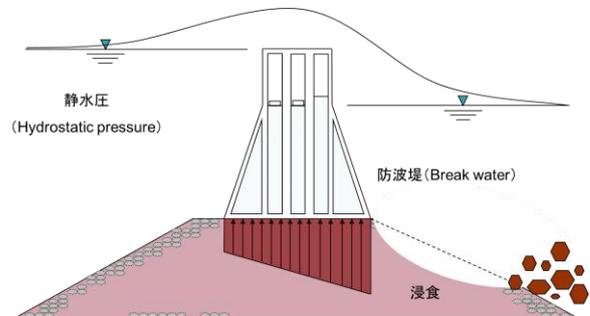
Many breakwaters and RC buildings at the Tsunami affected area were also severely damaged as shown in Figure 12 and Photo 3. For breakwaters, research need to be done on foundation design subjected to the overflow of water. With regard to building foundations in Tsunami affected areas, the external design force of

Figure 12 Schematic diagram of the failure mechanism of a breakwater mound due to the tsunami

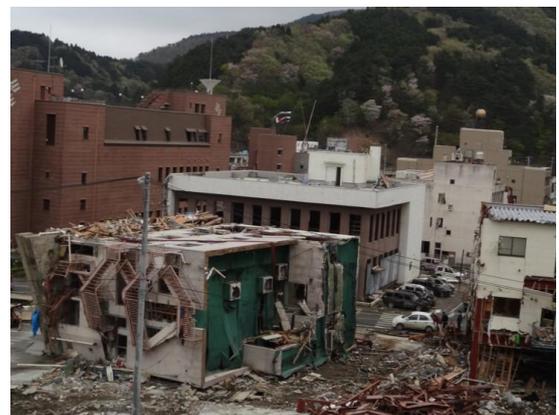
the Tsunami wave has to be evaluated. In addition to this, it is pointed out that the liquefaction that took place before the tsunami reduced the frictional resistance of the pile foundations.

Photo 3 A collapsed RC 4 story building with pile foundations due to the tsunami at Onagawa town in Miyagi prefecture

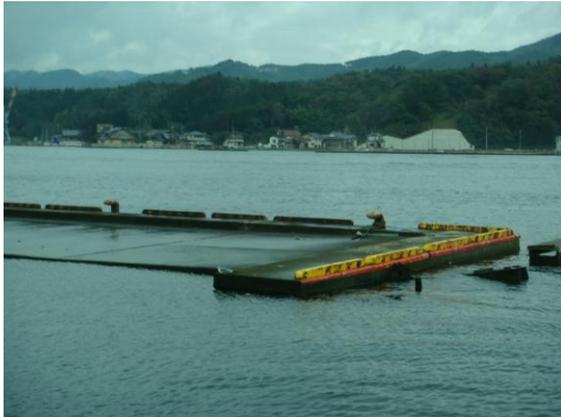
Due to this earthquake, tens of centimetres of land subsidence was noted in coastal areas. For example, in the Sendai plain, the area under the sea level increased from 3 km² to 16 km². Quay subsidence has interfered with the cargo work as shown in Photo 4. Such lowlands become not only vulnerable to flooding in the event of a tsunami but also in the event of freak high tides and weather. Many of the places where land subsidence occurred experienced problems in the storm surge disaster from typhoon No. 12 this summer. From another perspective, subsidence of the foundation is equivalent to a rise in the sea level. Although a rise in the sea level was thought to be a problem of the future as a long-term consequence of climate change, it has been actualized as a real

Photo 4 The quay submerged in water due to the ground subsidence at Kesen-numa Port in Miyagi prefecture

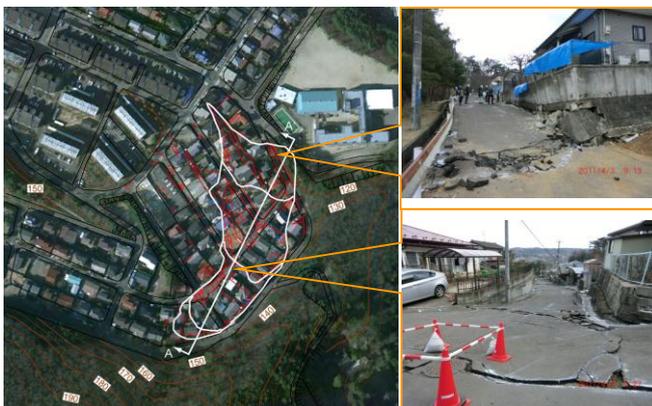
Photo 5 shows an example of damaged residential area in Sendai city. In this case, three sliding failure blocks were presumed by damage investigation. However, about the view of the subterranean slide, a specialist's opinions were divided. One considers deep sliding surface between original ground surface and fill, the other considers shallow ground deformation due to ground shaking as shown in Figure 13. Though the restoration measures depend on the failure mechanism, it is very difficult to identify the sliding surface under the artificial inhomogeneous fill ground.

Photo 5 Damage to the residential area ground in Sendai city in Miyagi prefecture

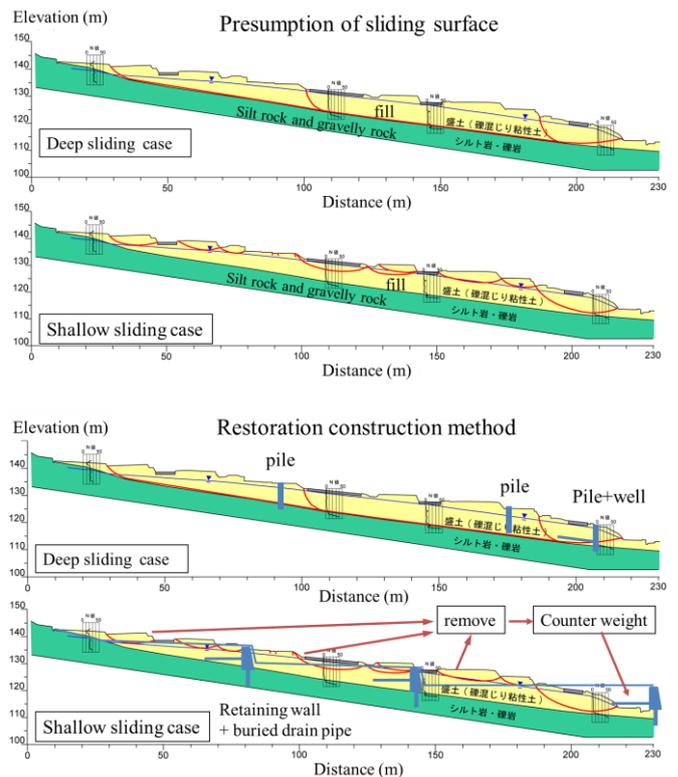
Figure 13 Restoration countermeasures depend on the failure mechanism, such as a presumption of a sliding surface

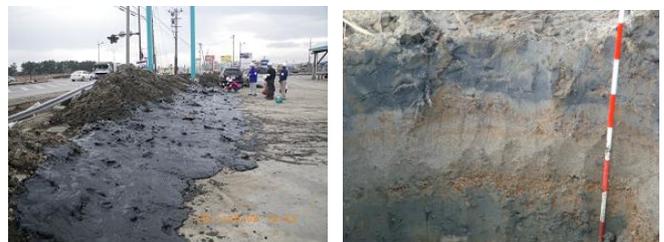
In this disaster, the sheer quantity of earthquake disaster waste and earth and sand deposited by the tsunami, an example of which is shown in Photo 6 has posed important considerations regarding how to use and process it all and how to do this economically. In order to make it possible to use such large quantities of earth and sand as resources and to use them effectively, improvements in the field of earth material management are required. The management measures ultimately employed should ideally also contribute to the preservation of the geotechnical environment. From this perspective, this disaster has provided an opportunity to rethink and improve the framework of regular waste treatment. Foundation engineering can make a significant contribution in this field.

Photo 6 Tsunami deposits, in Higashi-matsushima city in Miyagi prefecture (left) and a rice field in Soma city in Fukushima prefecture (right). The characteristics of the deposited soil from the tsunami change from area to area.
