## Advance in Geogrid Reinforced Slopes in Malaysia

T.A. Ooi<sup>1\*</sup> and C.H. Tee<sup>2</sup>

**ABSTRACT:** Geogrid product was formally introduced into and developed in Malaysia after Pilecon Holdings Sdn Bhd signed a distributorship agreement with Netlon Ltd (now Tensar International Ltd) United Kingdom in 1985. Prior to that Star Art Sdn Bhd was the distributor of Netlon product in Malaysia. Ooi & Tee (2004) examines the various case histories of slope repair and the role of geosynthetic reinforcement used in slope reconstruction and their performances for the last twenty years since the introduction of geogrids to Malaysia. Slope failure is not uncommon in many parts of Malaysia. Asahari (2009) reported more than 100 landslide incidences a year in Malaysia at a seminar on safe hill-site development in Kuala Lumpur. The frequency of occurrence of slope failure increases during the monsoon seasons where incessant rain extended over long period of time caused the slope to fail despite the fact that it may be stable for a long time. The infiltration of rainwater causes the reduction of soil suction, rise in water table and reduction of the shear strength of soil. In the cas

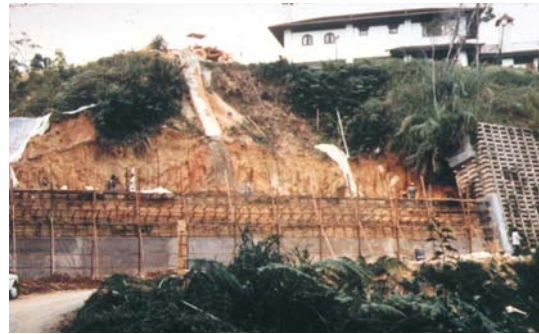
Figure 2a Petronas bungalow with failed slope in 1987

This work was carried out by the late Professor Chin Fung Kee in 1987 and reported by Chin *et al* (1989) at the first symposium on the application of geosynthetic and geofibre in Southeast Asia. Figure 2 shows the collapse of the cut slope and the subsequent rehabilitation. Pictures taken over the years were also included to show the conditions of the rehabilitated slope. The exposed SS1 biaxial geogrid is in perfect condition. The instrumentation and finite element analysis showed that the movements are within acceptable limits.

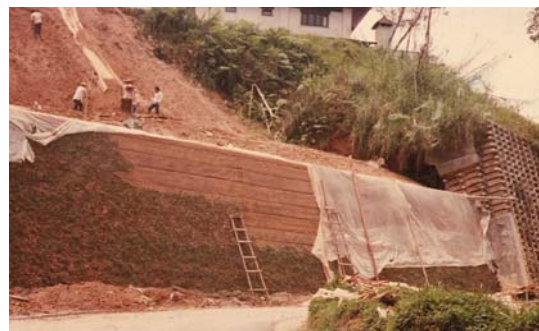
Figure 2c Slope rehabilitation in progress, 1987

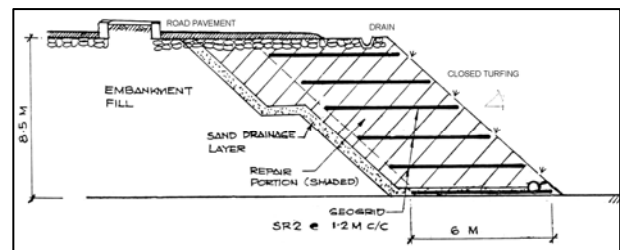
Figure 3a Schematic repair using geogrid, Temerloh Mentakab, 1985

In Malaysia, the use of geosynthetics for reinforcement of road embankment was introduced into JKR in early 1985 in the Temerloh – Mentakab bypass. In this instant, it was not possible to use stabilizing berm technique due to the limited width of the road reserve and the embankment had failed. In order not to encroach into private land, a 45° slope with 8.5m high embankment was reconstructed and reinforced with 6m length of SR2 uniaxial geogrid at 1.2m. The material used was residual soil of sandstone / shale compacted to wet of optimum moisture content at 90% degree of compaction using B. S. heavy compaction. An internal drainage system using sand drainage layer was provided at the back of the cut back slope and the base of the embankment with suitable drainage outfall as shown in Figure 3. This embankment has remained stable for 25 years.

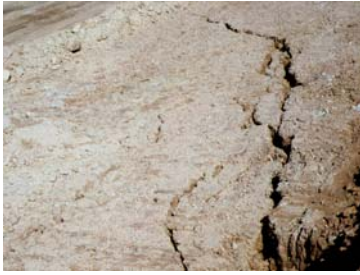
Figure 4a Crack in embankment

The Jitra – Butterworth Highway Embankment was the first to use geogrid in Malaysia in year 1984/85 as basal reinforcement to rehabilitate an embankment failure due to failure of a 4m high embankment during construction in soft marine clay. Chan (2000) has reported this work. Prior to the use of geogrid basal reinforcement, bakau mats, made from a local species of tree with aerial roots with up to 150mm diameter trunk that grows well in brackish water in coastal swamp land, are placed on top of the soft ground before placement of the soil fill. Figure 6 shows picture of such application. After 1970s geotextiles were later used in its place. The disadvantage of geotextile is the large extension during placement of fill material and large lateral displacement of the embankment. In 1984, uniaxial geogrid was used in Jitra - Butterworth Highway as basal reinforcement in order to build higher embankment on coastal marine clay as shown in Figure 4. A layer of biaxial geogrid was used to control surface cracking of the embankment. Figure 7 shows picture of fill placement using biaxial geogrids in soft ground. Ooi *et al* (2004) reported the performance of biaxial geogrid in road pavement and fabrication yard for offshore structures. Figure 8 shows the load transfer mechanisms in geogrids and geotextiles respectively. Geotextile is commonly used as separator. The geotextile transfers load based on membrane tension while geogrid transfers load by shearing of interlocked soil particles. Figure 9 shows the rutting of the geotextile-reinforced section under vehicular load. Ooi *et al* (2004) shows geogrid significantly reduced the rutting of pavement at the Sungei Way Trial.

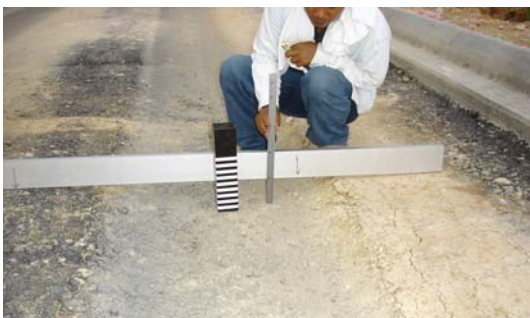
Figure 5c 100mm rut depth @ 120 passes Missing Link unpaved section

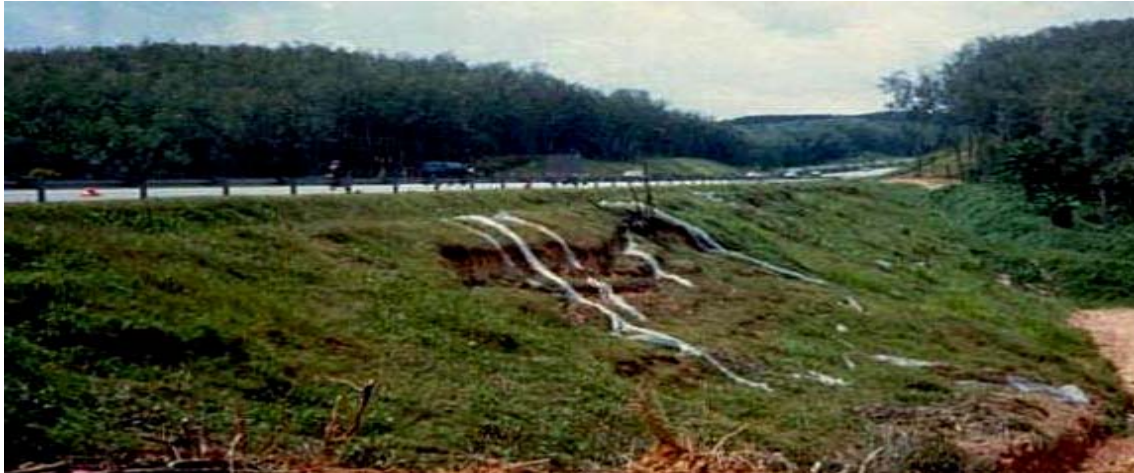
The Senawang – Air Keroh road embankment slope failure happened as a result of not cutting back the loose overfill on slope which has moved down the slope with passage of time. Figure 10a shows picture of the failure. Figure 10b & 10c show typical sections of the schemes for slope rehabilitation. The geogrid alternative was selected by the client in preference to the exhibited design using crib wall supported on precast reinforced concrete (RC) piles. The geogrid solution is more cost and time effective and blends in well with the existing green environment. This method of rehabilitation was often preferred by the client.

Figure 10a Picture of embankment failure, 1989.

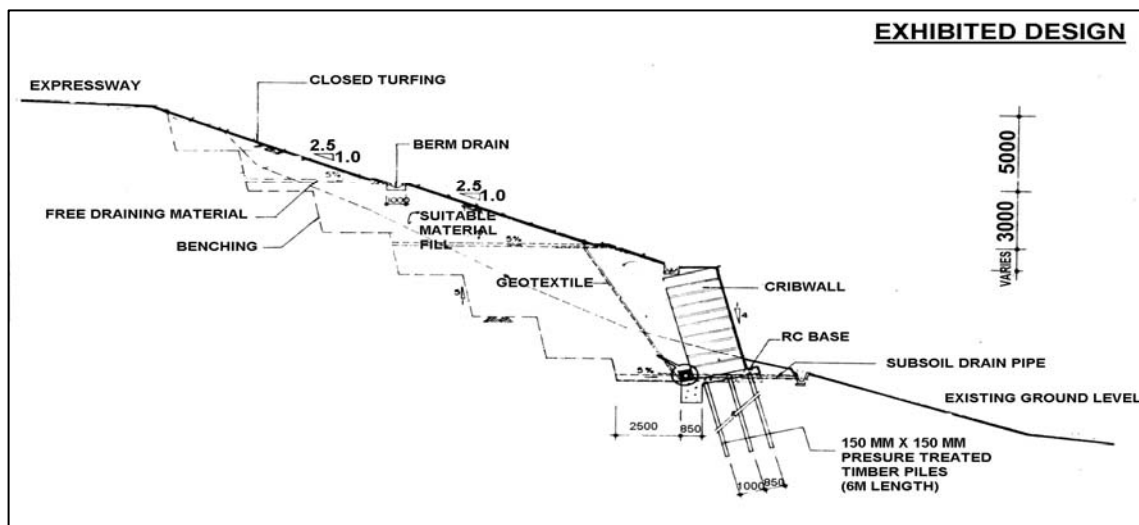
Figure 10b Exhibited design

The repair work was carried out in 1989 using uniaxial and biaxial geogrids. The depth of excavation of the failed slope was determined using the JKR probe, a light dynamic cone penetrometer. The rehabilitated embankment was about 12.5m high with a slope angle of 33° and reinforced with geogrids and compacted in layers using insitu residual soil. A berm was provided at mid height so that surface and subsoil water can be drained out and collected and led away from the slope. Internal drainage was provided using sand counterfort drain spaced at 3m

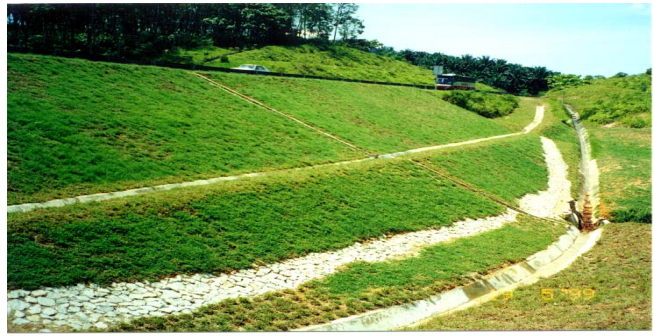
Figure 10e Picture of rehabilitated slope, 1989

centres. A rock fill toe and toe drain was also provided to avoid toe softening due to poor drainage. Figure 10d shows rehabilitation in progress. Figure 10e shows picture of rehabilitated slope.

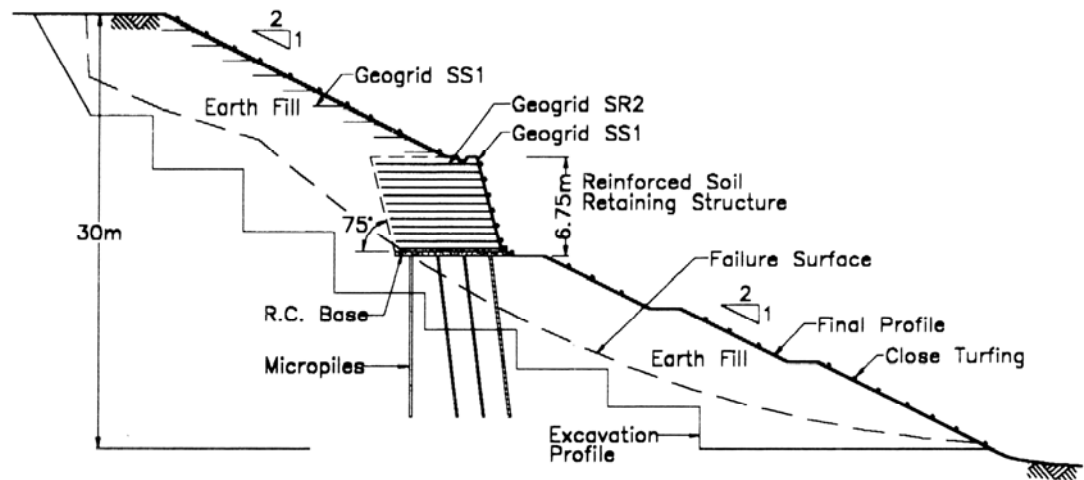
In Malaysia, very careful works has been done in pioneering the use of geosynthetics in very high slope as early as 1985 in a slope failure at Motel Desa, Kuala Terengganu. This is because for the first time geogrid is being designed for the rehabilitation of such a high slope. The total height of the slope failure was about 30m. A geosynthetics reinforced wall of about 7m high was constructed with full instrumentation at about 12m above the toe level of the slope to provide support for the unreinforced top 11m high section of the slope compacted at 25° slope angle. Figure 11 shows a schematic profile of the slope together with the micro pile supported platform and the geogrid reinforced wall at mid-slope. Toh *et al.* (1986) and Chan (1996) reported the details of construction and monitoring work. Subsequent to this work, numerous slopes have been repaired using the same basic

principle but improvements to construction methodology and design have been made. The instrumentation shows that the bottom un-reinforced portion of the slope was subject to settlement movement of 200mm and a lateral displacement of 87mm. For the reinforced soil block, SR2 uniaxial geogrid was used as main reinforced element and SS1 biaxial geogrid was used as surface wrapping and secondary reinforcement. Closed turf and creepers were used as surface finish.

Figure 11 Motel Desa slope failure rehabilitation (after Toh *et al.*, 1986).

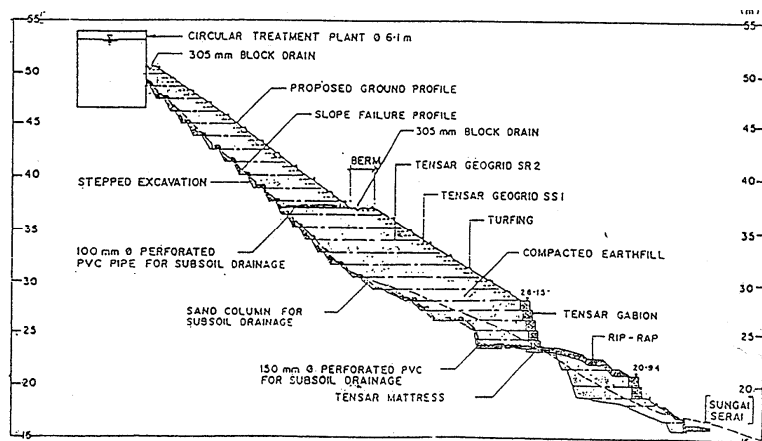
The Sungai Serai treatment plant landslide in Hulu Langat, Selangor is an important milestone for the repair of slope using geosynthetics. The landslide that occurred in January 1987 affected the 6m diameter R.C. circular tank structure located at the top of the failed slope of 33m high. Water from the scour pipe washed away part of the slope and left the tank perched precariously at the top of the slope. The slope has been stable for more than 50 years since completion. Ooi & Tee (2004) at the Malaysian Geotechnical Conference held in Kuala Lumpur in 2004 reported this rehabilitation work. Urgent action was required to immediately reinstate the slope and no insurance company was prepared to issue an insurance cover for the Contractor All Risk (CAR) policy for the work. Work started at the toe of the slope near the river with mattress and tail-in gabions together with rip rap for protection of the river bank for the first 8m height. Another 5m high of tail-in gabions were

Figure 12a Schematic rehabilitation (Figure are in metres)

constructed to provide support for 23m high SR2 uniaxial geogrid reinforced slope with a slope angle of 33°. The slope surface was reinforced with SS1 biaxial geogrid to facilitate turfing and to contain the compacted residual soil. A berm was provided at mid height of the upper slope in order take away the surface run off as well as the subsoil drainage water. Figure 12 shows the schematic view of the section of the slope rehabilitation and picture of work in progress when construction has reached a safe height. In-situ residual granite soil was used in 300mm layers and compacted with geogrid reinforcements to 90% B.S heavy compaction. Internal drainage of the reinforced slope was facilitated by using sand column and 150mm diameter PVC pipes. The completed surface was close turfed and trees planted. Monitoring of slope movement after completion was carried out. To date 23 years after rehabilitation, the slope remains stable. The slope rehabilitation was the first of its kind in putting sustainable development effort into practice by using insitu residual granite soil having angle of internal friction of 26 degree for the reconstruction of a failed slope to 33° slope angle.

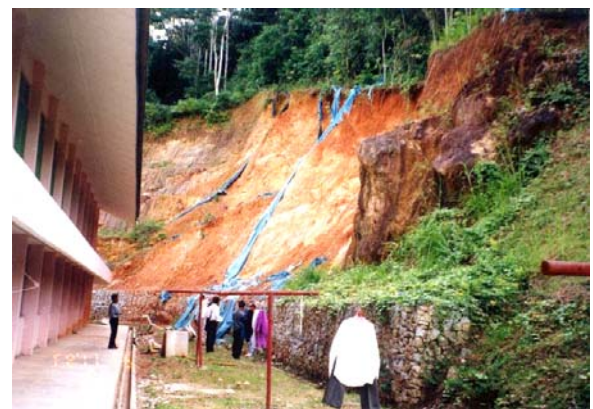
In 1997 landslide occurred behind a school hostel at Tun Saban secondary school in Pengkalan Hulu, Perak as a result of incessant rain in the monsoon season. The 17m high slope was stabilized first by using soil nails at 1.5m intervals as the failed slope was being excavated to profile for the geogrid reinforced slope. Soil nails were necessary to provide the required factor of safety of 1.2 for temporary stage during the construction of the slope. Two levels of 3.6m high geogrid reinforced vertical Modular Block wall were used. The method of construction enables rapid building up of the walls without temporary forms. Figure 14 shows picture of the slope failure, a schematic slope rehabilitation and picture of the completed repair work. The Modular Block wall also provided the support for the upper geogrid reinforced slope of 11.6m high with slope angle of 46°. It carries the perimeter fencing and drainage at the top of the slope. The reinforcement elements used were 160RE, 120RE, 80RE, 55RE, 40RE uniaxial geogrids and SS20 biaxial geogrid. The completed slope was close turfed. The soil nails, apart from giving the required safety factor for temporary stage, also prevented deep seated slope failure and increased the overall safety factor of the geogrid reinforced slope and that of the Modular Block wall. This type of combined technology in soil reinforcement was carried out for the first time. The combined technology was also used in the case of Motel Desa slope rehabilitation where micropiles were used to support the geogrid reinforced soil wall. During that time terminologies such as sustainability and combined technology were not used.

Figure 14a Slope failure above toe wall close to the school block

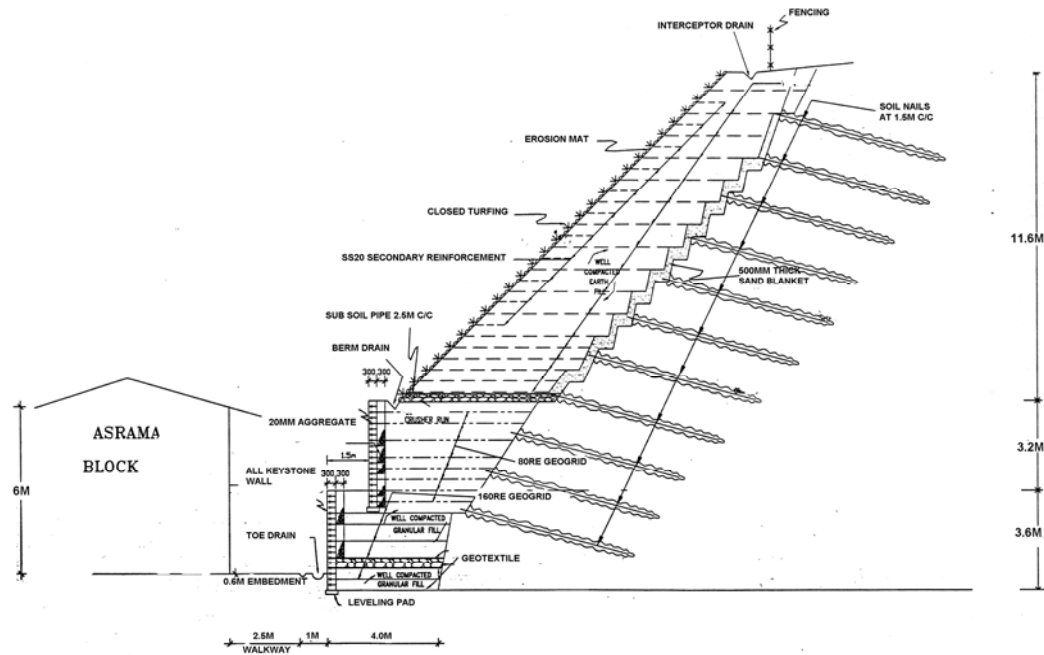
Figure 14b Schematic rehabilitation using combined technology of soil nails, modular block wall and geogrid reinforced slope.

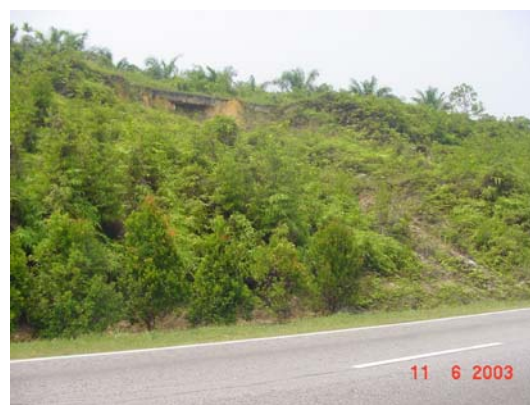
In the October - December 2002 monsoon, landslide occurred at Seksyen 536 along Federal Road FT01 at Tapah, Perak. The slide involved the bottom 17m of a 20m high slope cuttings in Kaolin formation. The client opted for a geosynthetic solution with turfed slope for the rehabilitation work. Rock toe was first constructed at the bottom of the slope with sandfill as the base with two layers of uniaxial geogrid reinforcement. Sandfill base serves as a internal drainage for the sand drainage columns of 1m x 0.5m spaced at 5m centres at the back of the re-profiled slope. On top of the sandfill, base layers of uniaxial geogrid were placed within the residual soil fill compacted in layers to the original slope profile of approximately 32°. Residual soil was used in the reinforced block to replace the existing Kaolin which has high moisture content and is susceptible to softening and landslide. Sandfill is also used extensively because of its low cost, better strength and well drained properties. Figure 15 shows picture of slope failure, a schematic slope rehabilitation, construction of sand layer with rock toe and the rehabilitated slope.

Figure 15a View of slope failure

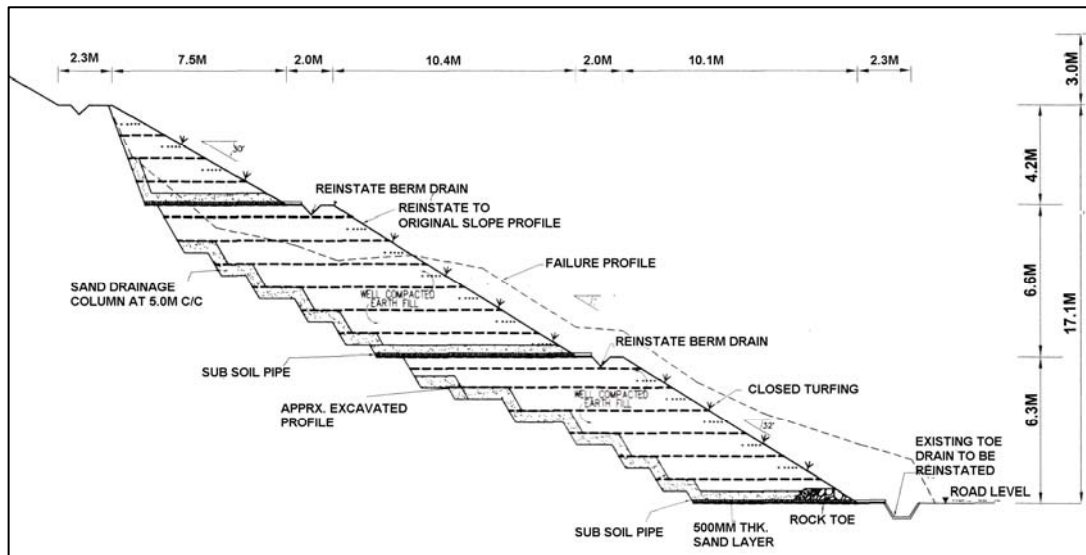
Figure15b Schematic rehabilitation with emphasis on drainage

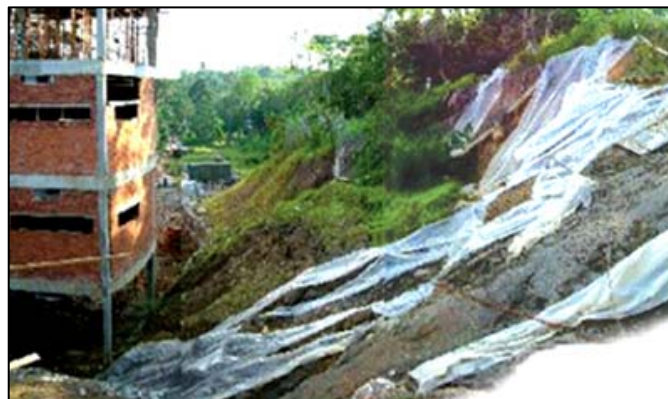
In late 2002, a landslide occurred at a slope behind the Lecture Block of a Sains Kolej in Kuching, Sarawak. An 11m high slope with existing 3m high gabion toe wall moved laterally towards the building columns and burying them. Fortunately, the movement did not cause the collapse of the lecture block columns. Figure 16 shows picture of the slope failure, the schematic slope rehabilitation and the rehabilitated slope. A 3m high basal block of geogrid reinforced Modular Block wall was

Figure 16a Slope failure affecting the lecture block

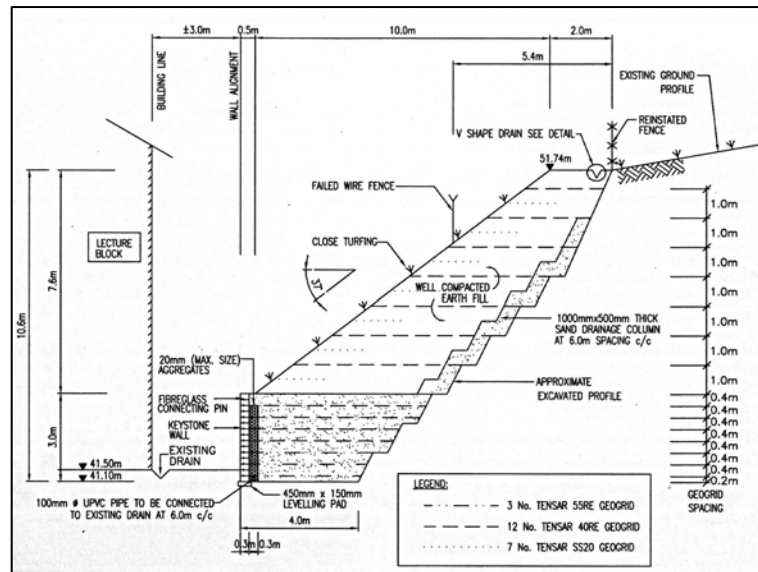
Figure16b Schematic slope rehabilitation

constructed to replace the damaged gabion wall. From the figure it can be seen that internal drainage was provided by the sand columns spaced at 6m centres. The sand columns are connected to basal block of geogrid reinforced Modular Block wall with granular backfill and aggregate drainage layer at the back of the wall. 100mmØ UPVC drainage pipes are provided at 6m centres to lead the subsoil water to the existing drain. External drainage was also provided by cut-off drain at the top of the slope.

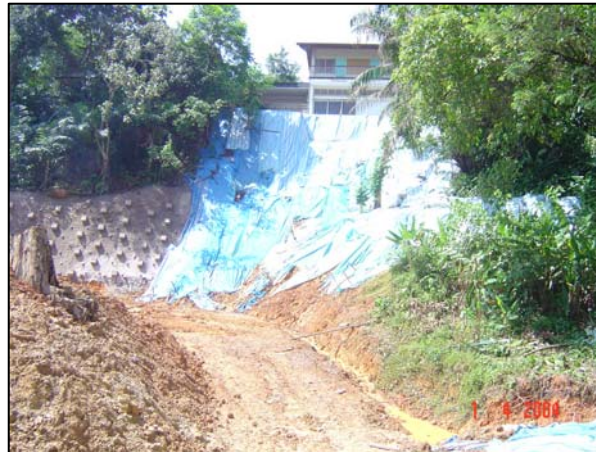
The Faculty of Economics of University Malaya in Kuala Lumpur was constructing an additional block of building in 2004 near a filled slope that was constructed some 40 years ago. The site was very restricted as can be seen from Figure 17. At the top of this slope was a double story university residence. In order to gain space for the construction of an additional block of buildings with car parking bays, it was necessary to cut the former filled slope to a steeper slope angle. Originally, soil nails were prescribed for stabilizing the cut slopes. As the soil nailing work was proceeding for other lower sections of the slope, the higher section of the cut slope collapsed leaving the building on top of the slope perching precariously. Figure 17 shows picture of the failed slope, the scheme for the rehabilitation of slope, stability analysis, construction of Modular Block wall and the rehabilitated slope. It was clear that the 17 m high cut slope collapsed due to inadequate provision or precaution taken by the soil nail contractor to ensure that the slope had an adequate factor of safety during the temporary stage. Had a proper and comprehensive method statement of work been closely followed by the contractor it would have been clear that soil nails should have been installed following closely the cutting down of the slope. The contractor should have soil nailed the slope immediately after cutting instead of doing the soil nailing after

Figure17a Collapse of cut slope during soil nailing

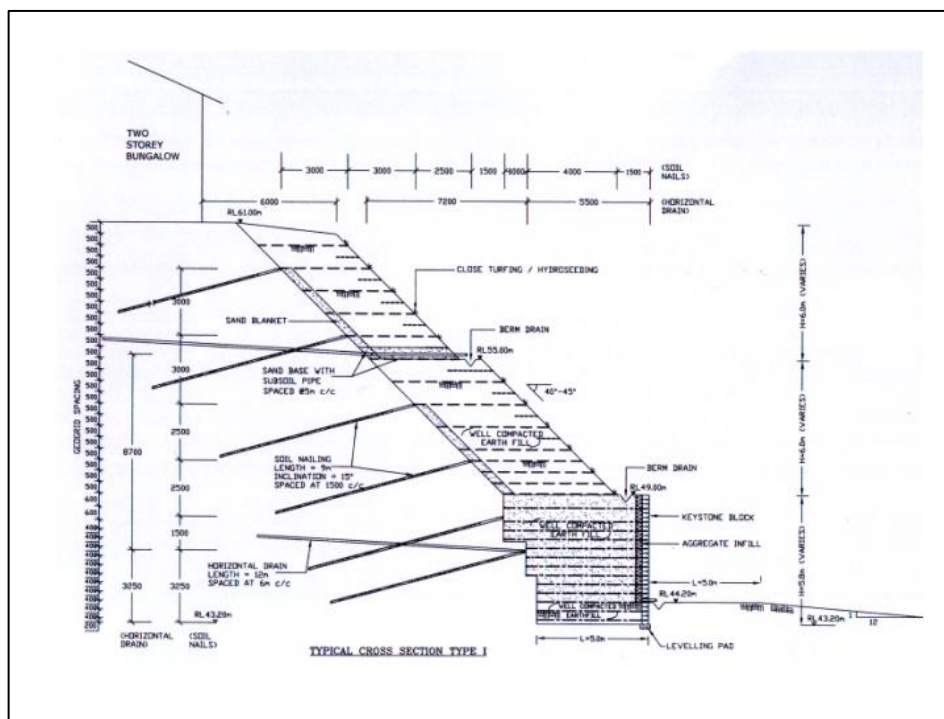
Figure17b Scheme of slope rehabilitation

completion of the entire excavation. The proposed scheme of rehabilitation as shown in Figure 17 considered both short term as well as long term stability of the cut slope. The high slope was located in a former fill over a valley where a stream existed. Despite the fact that filling was done over forty years ago, the material remained a loose tipped fill except for perhaps significant "collapse settlement" that had taken place within the soil fill during the repeated wetting and drying process. Continuous heavy rainfall that happened after the cutting of the former fill slope to a steeper angle was obviously the cause of the slope failure that had affected the perimeter drains and caused cracking of the concrete drain apron. The strategy for reconstruction of this slope is to soil nail the cut slope first to provide the short-term stability and then construct a 5.4 m high geogrid reinforced wall at the toe of the slope to provide for the long-term stability. This also provided a solid base to support the upper reinforced soil slope. The combined technology is employed here to solve a unique problem. Internal drainage system is provided to ensure that the ground water table level is controlled. This method of combined technology using soil nail, Modular Block wall and geogrid reinforcement has been widely used in slope rehabilitation of a number of restricted sites.

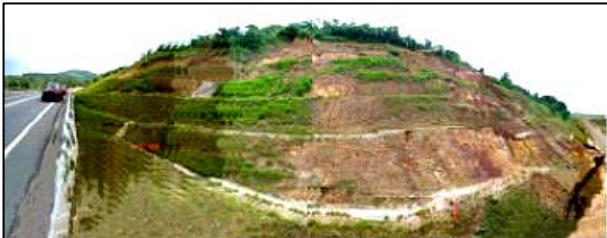
The Kuantan – Kerteh railway landslide at Chainage 19700 happened during the monsoon period of November – December 2005 soon after the project was completed and in operation. The cut slope of more than 40m high consists of residual soil of sandstone/shale formation. Poor drainage caused serious soil erosion and slope toe softening. The slope failure involved a slope height of 37m. Sheet piles were driven in an attempt to prevent the slope toe from encroaching into the ballast of the

Figure 18a Overview of cut slope failure

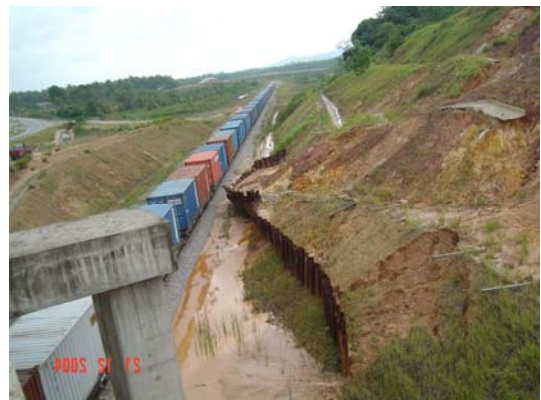
railway lines. The sheet piles tilted badly shortly after installation and threatened to endanger the safe operation of the railway lines. The slope toe including the railway lines were all waterlogged. The detail of this slope repair was reported by Ooi *et al* (2007). Figure 18 shows the picture of the slope movement and the railway lines, the schematic rehabilitation, the construction of the geogrid block and the rehabilitated slope.

Figure 18b Collapse of slope and sheet pile movement

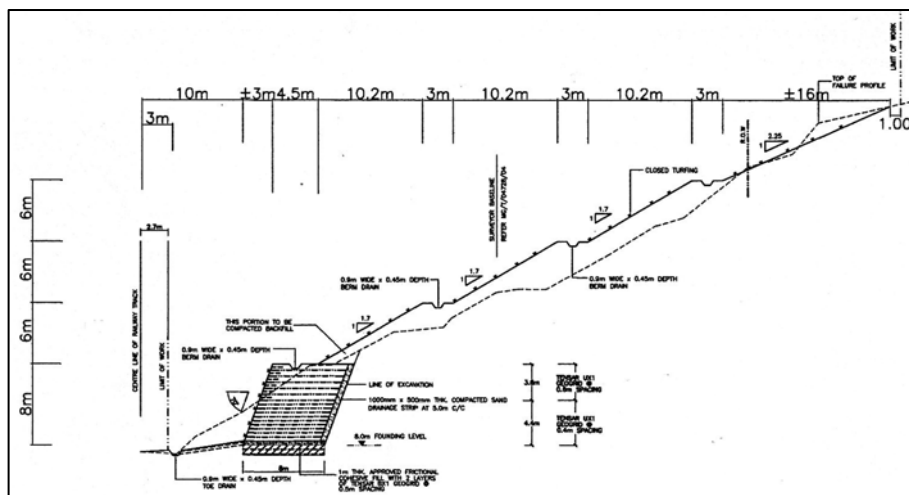
Figure 18c Schematic rehabilitation with setback of slope using reinforced geogrid block

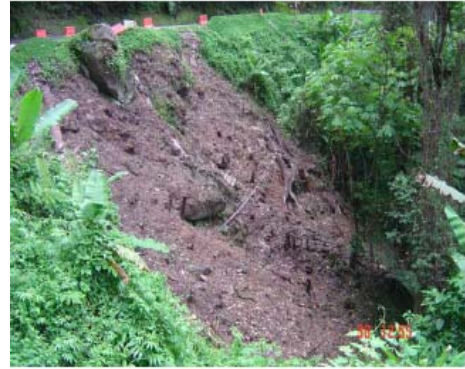
In 2007 a slip occurred at the road embankment of the Tapah-Ringlet road in Batang Padang in the Perak state of Malaysia. The slip affected the traffic flow between Tapah and Cameron Highland. The slip also affected a culvert and the cascading drain of the road. It was observed that the slip was caused by surface water flowing over the embankment during exceptional monsoon rainstorm. Figure 19 shows picture of the collapsed embankment, the schematic rehabilitation, the construction in progress and picture of the rehabilitated slope. It can be seen that for vertical face wall the galvanized, PVC coated rock-filled gabion was used with geogrid as reinforcement and tailed in of gabions to prevent any tilting of the gabions. For slope with 70 degree, steel mesh was used as permanent formwork and 0.5m thick rock-filled faced, wrapped around and reinforced with geogrid. In the case of 45 degree slope closed turfing (full-grown cow-grass cut-out with top soil in size of 300mmX300mm and secured with timber pegs) was adopted. It is important to water and maintain the new turfing for initial period of few weeks until it is capable of being self-sustained. It is normally good practice to provide wide road shoulder to ease traffic flow and to allow easier negotiation of

Figure 19a Collapse of embankment

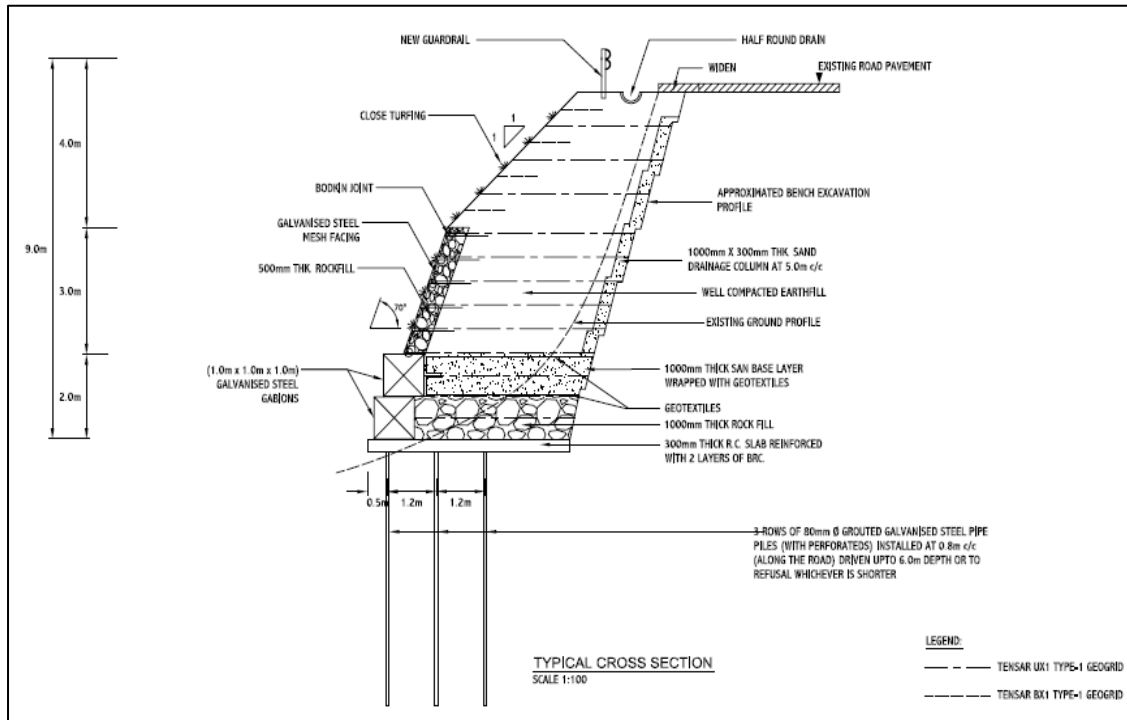
Figure 19b Schematic rehabilitation of embankment failure

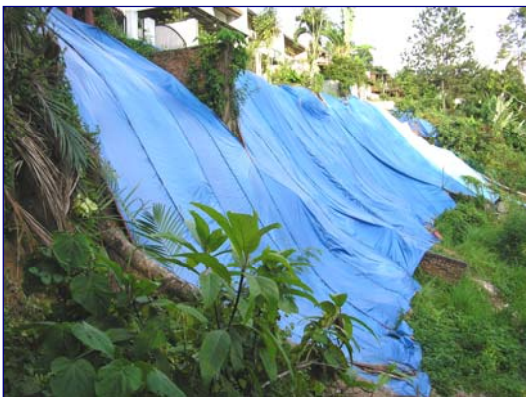
An old filled slope of an existing housing scheme has been a constant source of worries and nightmares to the row of terrace houses on top of the Taman Zooview slope with a commanding view of Kuala Lumpur city centre. The site was a former valley filled by the Taman Zooview developer. Figure 20 shows the condition of the site two years before the landslide, the construction of the anchored reinforced soil wall, the rainfall histogram, the landslide, the rehabilitation and the completed geogrid reinforced soil slope. Figure 20a shows picture of the Zooview slope in 2004 all covered with plastic sheets. Behind the plastic sheets all is not well. An anchored reinforced soil wall was constructed in 2006 as shown in Figure 20b. The year 2006 has been particularly wetter than previous years. Figure 20c shows the histogram of the rainfall 2005 and mean.

Figure 20a Condition of Zooview slope in 2004

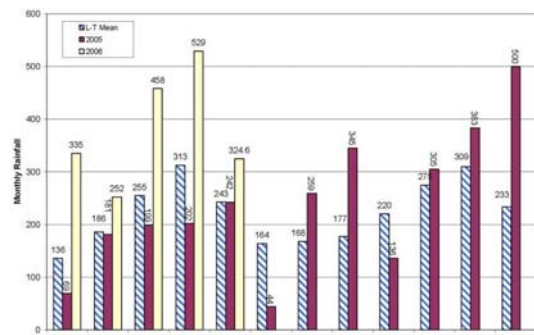
Figure 20c Histogram of monthly rainfall record for 2005 & 2006

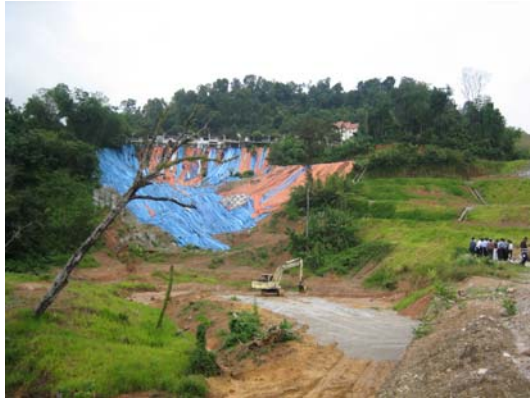
Figure 20d shows the collapse of the anchored reinforced soil wall 10 days after completion during the May 2006 monsoon season. Figure 20e shows a distant view of the landslide area covered in plastic sheets. Figure 20f shows the condition of the slope behind the plastic sheets. Figure 20g shows the schematic of rehabilitation of failed slope. Figure 20h and 20i show the respective picture of lower rock fill and upper geogrid embankment. Figure 20j and 20k shows the earthworks at formation level of the backyard. Figure 20l shows the spacious back garden. Figure 20m shows the devastated condition of the back yard before rehabilitation. Figure 20n shows the rehabilitated slope on completion. Figure 20p shows the rehabilitated slope with turf established.

Figure 20e A distant view of the Zooview landslide with plastic sheet cover

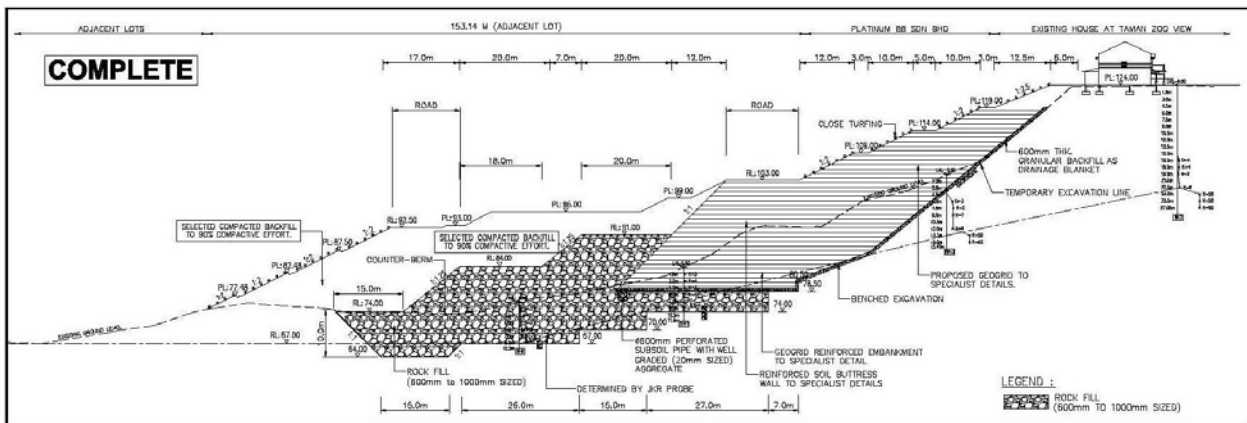
Figure 20g Schematic rehabilitation of slope failure

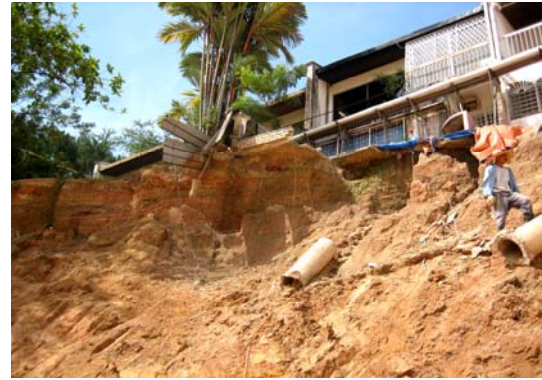
Figure 20m Condition of backyard before rehabilitation

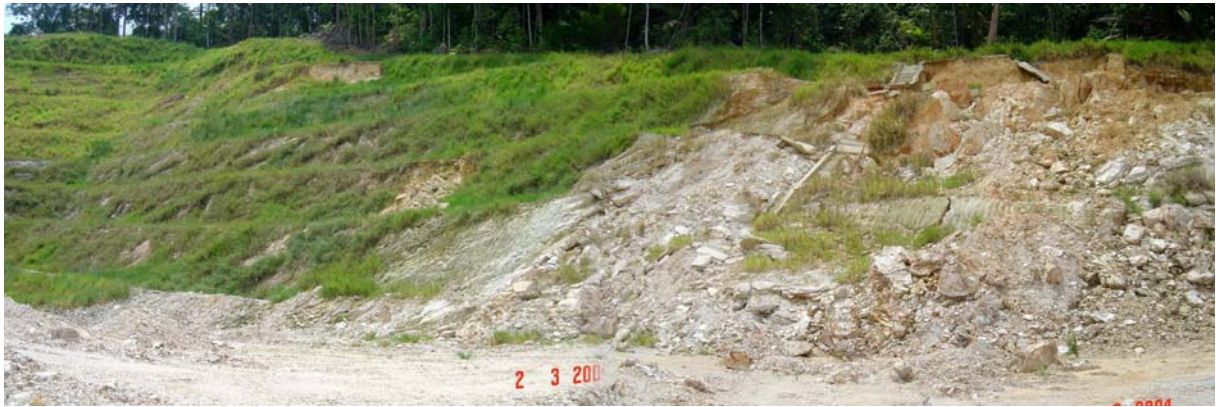
U9 slope is a residual soil slope of Kenny Hill Formation consisting of sandstone and shale with quartzite intrusions. The slope is about 25m high and has been cut back for housing development. Figure 21a shows the slope failures. In 2004 a tender was called to rehabilitate the slope. Unfortunately, the slope collapsed during the midst of rehabilitation and affected the sale of the houses. Figure 21b shows the schematic rehabilitation using Terramesh solution. Figures 21c and 21d show the conditions of the site after the collapse. The toe wall at the bottom of slope had moved and tilted and were demolished. Figure 21e shows Terramesh in slope area not affected by landslide. The slope failure had caused the developer to hold back construction of houses near the slope.

Figure 21a View of slope failure in March 2004.

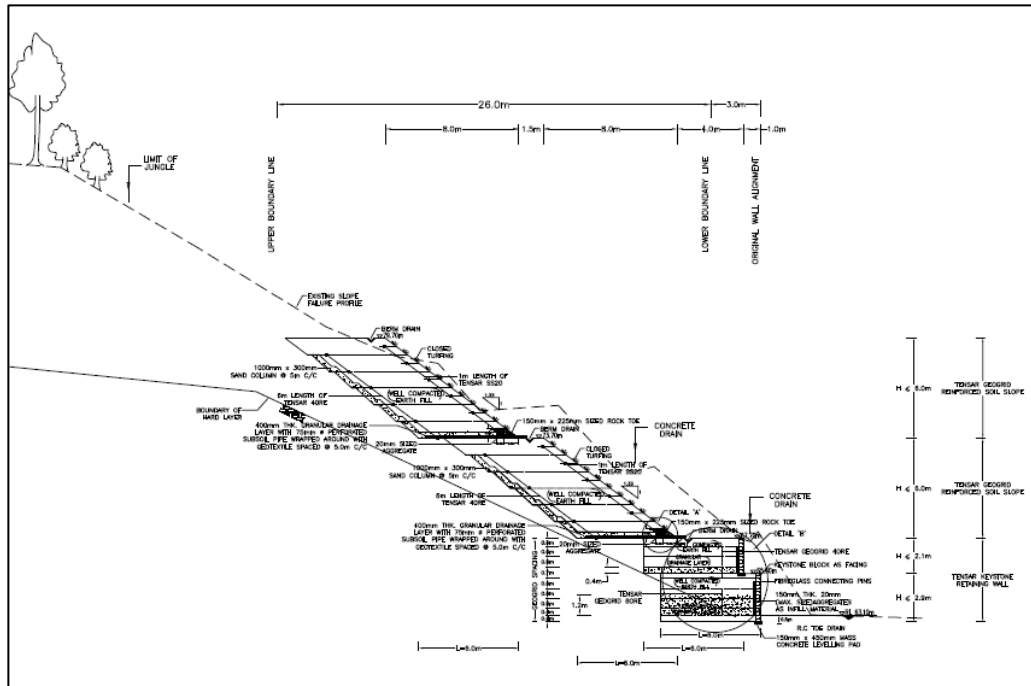
Figure 21f Geogrid solution for rehabilitation of failed slope.

In September 2007 another tender was called to rehabilitate the failed slope as a Design and Build project. Geogrid solution was selected based on the schematic rehabilitation proposal as shown in Figure 21f. This proposal has a minimum factor of safety of 1.55 as shown in the slope stability analysis in Figure 21g. It was the most competitive tender accepted by the client.

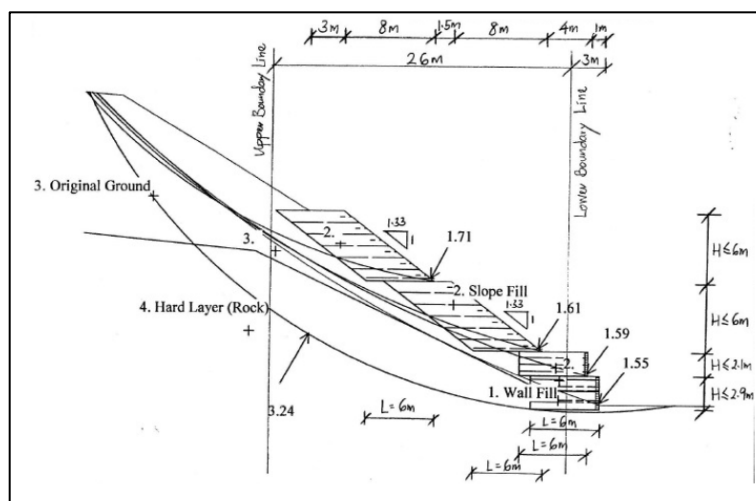
Figure 21g Slope stability analysis.

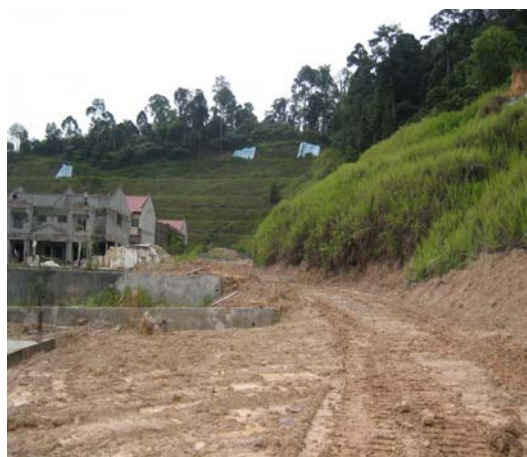
Figure 21h shows the commencement of rehabilitation works in November 2007. It can be seen that the landslide has encroached into the housing development site. Figure 21i shows the construction of slope drainage and Modular Block wall in progress. The rehabilitation work was completed with turfing in July 2008. The exposed fissures of the boulders were patched with cement mortars and formed part of the landscape features of the upper turfed slope. Figure 21j shows the view of completed slope rehabilitation with Modular Block wall and construction of houses in September 2008. Figure 21k shows the picture of the completed slope rehabilitation, Modular Block wall and houses in April 2009. The construction of houses were completed in October 2008. Modular Block wall, geogrid reinforced slopes complete with drainage and turfing were completed in December 2008. By April/June 2009 all houses were constructed, sold and occupied. This is a project where the purchasers are comfortable with the idea of living near a slope. Throughout the design and construction of slope rehabilitation, public safety and drainage were both amongst the top most priority of the client.

Figure 21h Picture shows clearing for access to site.

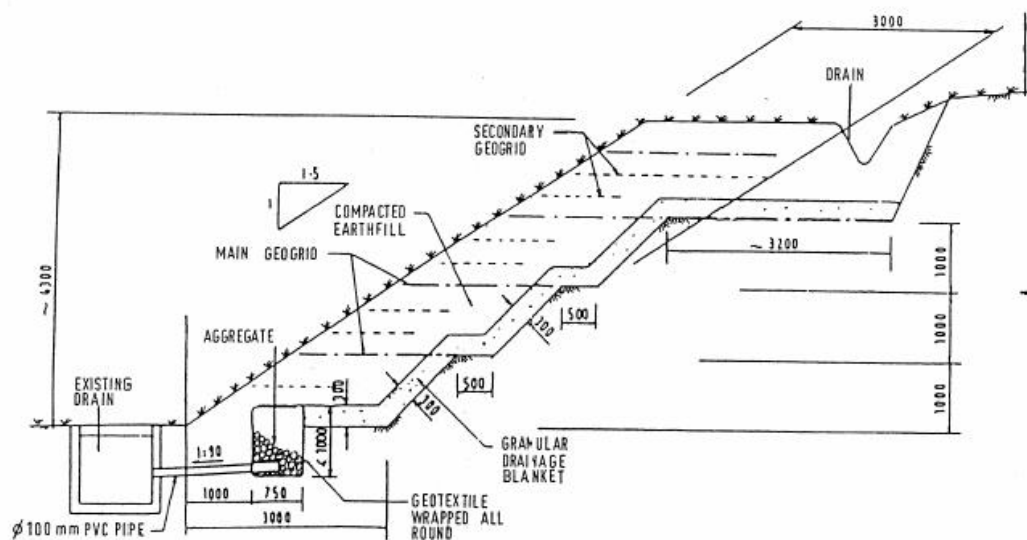
Yong *et al* (2007) reported in the 40<sup>th</sup> Anniversary SEAGS volume that in Singapore, the Public Works Department (now known as Land Transport Authority (LTA)) specified horizontal layers of geogrids or polymer mesh to reinstate slope failures. The stronger or main geogrids were laid at every 1.0 m vertical intervals with two layers of secondary geogrids in between. The geogrids were placed to intersect potential failure planes and they helped to reinforce the slopes. A 300 mm thick drainage layer of sand was also provided at the excavation surfaces in order to control any groundwater seepage as shown in Figure 22.

Figure 22 Slope stabilization using geogrids in Singapore (after Tan S. B., 1997, Yong *et al* 2007)
