Anchors of Anchored Slopes in Taiwan

Hung-Jiun Liao¹, Shih-Hao Cheng² and Chun-Chung Chen³

ABSTRACT: A catastrophic failure of an anchored cut slope at the national expressway in 2010 uncovered the status quo of tie-back anchors in Taiwan. Serious corrosion of anchor components due to poor corrosion protection was found to be the most obvious factor contributing to this landslide among other factors. After an extensive island-wide investigation on the existing anchored slopes, similar corrosion problem was found in many other anchored slopes. After the investigation, the construction and maintenance practice of anchored slopes had been fundamentally changed in Taiwan. This paper covers the inspection results on anchored slopes and also the measures taken to improve the corrosion protection of existing anchors and new anchors. Based on the problems found from the existing anchored slopes, some modifications on anchor tendon assembly and cement grouting practice had been developed to upgrade the corrosion protection of the new anchors and to monitor the long-term anchor load change as well.

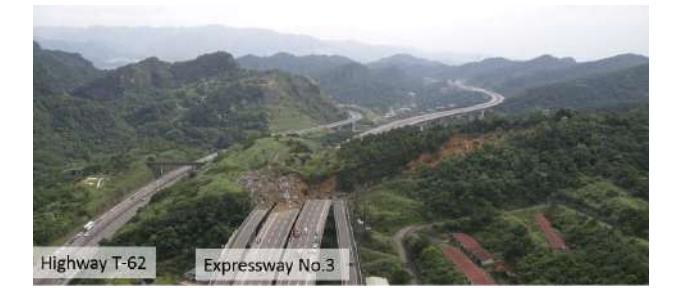
A catastrophic dip slope failure occurred suddenly at an anchored cut slope of Taiwan national expressway No. 3 in 2010 after 13 years in service (Figure 1). Originally, this slope was supported with a 20 m high retaining structure with precast RC crosses on slope face and 10 levels of tie-back anchors. Totally, 572 ground anchors were installed with a pre-stressed load of 60 tons each. From the remains of anchors on site, it was found that a large portion of anchors were seriously corroded (Figure 2) due to improper corrosion protection under the anchor head. Since ground anchors with the similar construction practice have been widely used to support the roadside slopes in Taiwan, they are likely to suffer similar corrosion problem (Lee et al., 2013 and Liao et al., 2013). The Ministry of Transportation and Communication (MOTC) of Taiwan government launched an extensive island-wide inspection program on the status quo of existing anchored slopes along the highways, railways and public roads (TGS, 2011 and Liao et al., 2014). Totally, more than 30,000 anchors were inspected and it had been concluded that anchor corrosion was a systematic problem island-wide for anchored slopes. After the investigation, immediate measure was taken to protect the existing anchors from further corrosion. In the meantime, the stability of existing anchored slopes was checked and additional measures were taken to make up the loss of anchor capacity due to corrosion and other causes. For the new anchors being installed to compensate the loss of tie-back capacity of corroded anchors, some modification on anchor tendon assembly and cement grouting process are suggested to upgrade the corrosion protection of the new anchors and to reliably monitor the long-term anchor load change.

Figure 1 Landslide on National Expressway No. 3 in Taiwan (photo taken on April 25, 2010)

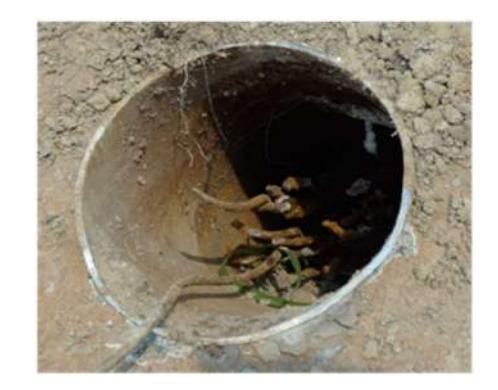
Figure 2 Seriously corroded and broken steel strands found from at the landslide site

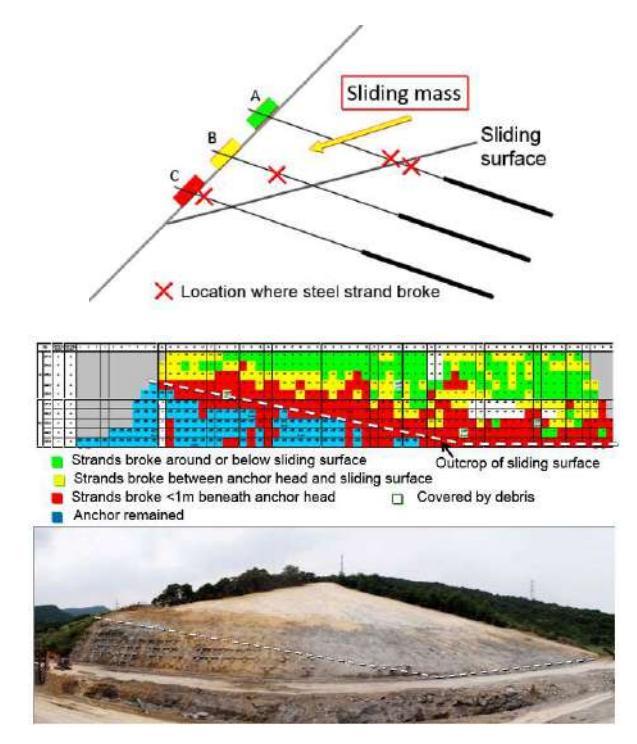
During the process of slope sliding, a large number of ground anchors were ripped off by the massive forces generated from the sliding mass. Serious corrosion observed on the ground anchor components indicated the abundance of groundwater in the slope. Figure 3 summarizes the field inspection results of ground anchors. By measuring the length of remained steel strands on the sliding surface, three types of steel strands breakage can be categorized. The "Red" category stands for the anchors of which strand breakage was closely under the anchor head. The "Yellow" category stands for the strand breakage in between anchor head and sliding surface. The "Green" category stands for the strand breakage near the sliding surface. The "Blue" category stands for the anchors remained on the slope face. Since the "Blue" anchors located on the not moving portion of the slope, they had no direct link to the causes of this landslide.

If neglecting the number of anchors still remained on the face slope (Blue category), approximate 40 percent of the broken ground anchors were in Red category. They were all located in the range between 5 - 7m above and 1- 3 m below the outcrop line of sliding surface on the face slope. For anchors located within this range, some showed white stain under the RC cap of anchor from the photos taken prior to the landslide. It is the deposit of calcium carbonate and is the sign of long time groundwater effluent from the anchor hole. As indicated by the distribution of Red marked anchors

in Figure 3, the groundwater level could rise to 5 - 7m above the outcrop line on the face slope. When the slope mass slid down, the steel strands of anchors in Red category broke at a location very close to the anchor head. It implies that steel strands were corroded under the anchor head for anchors in the Red category. Above the Red zone was the Yellow zone where steel strands were broken in the free length section and the breakage location was at some distance away from the anchor head. Since no anchor was actually pulled out from its fixed end, it can be concluded that all the failed anchors were resulted by the breaking of steel strands at different locations in free length.

Figure 3 Exposed sliding surface and distribution of anchors with different strands breakage locations on the free anchor end (Liao et al, 2013)

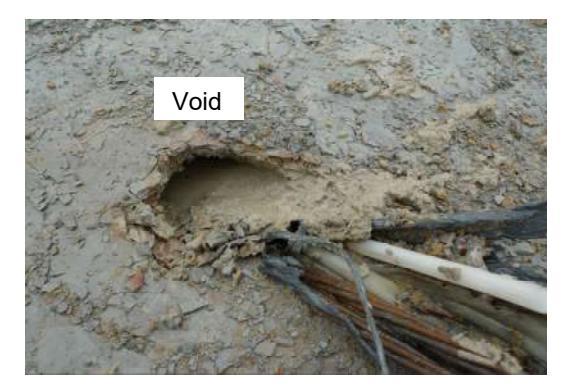
During anchor construction, it was the standard operation procedure to inject the entire anchor hole with cement grout first and then inserted the tendon assembly to the hole later. In theory, the annular space between anchor hole and plastic sheath of the free anchor end should be fully filled and sealed with cement grout. However, the remains of anchors left on the sliding surface did not show that way (Figure 4). There was ungrouted void both inside and outside of the plastic sheath in free anchor end. Obviously, some cement grout might have leaked out through the cracks and joints inside the slope or it might simply be a result of mal-practiced anchor construction. Not surprisingly, steel strands with improper corrosion protection corroded due to exposure to humid underground environment or being submerged by groundwater.

Figure 4 Ungrouted void in free anchor end (inside and outside of plastic sheath) found from anchors left on the sliding surface

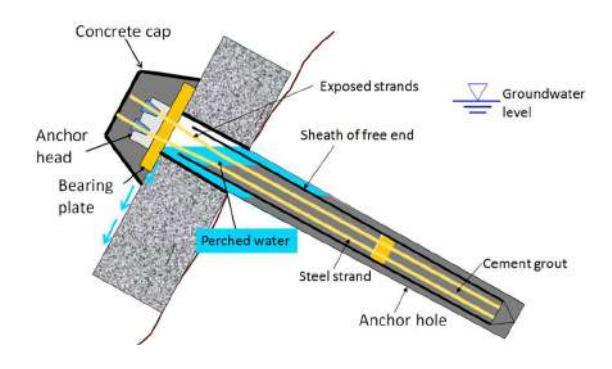
Figure 5 illustrates the ungrouted void under the anchor head due to improper anchor hole grouting. When anchor is inclined downward, the void and the ungrouted annular space outside the plastic sheath can easily become a storage space for the perched groundwater in slope. Having the perched water in the anchor hole, the unprotected steel strands are constantly exposed to or submerged by groundwater. Not for long, the steel components of anchor become corroded quickly. The corrosion of steel strands can be inspected by the endoscope images taken when inspecting the portion of steel strands under anchor head.

Figure 5 Schematic diagram of ground anchor installed in the slope

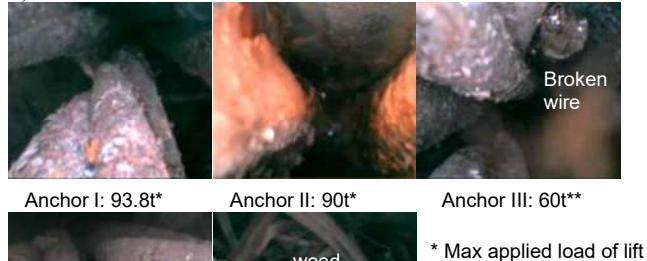
Figure 6 shows the endoscopic images taken from the anchors remained on the face slope of the Expressway landslide. In general, all anchors inspected suffered serious strands corrosion problem and should be classified as unacceptable condition according to the BSI standards for ground anchorages (BSI, 1989). Interestingly, the endoscopic images showed some wires of the strand had already broken at the time of endoscope inspection (Anchor III) and some strands were surrounded by weeds inside the anchor hole (Anchor V).

Anchor IV: 68.7t** Anchor V: 50t**

Figure 6 Images of endoscope inspection taken under the anchor head before carrying out the anchor lift off test

Lift off test was carried out on these anchors and the test results, such as lift off load and maximum applied load, are listed in Table 1. Obviously, there is no clear correlation between breakage load and the extent of surficial corrosion of steel strands. For example, the surficial corrosion condition of steel strands of Anchors I & II is no better than Anchors III, IV, and V. But Anchors I & II could sustain the maximum pull-out load about 50% higher than the other three anchors. Anchors I & II showed no strand breakage up to maximum applied load; Anchors III, IV, and V showed strand breakage during stressing and the maximum load applied was lower. For those anchors failed by strands breakage, some wires in the strands (i.e., the strands which are subjected to most serious corrosion or most stressed) broke first during stressing. After that, the load was redistributed to other wires and caused a chain-reaction type of breakage. In other words, strands may be broken in a wire-by-wire pattern; anchors may be broken in a strand-by-strand pattern and then a brittle type of failure occurs on anchor.

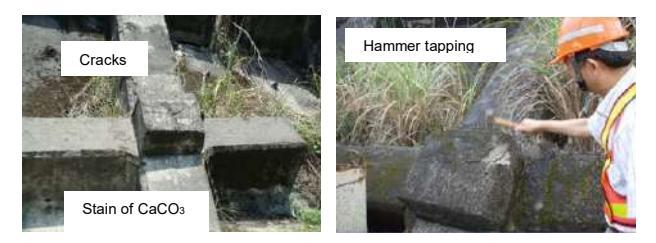
(1) Visually inspect and hammer tapping all the concrete protection cap of anchors (Figure 7): The integrity of concrete cap can be easily detected by hammer tapping. Special attention should be paid to the cracks on concrete cap and the sign of groundwater leaking out from the concrete cap. If there is a constant water flow from within the anchor hole, calcium carbonate (white stain CaCO₃) will deposit under the concrete cap and can be easily spotted.

Figure 7 Visual inspection and hammer tapping on the concrete cap of anchor

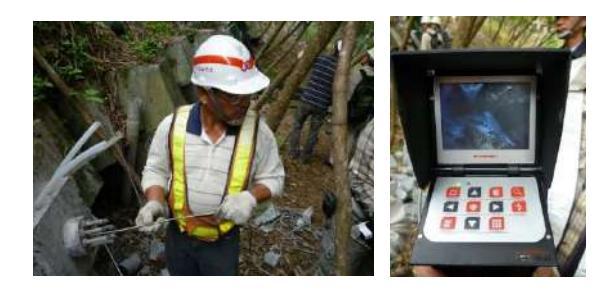
(3) Use endoscope to inspect the condition of steel strands beneath the anchor head (Figure 9): Usually, the appearance of anchor head components does not necessarily correspond to the extent of corrosion on steel strands beneath the anchor head. So it is necessary to use endoscope to do a close up inspection on the corrosion condition of steel strands under the anchor head.

Figure 9 Use endoscope to inspect steel strands under anchor head

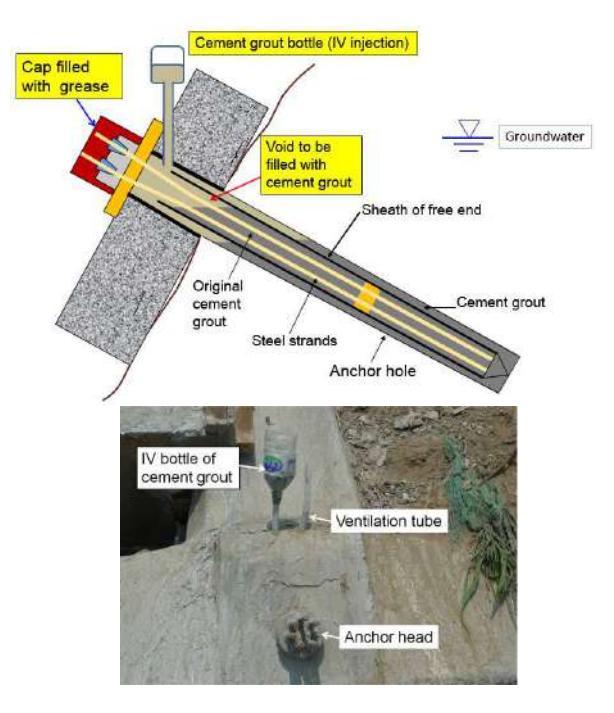
Figure 11 Fill up the voids under anchor head with cement grout for the existing anchors

Although many inspected anchored slopes show no sign of instability in Taiwan, a large number of anchors are suffering steel strand corrosion problem. There is an urgent need to prevent the rusting condition of existing ground anchors from getting worse. To do so, cement grout, which was low cost and commonly used, was injected to fill up the voids below the anchor head of the existing anchors to stop further corrosion on steel strands. This work could be carried out by drilling two holes from outside of the anchor to reach the void under the anchor head first (Figure 11). One hole was for cement grout injection; the other was for air ventilation. Cement grout (water/cement ratio = 0.5) was injected to the void with grouting pump. Since cement grout may settle or leak out from the anchor hole, pumping process may have to repeat several times and it could be time consuming. To make sure cement grout had filled up the anchor hole, an intravenous (IV) injection method is adopted as the final step of this remedial treatment. When the cement grout was effluent from the ventilation hole and was in balance with the grout supply bottle, then it could be certain that the void underneath the anchor head was filled with cement grout and the steel strands were safely covered with cement grout.
