Characteristics of Slope Failures During Natural Disasters Considering Geographical Features and Groundwater Level: Case Study of the Chuetsu Region of Niigata, Japan

H. Toyota¹

¹Department of Civil and Environmental Engineering, Nagaoka University of Technology, Niigata, Japan E-mail: toyota@vos.nagaokaut.ac.jp

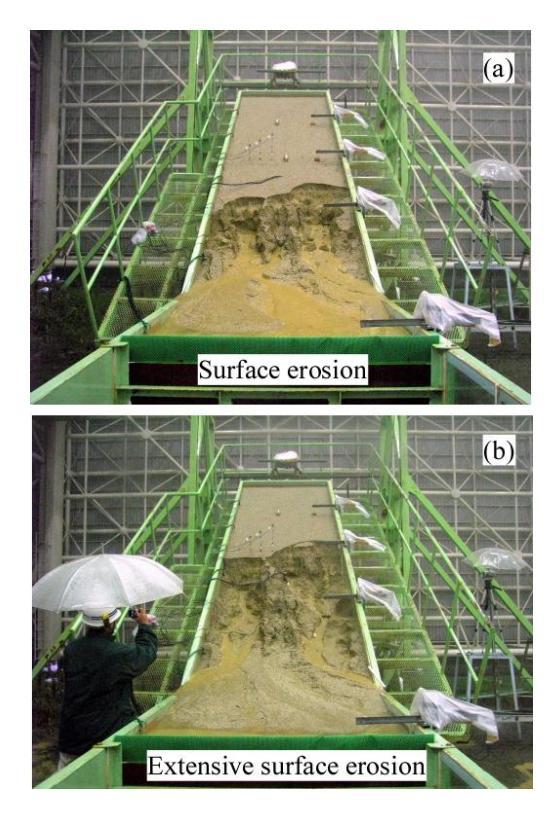
Photo 1 Progressive failure during rainfall (drained condition)

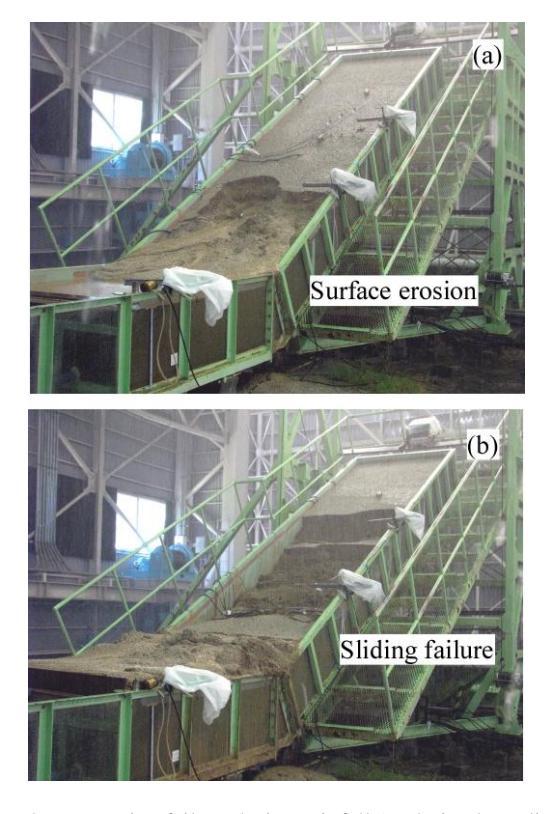
Photo 2 Progressive failure during rainfall (undrained condition)

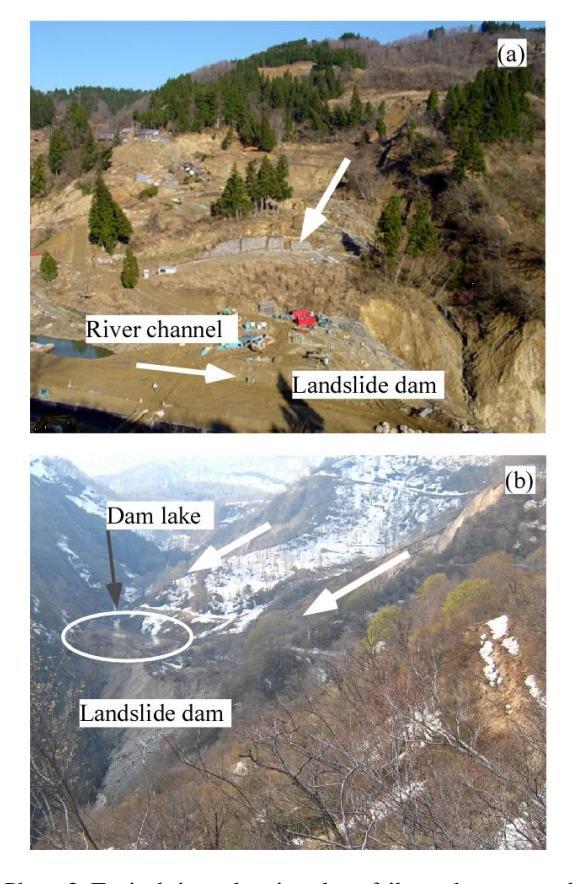
Photo 3 Typical river-clogging slope failures that occurred (a) during the Chuetsu Earthquake and (b) during the Northern Nagano Earthquake

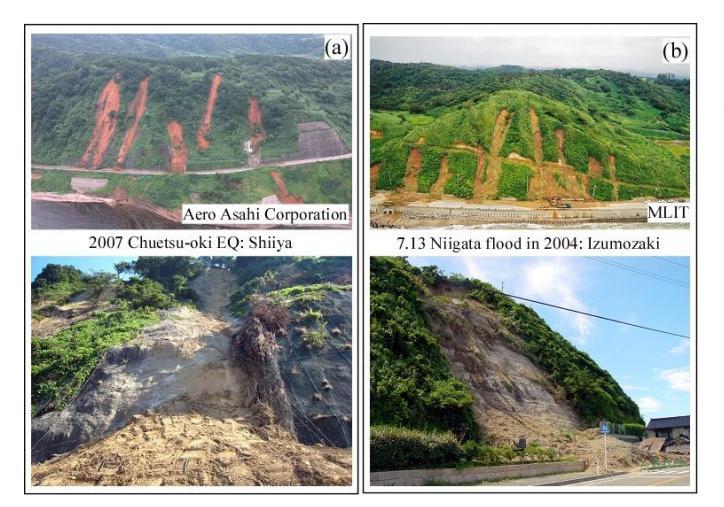
Photo 4 Surface failures that occurred (a) during the earthquake and (b) during the heavy rainfall

Three months after the 7.13 Niigata flood disaster, the Chuetsu Earthquake occurred. The centres of the rain and the earthquake were near each other, but there was low agreement in areas and slopes damaged by the rain and the earthquake. The slopes damaged during rainfall are always vulnerable to earthquakes. Moreover, slope failures of similar types occurred during both rainfalls and earthquakes. Photo 4(a) shows the surface failure in Shiiya (Toyota and Onoue, 2008) that occurred during the Chuetsu-oki Earthquake. Photo 4(b) also shows a surface failure that happened during the 7.13 Niigata flood disaster in 2004 in Izumozaki (Fig. 3), which is about 10 km north of Shiiya. The weathered surface, which lies in a steep coastal terrace with reverse-dip slope, fell in both earthquake and rainfall events.

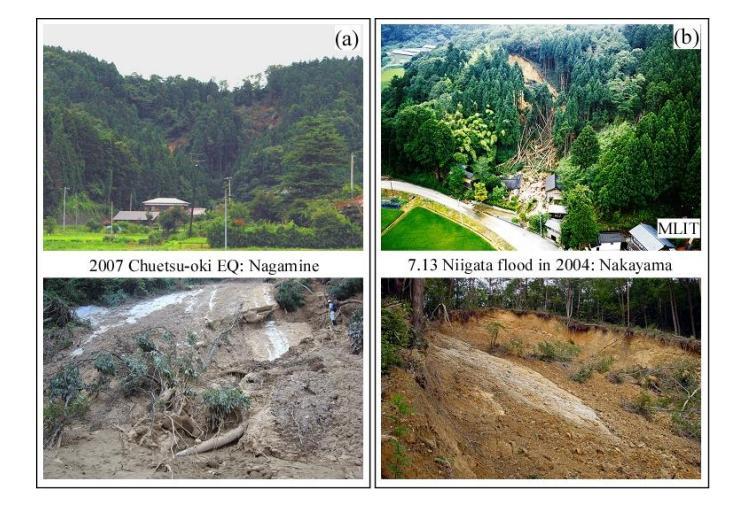
Photo 5 Dip slope failures that occurred (a) during the earthquake and (b) during the heavy rainfall

Smooth mudstone appeared after the slope failure in both Photos 5(a) and 5(b). They are, respectively, Nagamine during the Chuetsuoki Earthquake (Toyota and Onoue, 2008) and Nakayama of Izumozaki during the 7.13 Niigata flood disaster. Colluvial mass movement often occurs on a discontinuous smooth layer having low permeability in both earthquake and rainfall events. Toyota et al. (2006a) stated that the strength of three types, which are colluvial deposits, mudstone, and friction between colluvial deposits and mudstone, should be estimated as determine the location of the slip surface in this type of slope failure. The results of triaxial compression and ring shear tests demonstrated that slope failure in Nakayama was triggered at the slip surface between colluvial deposits and mudstone. Another case also exists in which a lowcemented thin sandy layer is sandwiched by mudstones. In that case, pore water pressure increases with cyclic loading induced by an earthquake. The strength decrease, exacerbated by increase of pore water pressure, causes landslides along the weak layer. As a case study of the Chuetsu Earthquake, Deng et al. (2007) conducted plane–strain compression tests using undisturbed siltstone including thin tuffaceous sandstone layer. They reported that the failure mechanism was controlled by the tuffaceous sandstone because it was much weaker than pure siltstone. Although it is difficult to identify the existence of a weak layer before failure, its detection is crucial to specify hazard zones.

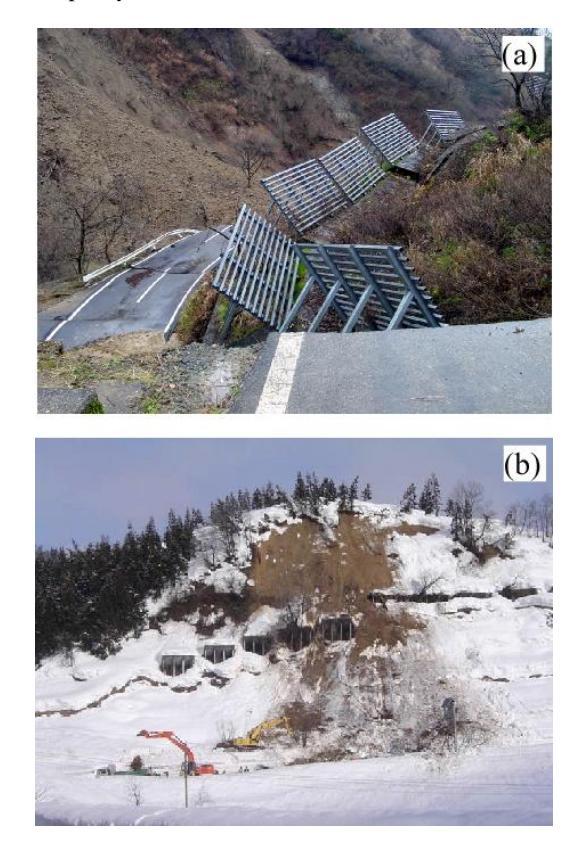
Photo 6 (a) Damage of snow avalanche fence and (b) a snow-earth avalanche (Kamiishi and Machida, 2008)

The Chuetsu region is a heavy snow area. The risk of snow avalanche has been increasing because the Chuetsu Earthquake damaged snow-protection facilities and natural vegetation. According to Niigata Prefecture government reports, 228 snow avalanche prevention fences and 8 snow sheds were damaged during the earthquake. Moreover, slope failures involved fences (Photo 6(a)), although the sliding masses were not huge in many cases. Surface failures scoured the fence foundations and the fences were deformed by of the weight of the falling soil. Soil accumulation behind fences and above snow sheds was also a severe problem preventing the proper function of those facilities. As an emergency restoration activity, the accumulated soil was removed and large sandbags were emplaced to protect the infrastructure from a snow avalanche in case of the coming winter. Snow avalanches occurred frequently than during a normal winter. Some slopes were not covered with deep snow because small snow slides had occurred with each snowfall. Nevertheless, heavy damage did not occur because patrols were conducted frequently, and the risk of avalanche was reduced through removal of unstable snow, construction of snow walls, and road closures during the winter. A new type of avalanche, in which snow fell together with surface soil of the damaged slope, was observed in Tokamachi city (Fig. 1) as

portrayed in Photo 6(b). This type of avalanche, called a "snowearth mixture avalanche", is regarded as a compound natural disaster causing extensive damage to homes and roads (Kamiishi and Machida, 2008).
