DAMAGE PROCESS AND PATTERN OF AN RC STRUCTURE AFFECTED BY COMBINED FROST AND SALT ACTIONS

In this study, a RC bridge wall rail affected by frost and salt actions was investigated in order to propose a maintenance planning of a RC structure subject to the combined attacks. A studied structure had been in service for more than forty years in Hokkaido in the northern part of Japan. Experimental results of material properties brought relationship between deterioration degrees of concrete and reinforcement. A compressive strength / Young's modulus ratio was defined as the deterioration degree of concrete influenced by frost action and the deterioration degree of reinforcement was expressed by weight reduction rate. Further, the relationship was classified by degradation in appearance. On the assumption that the degradation in appearance depends on a balance between frost damage and salt damage, a developing process of the combined deterioration was observed. As a result, the deterioration degrees of concrete and reinforcement could be associated with the damage patterns. Especially, in case of the RC bridge wall rail with a loose concrete cover, the deterioration degree of concrete had

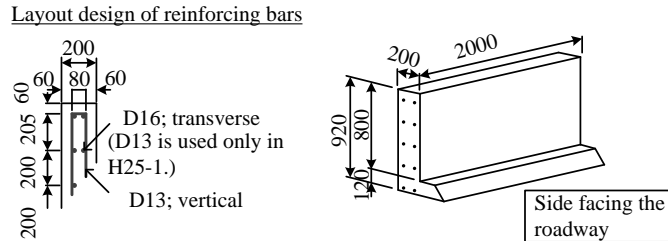
Figure 1. Configuration of a RC bridge wall rail.

The configuration of the RC bridge wall rail and its reinforcement arrangement are shown in Figure 1. Nine parts of RC bridge wall rails with different damage patterns were chosen in order to obtain developing process and tendency of the combined deterioration. They had latticed reinforcements at intervals of around 200mm. Vertical and transverse bars were D13 and D16, respectively. Also the vertical bars were spliced on the side facing away from the roadway. The design strength of concrete was

24N/mm². The surfaces of some wall rails had been repaired by resin coating and/or FRP mesh sheets as noted in Figure 1.

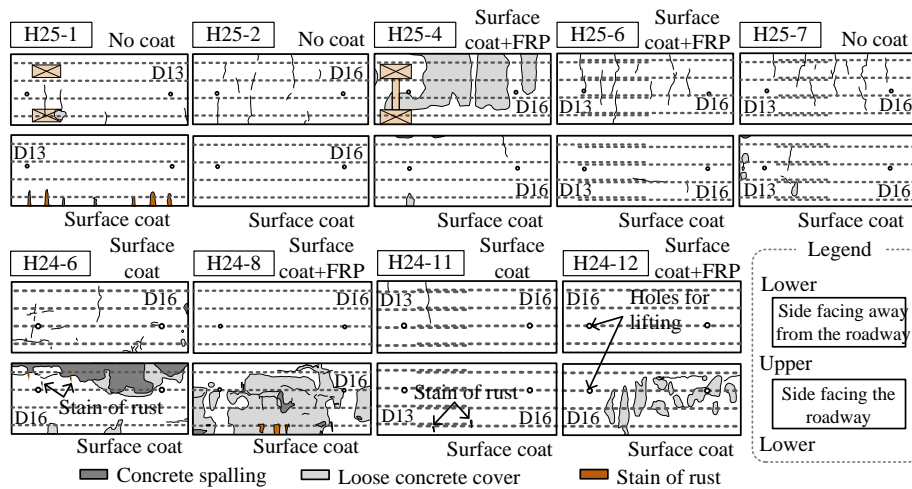
Figure 2. Results of visual observation and hammer tapping.

Figure 2 shows the results obtained by visual observation and hammer tapping. The figure also provides information about the repaired state of the surfaces, the splices and the diameters of transverse bars.

The followings were the major degradation in appearance for each wall rail: a concrete spalling in H24-6, a loose concrete cover in H24-8, H24-12 and H25-4, stain of rust in H25-1. The other four parts of the wall rails were slightly damaged.

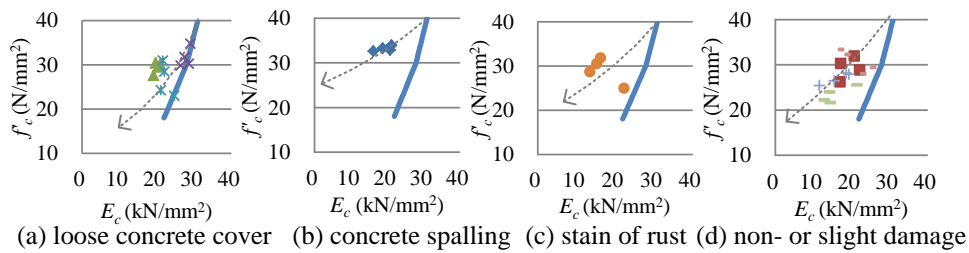
Figure 3. Relationship between compressive strength and Young's modulus.

Figure 3 shows the relationship between compressive strength, f'_c and Young's modulus, E_c of concrete. According to the major degradation in appearance for each wall rail, Figure 3 is classified into four. All figures include the relationship by the JSCE standard specifications for concrete structures.

Experimental results were investigated referring to the JSCE standard specifications because of no initial information. Most of all results of the compressive strength were larger than the design strength. However, the results of the Young's modulus were likely to be less than expected comparing with the JSCE relationship between f'_c and E_c .

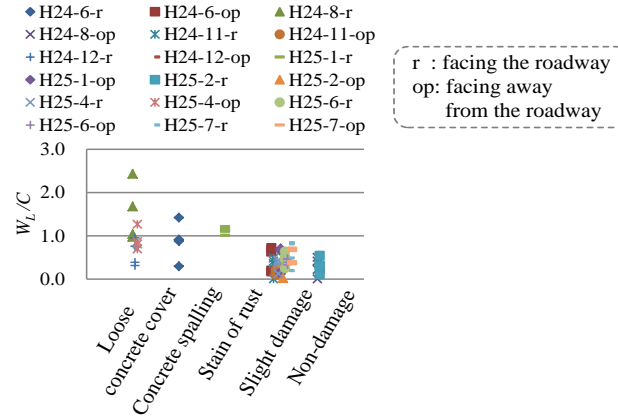
Figure 4. Relationship between W_L/C and a damage pattern.

Relationship between W_L/C and the major degradation in appearance as shown in Figure 4 was obtained. Although some wall rails have uneven values of W_L/C , it is

Regarding the major degradation in appearance, the concrete properties of H24-8, H24-12 and H25-4 with a loose concrete cover had a specific tendency and they were close to the JSCE relationship. In view of the previous results, it is likely that non- or slight damage of Figure 4(d) will develop into more serious condition of Figure 4(a) to (c) and that a damage pattern will be associated with relationship between f'_c and E_c . On the basis of this consideration, a hypothesis was framed as following; Freezing and thawing action has an influence on compressive strength, f'_c and Young's modulus, E_c of concrete and the change of f'_c/E_c ratio is brought by the continuous action. Thus, a gradient of an arrow, f'_c/E_c in Figure 4 is defined as a deterioration degree of concrete affected by frost action. Further, in case of combined deterioration of frost and salt actions, a ratio of frost damage to salt damage decides the observable appearance.

likely that the value of W_L/C will be related to the observable appearance. Therefore, W_L/C is chosen to be a deterioration degree of a reinforcement damaged by salt action.

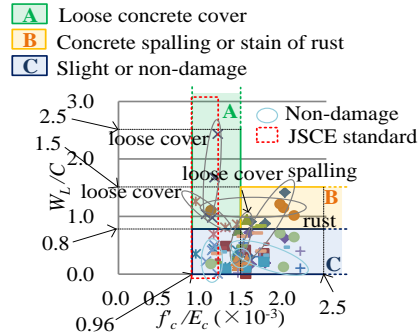
Figure 5. Relationship between deterioration degrees of concrete and reinforcement involving a damage pattern.

Figure 5 shows a relationship of deterioration degrees between concrete and reinforcement. The Y axis is a deterioration degree of reinforcement itself and more serious corrosion makes the value of W_L/C larger. Naturally, the larger value of W_L/C leads to the more serious degradation on a surface. The X axis represents a deterioration degree of concrete with the value of f'_c/E_c on the basis of the previous hypothesis. According to the JSCE standard specifications, f'_c/E_c of 0.96 to 1.19 is derived from the experimental results of f'_c of 24 to 35N/mm². However, this range does not include most of the experimental results of f'_c/E_c .

- (1) The time axis of Z was added to the relationship of Figure 5. The origin was set to the values such as $X(f'_c/E_c)=0.96$, $Y(W_L/C)=0$ and $Z=0$. The value of $f'_c/E_c=0.96$ was decided on condition that E_c was calculated by the JSCE standard specifications at $f'_c = 24$ N/mm² of the design strength. The other values were determined by $W_L=0\%$ and $Z=0$ year.
- (2) The positions of all results in Figure 5 were identified by X, Y coordinates at $Z=40$ years. If initial defects were neglected, these results could be connected with the origin.
- (3) The only range of the pattern C with slight or non-damage was reflected in the plane at $Z=0$.

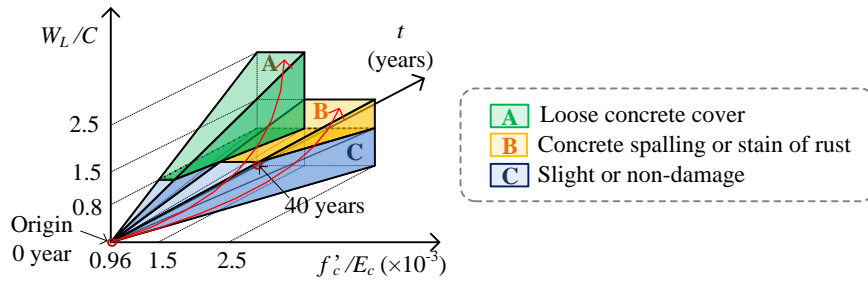
Figure 6. Developing process of combined deterioration.

Figure 6 is considered to be a set of damage process affected by combined frost and salt actions. Two red arrows in the figure offer explanations for developing damage process. The combined deterioration starts from the origin which is involved in the region of damage pattern C and the direction of the arrow means the deterioration development. Thus, this figure can be effectively used to predict a damage pattern in the future or judge the present material properties by observable appearance.

Developing process of combined deterioration was proposed as shown in Figure 6. This figure was obtained by the following procedures.
