EXPERIMENTAL BREAKING OF A PRESTRESSED CONCRETE BRIDGE BEAM REINFORCED WITH BONDED FRP

2 THE PROJECT FOR TESTING A PPCBB OF THE VIADUCT FROM CLERVAL (Aubagnac *et al.* 2015)

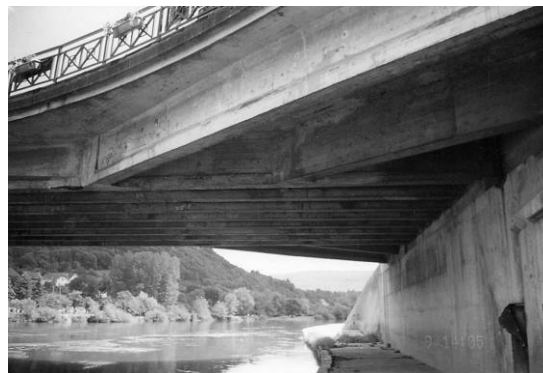
The Viaduct over the River Doubs at Clerval using PPCBBs was built between 1952 and 1954 (see Figure 1). It suffered from waterproofing and concrete injection defects which caused corrosion of the prestressed cables. As this reduced the load bearing capacity of the structure, it was demolished and rebuilt on 2002.

Figure 1. The upstream edge prestressed concrete bridge beam of the viaduct from Clerval.

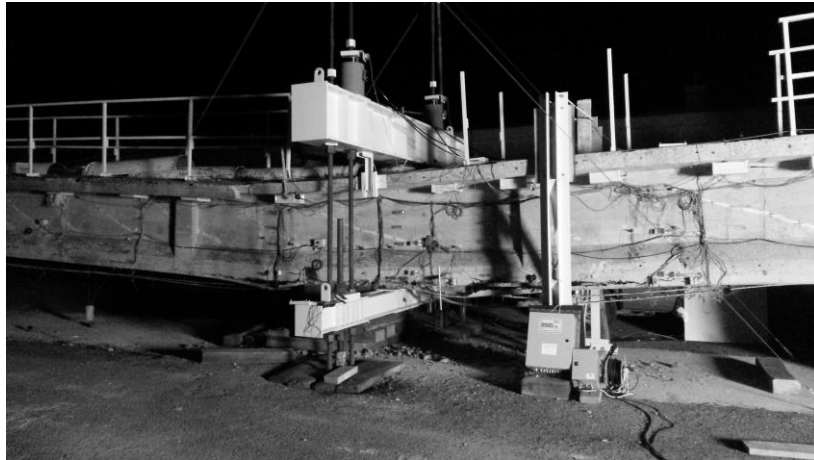
- Definitive break of the beam in section S2 with maximum bending of around 40 cm: vertical fracture from the bottom towards the top only a few centimeters from the top face.

Figure 2. Definitive break of the beam.

- First shearing of the side bonded composite strengthening plates of the first strengthening stage: flaking of the concrete surrounding the prestressed cables between sections S2 and S4 (flaking initially at section S2, due to partial sectioning during the strengthening process): maximum force = 614KN, maximum bending = 20.4 cm ; subsequently, the effort mobilized for the load continued to reduce;

- Second shearing of the bonded composite strengthening plates notably in the centre of the second strengthening stage: flaking of the concrete surrounding the prestressed cables between sections S2 and S4 and a long section of the central strengthening plates coming loose at the back of section S2, and further than section S4: force = 588KN, maximum bending = 26.3 cm;

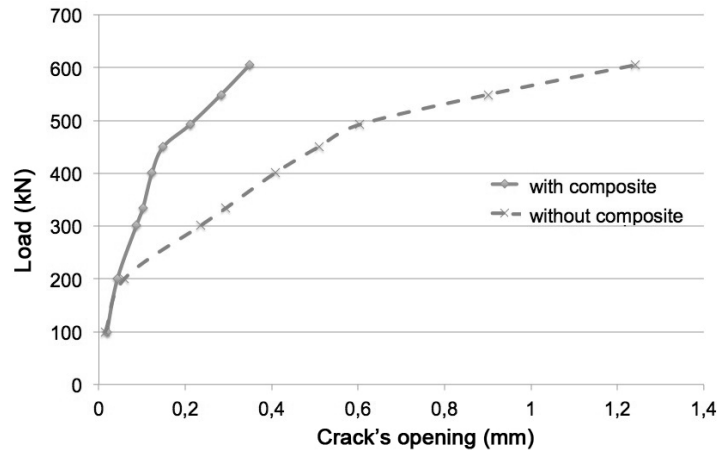
The carbon fiber plates have a positive local effect preventing cracks from widening. Without strengthening plates, the size of the cracks measured in section S4 on the underside of the beam's heel were practically identical, if not greater, than those measured on the side of the heel. After strengthening, once the load was greater than 200kN the cracks measured on the underside of the beam's heel were smaller (up to - 68%) than the cracks on the side.

Figure 3. Positive local effect preventing cracks from widening thanks to composite.

The carbon plates improve the distribution of the load and subsequent cracking in the areas where the load is greatest. During the tests the longitudinal distribution of the tractive force between the composite strengthening plates adapted to the load, with the maximum tractive force being between sections S2 and S4. From 334kN to 492kN,

the widening of the crack in section S2 accelerated, whereas the crack in section S4 remained stable, but new cracks appeared in the zone of section S4. From 492KN to 615KN, causing the first shearing of strengthening composite plates, the width of the cracks near S2 accelerated, whereas the crack in S4 closed slightly.
