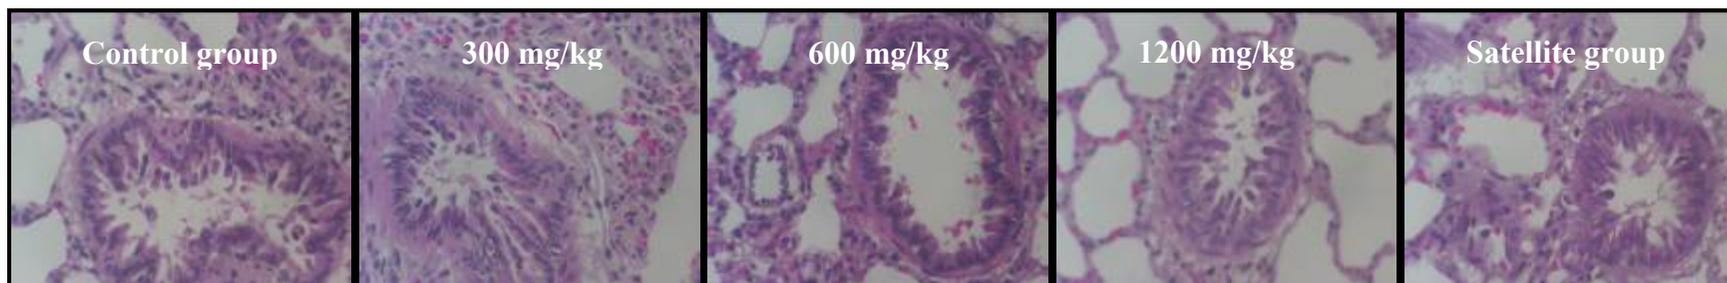
Figure 4.1

The histology of lung from female rats receiving *T. chebula* was compared with the control group (40x, stained with hematoxylin and eosin). No significant damage was detected in any treated group.

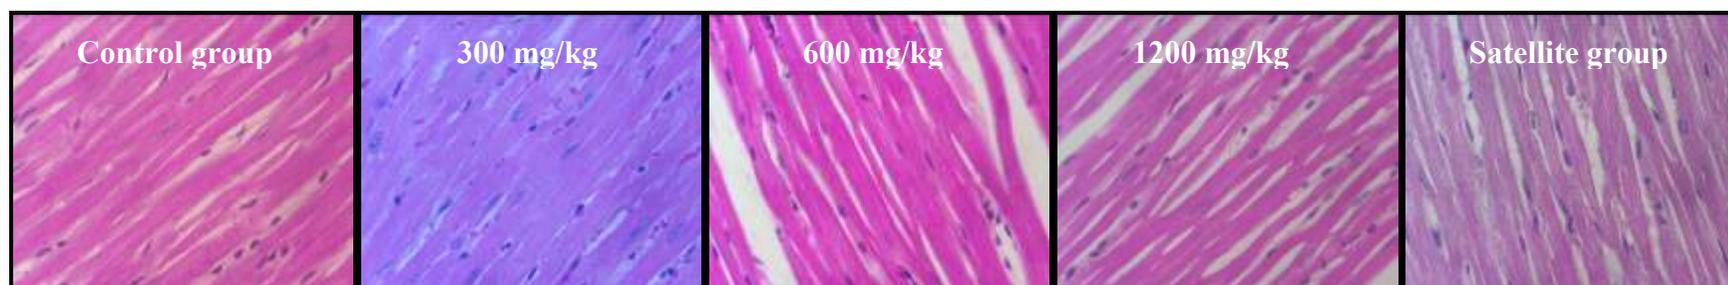
Figure 4.2

The histology of heart from female rats receiving *T. chebula* was compared with the control group (40x, stained with hematoxylin and eosin). No significant damage was detected in any treated group.

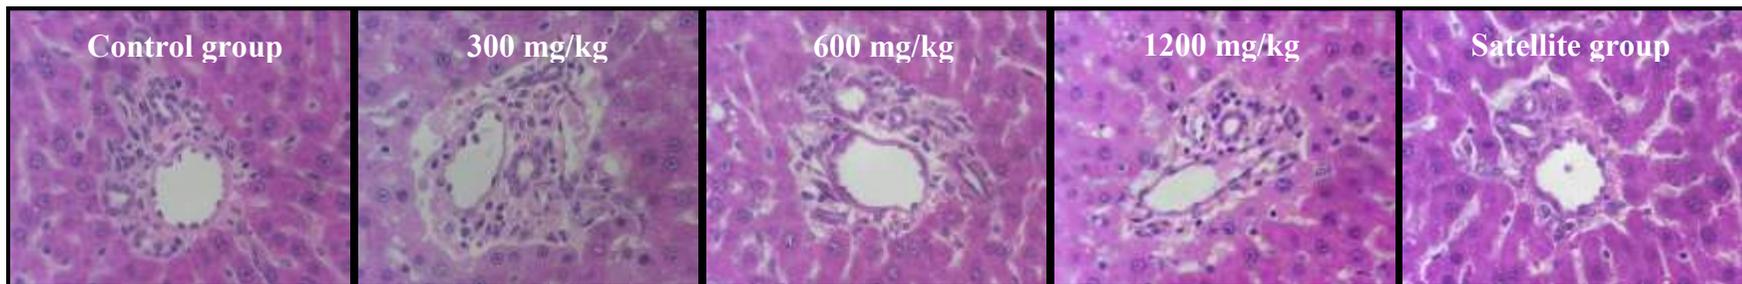
Figure 4.3

The histology of liver from female rats receiving *T. chebula* was compared with the control group (40x, stained with hematoxylin and eosin). No significant damage was detected in any treated group.

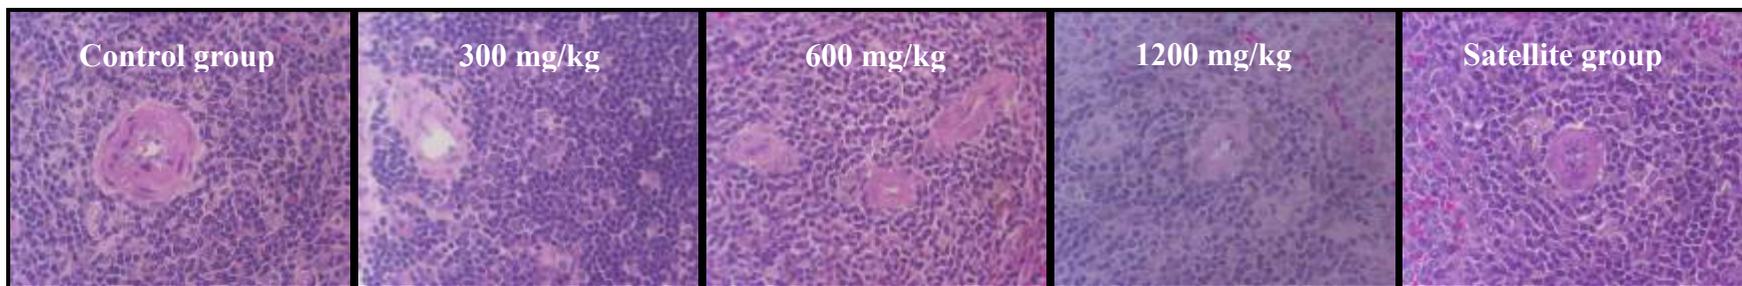
Figure 4.4

The histology of spleen from female rats receiving *T. chebula* was compared with the control group (40x, stained with hematoxylin and eosin). No significant damage was detected in any treated group.

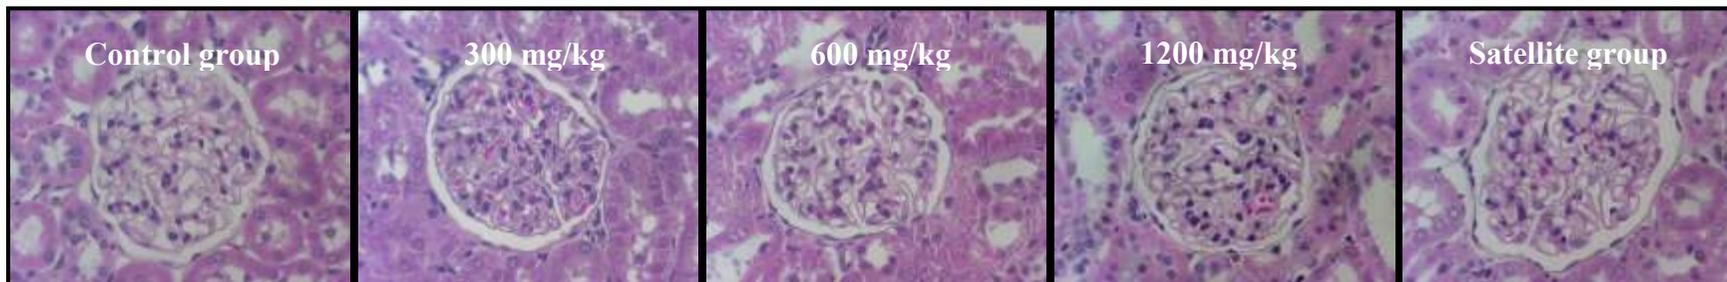
Figure 4.5

The histology of kidney from female rats receiving *T. chebula* was compared with the control group (40x, stained with hematoxylin and eosin). No significant damage was detected in any treated group.

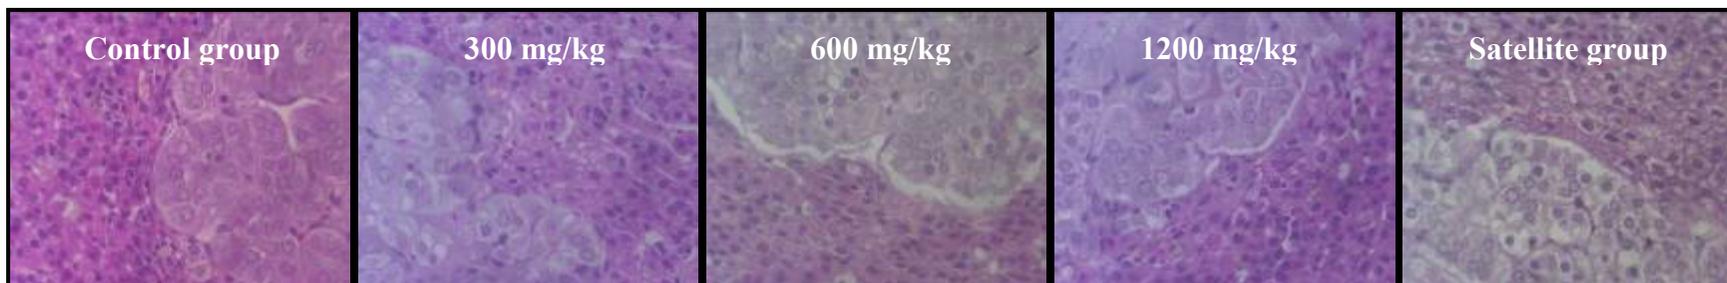
Figure 4.6

The histology of adrenal gland from female rats receiving *T. chebula* was compared with the control group (40x, stained with hematoxylin and eosin). No significant damage was detected in any treated group.

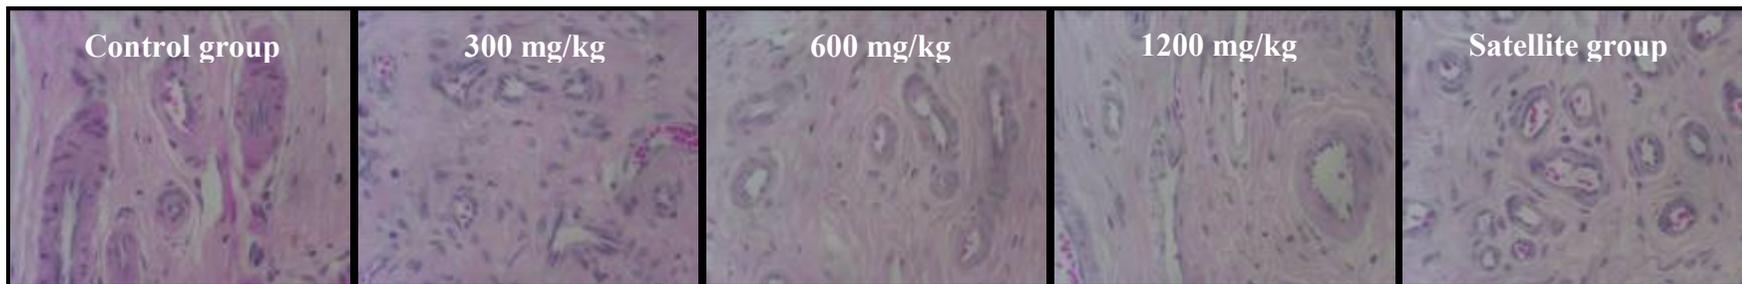
Figure 4.7

The histology of uterus from female rats receiving *T. chebula* was compared with the control group (40x, stained with hematoxylin and eosin). No significant damage was detected in any treated group.

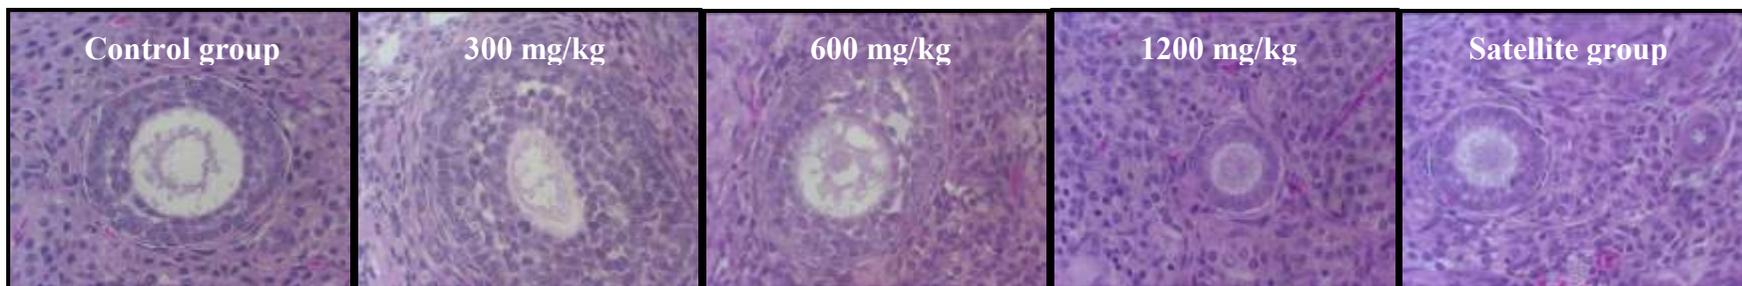
Figure 4.8

The histology of ovary from female rats receiving *T. chebula* was compared with the control group (40x, stained with hematoxylin and eosin). No significant damage was detected in any treated group.

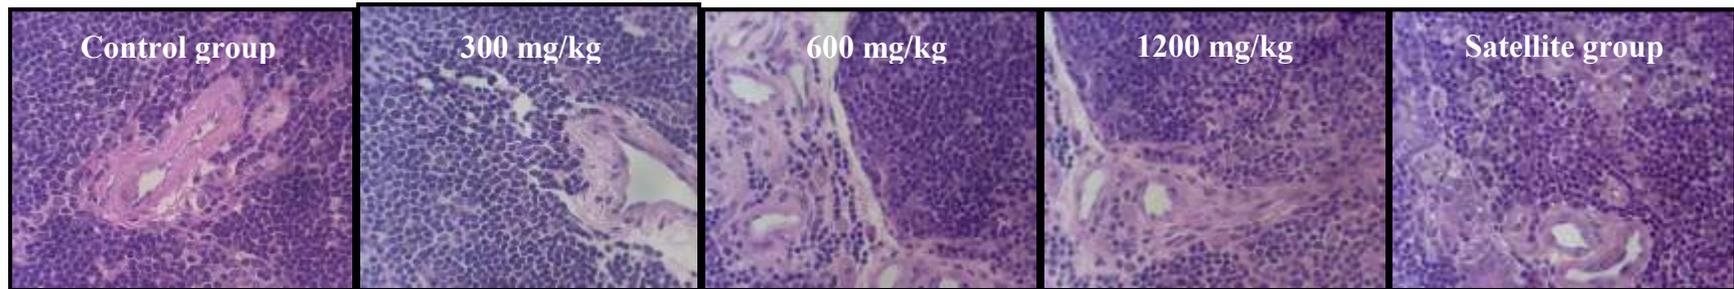
Figure 4.9

The histology of thymus from female rats receiving *T. chebula* was compared with the control group (40x, stained with hematoxylin and eosin). No significant damage was detected in any treated group.

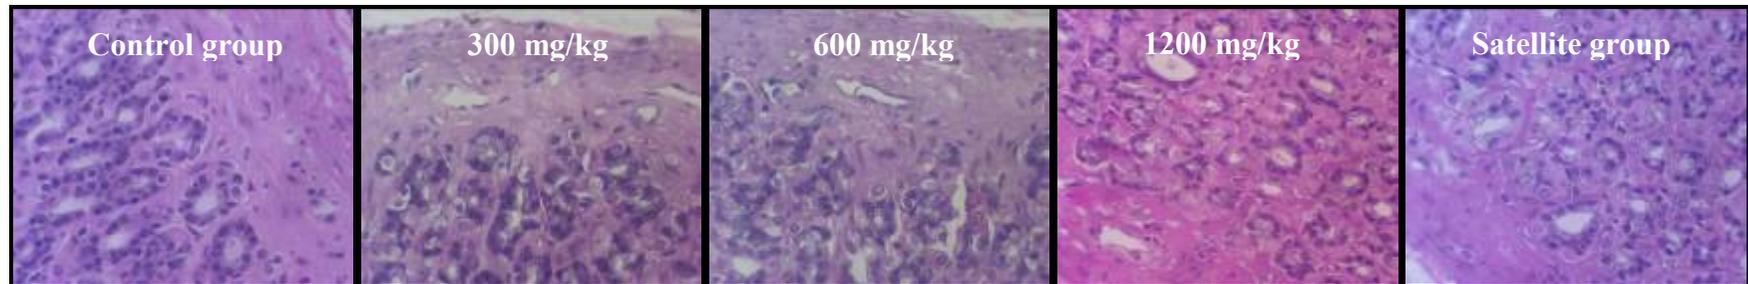
Figure 4.10

The histology of stomach from female rats receiving *T. chebula* was compared with the control group (40x, stained with hematoxylin and eosin). No significant damage was detected in any treated group.

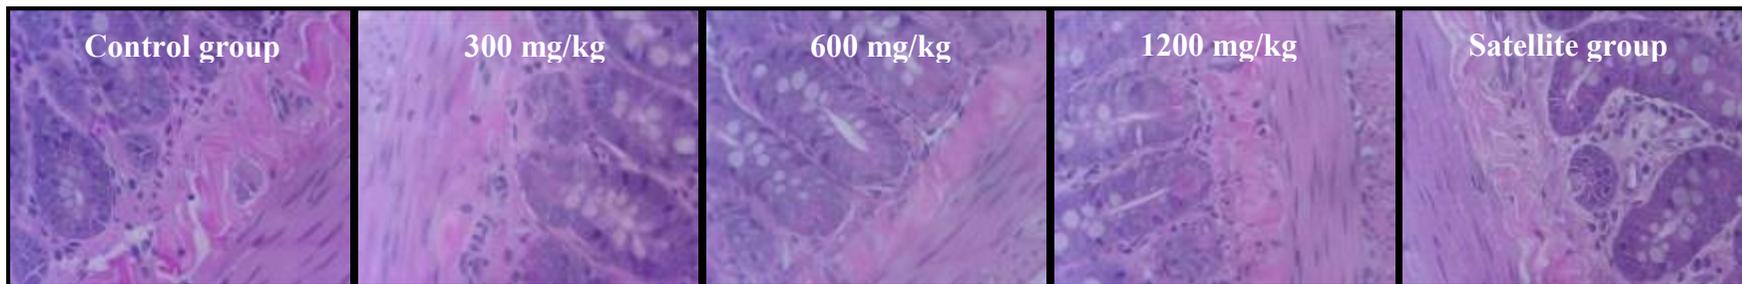
Figure 4.11

The histology of intestine from female rats receiving *T. chebula* was compared with the control group (40x, stained with hematoxylin and eosin). No significant damage was detected in any treated group.

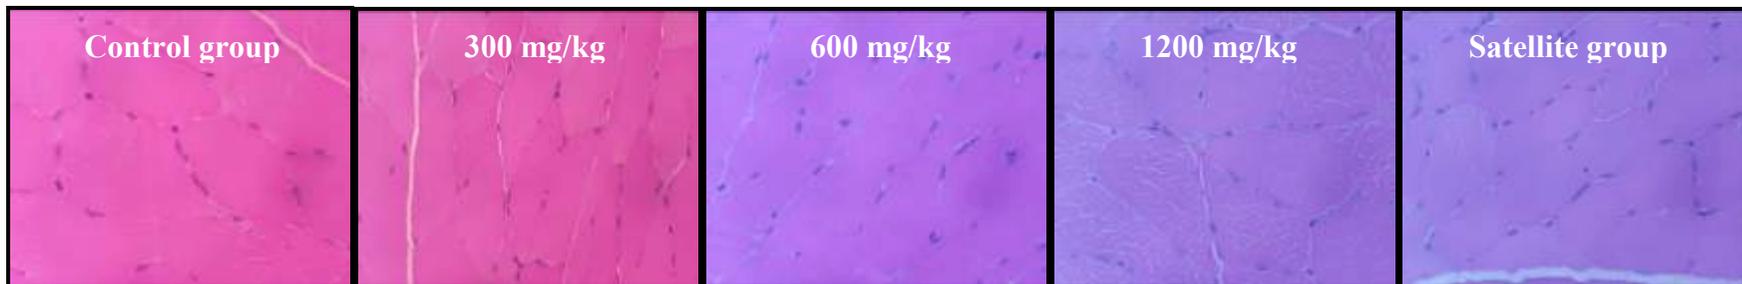
Figure 4.12

The histology of muscle from female rats receiving *T. chebula* was compared with the control group (40x, stained with hematoxylin and eosin). No significant damage was detected in any treated group.

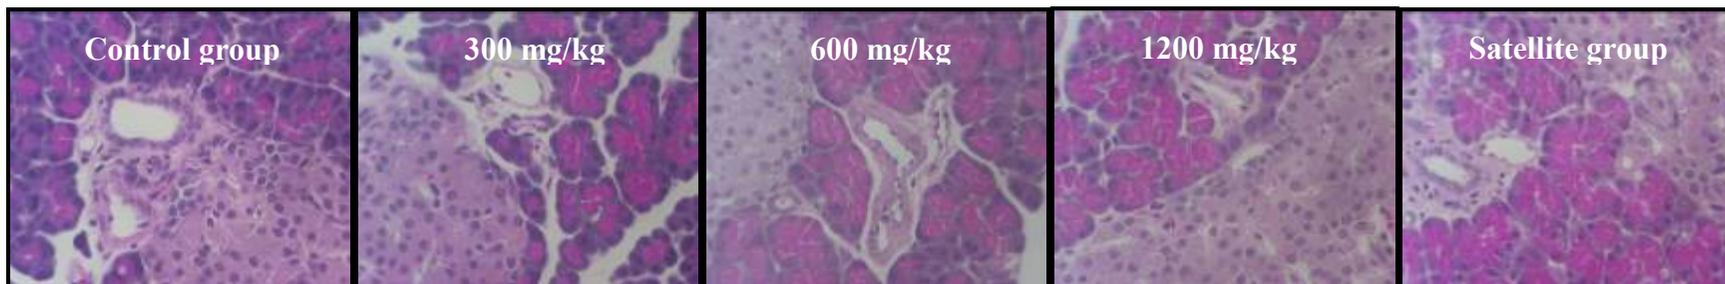
Figure 4.13

The histology of pancreas from female rats receiving *T. chebula* was compared with the control group (40x, stained with hematoxylin and eosin). No significant damage was detected in any treated group.

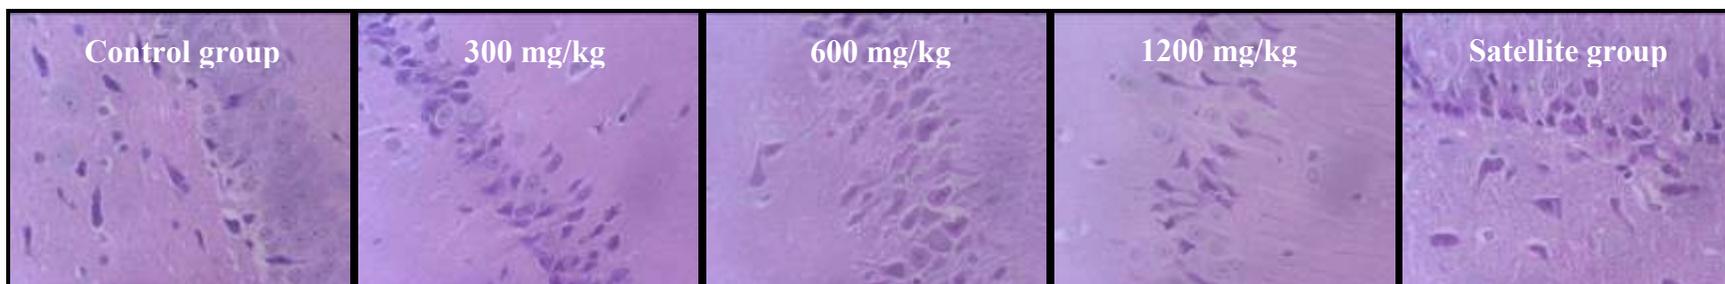
Figure 4.14

The histology of brain from female rats receiving *T. chebula* was compared with the control group (40x, stained with hematoxylin and eosin). No significant damage was detected in any treated group.

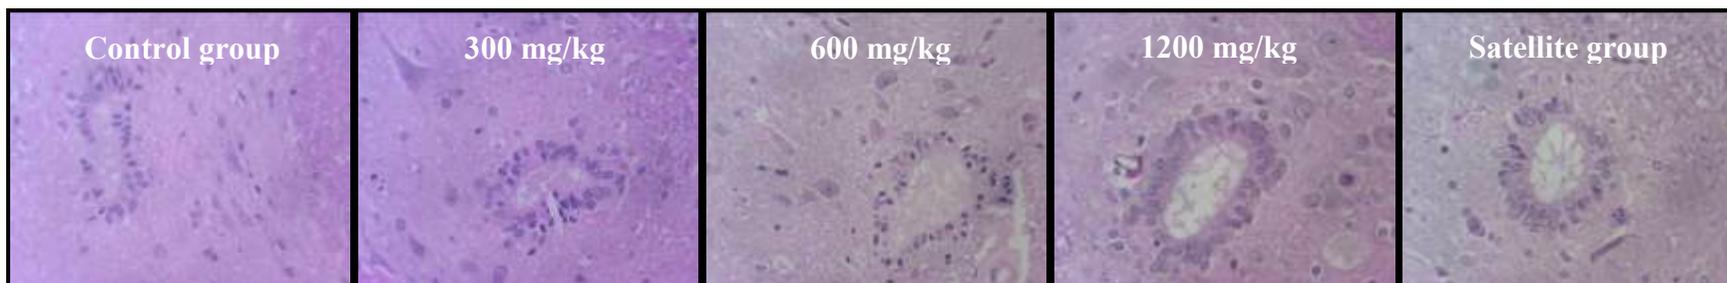
Figure 4.15

The histology of spinal cord from female rats receiving *T. chebula* was compared with the control group (40x, stained with hematoxylin and eosin). No significant damage was detected in any treated group.

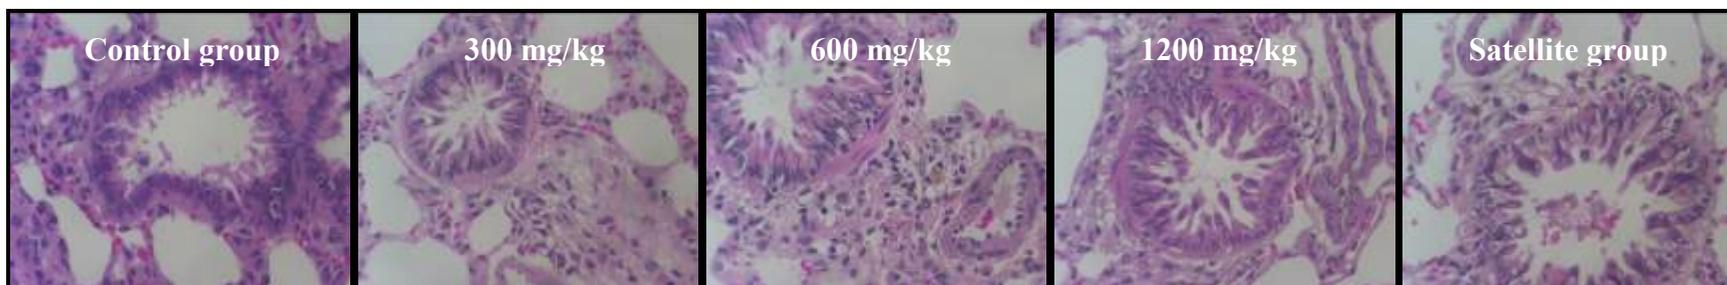
Figure 4.16

The histology of lung from male rats receiving *T. chebula* was compared with the control group (40x, stained with hematoxylin and eosin). No significant damage was detected in any treated group.

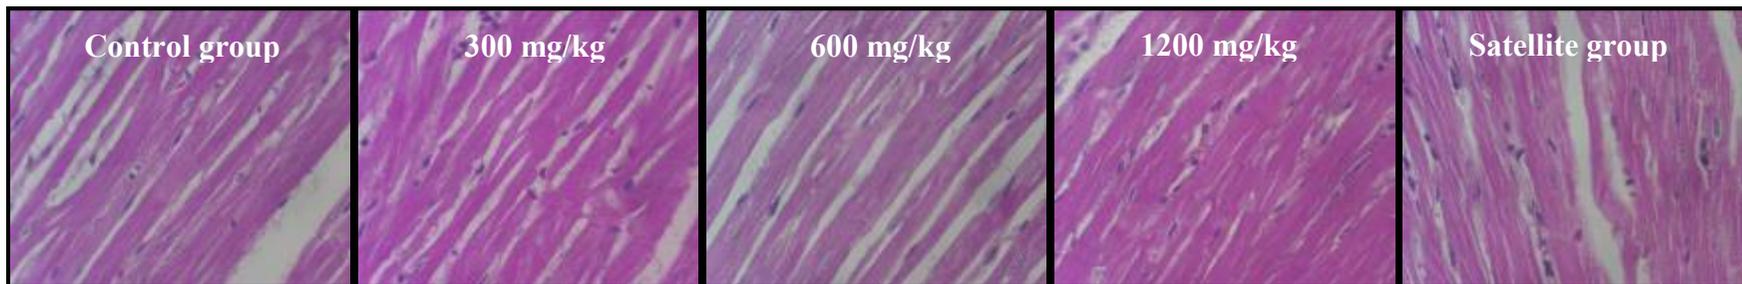
Figure 4.17

The histology of heart from male rats receiving *T. chebula* was compared with the control group (40x, stained with hematoxylin and eosin). No significant damage was detected in any treated group.

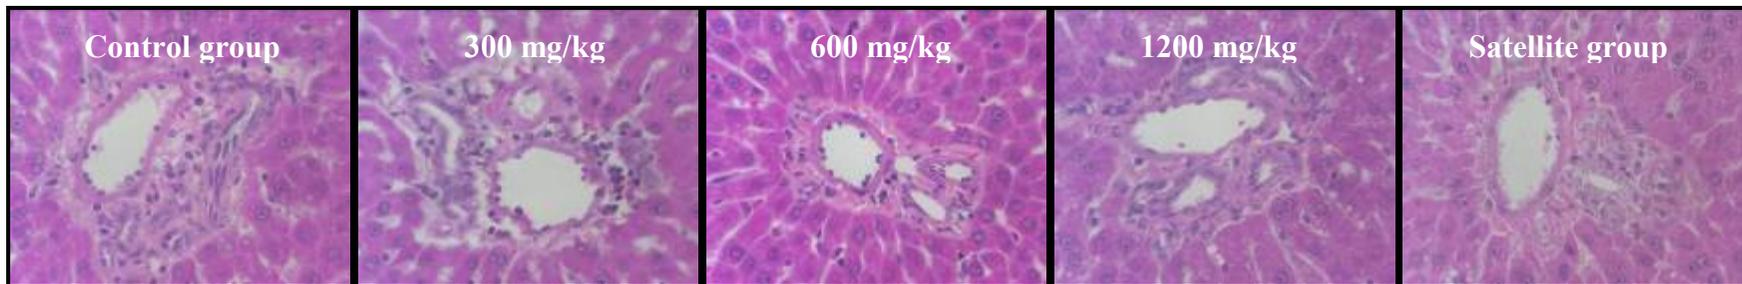
Figure 4.18

The histology of liver from male rats receiving *T. chebula* was compared with the control group (40x, stained with hematoxylin and eosin). No significant damage was detected in any treated group.

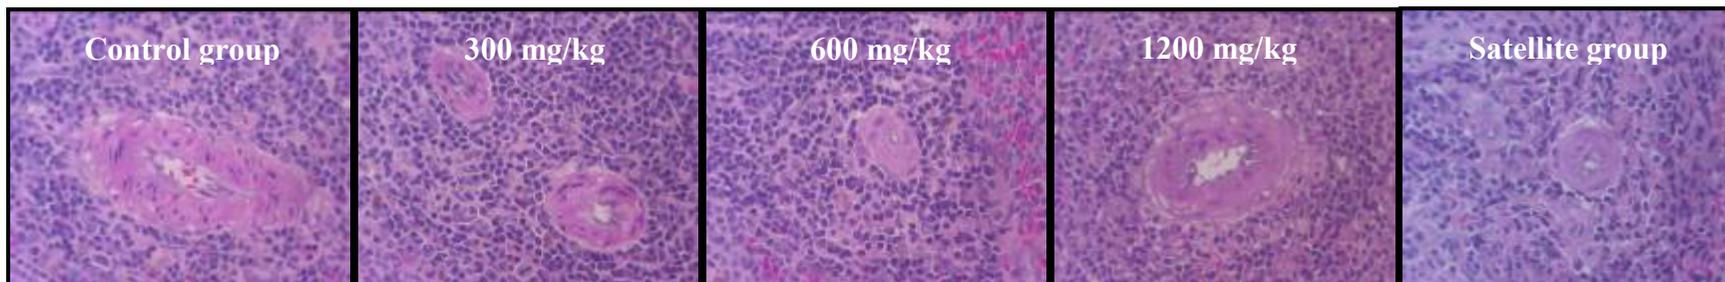
Figure 4.19

The histology of spleen from male rats receiving *T. chebula* was compared with the control group (40x, stained with hematoxylin and eosin). No significant damage was detected in any treated group.

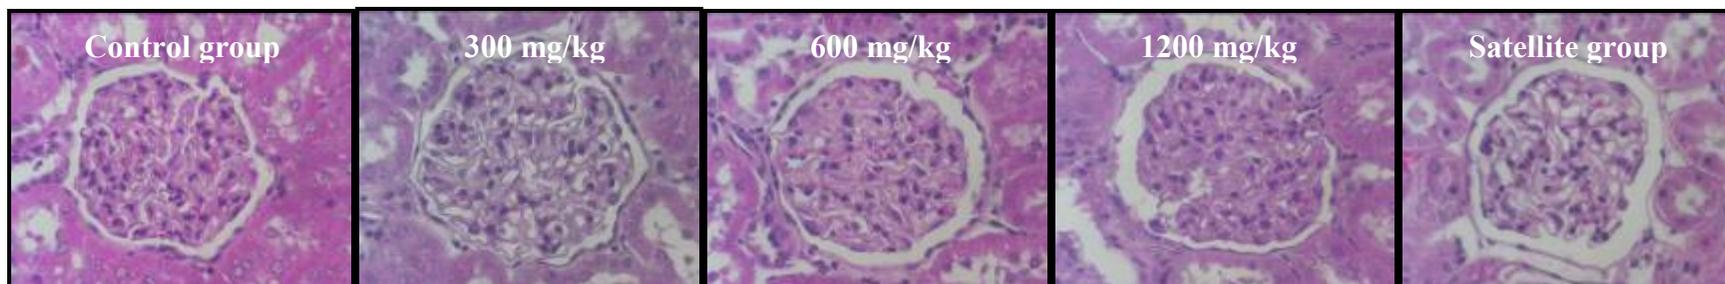
Figure 4.20

The histology of kidney from male rats receiving *T. chebula* was compared with the control group (40x, stained with hematoxylin and eosin). No significant damage was detected in any treated group.
