**LANNA ARCHITECTURAL CONSERVATION:
GUIDELINES FOR HISTORIC BUILDINGS IN NORTHERN THAILAND**

A Thesis Submitted in Partial Fulfillment of the Requirements for the Degree

Program of Architectural Heritage Management and Tourism

SILPAKORN UNIVERSITY

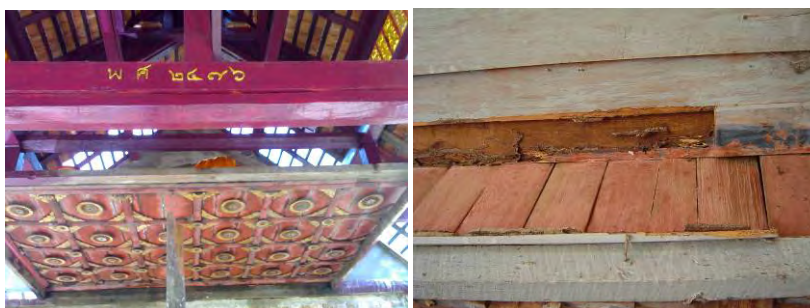
Figure 54 & 55:

Sinking and leaking ceiling in the *vihara* in *Wat Seang Khao Noi*, Pasang, Lamphun (left) and termites attacking at *Wat Baan Ko*, Lampang (right) (taken by Vitul L., 17/2/07 & 19/7/06)

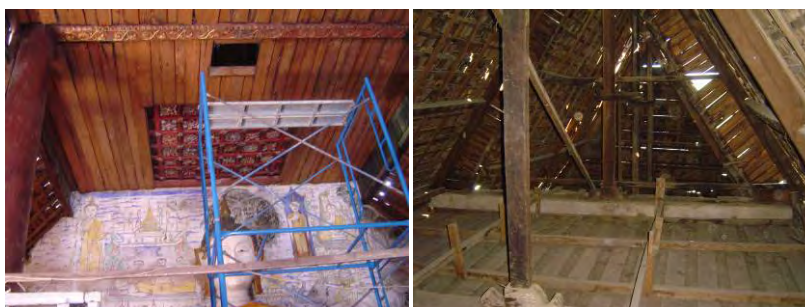
Figure 75 & 76:

The site investigation on roof and structure of the *vihara* in Wat Baan Ko, Lampang (taken by Vitul L., 9/8/06)

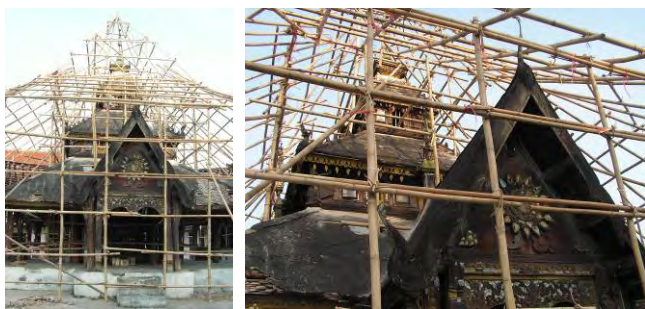
Figure 79 & 80:

Scaffolding for investigation in
Wat Pong Sanuk, Lampang
(taken by Vitul L., 17/6/05)

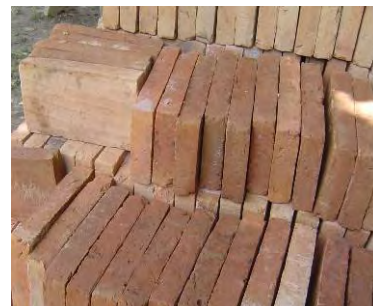
Figure 91: Typical *din kee* 15x29 cm, Chiang Mai (taken by Vitul L., 4/11/05)

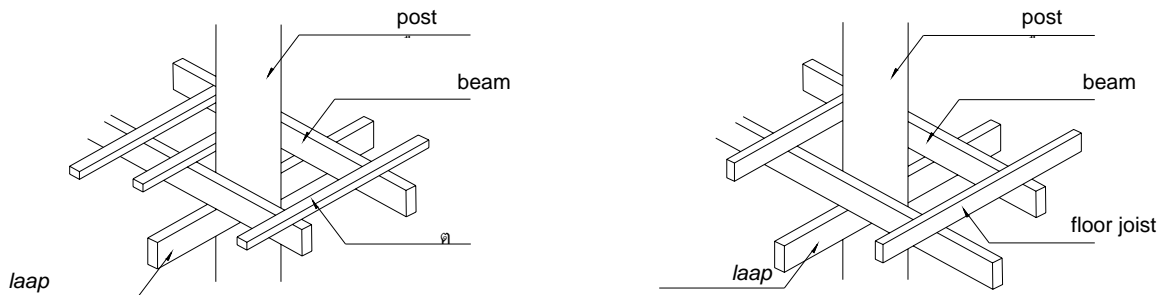
Figure 140 & 141:

Typical wood post, stair and floor beam, and typical wood beam on footing for houses (drawn by Vitul L., 24/11/07)

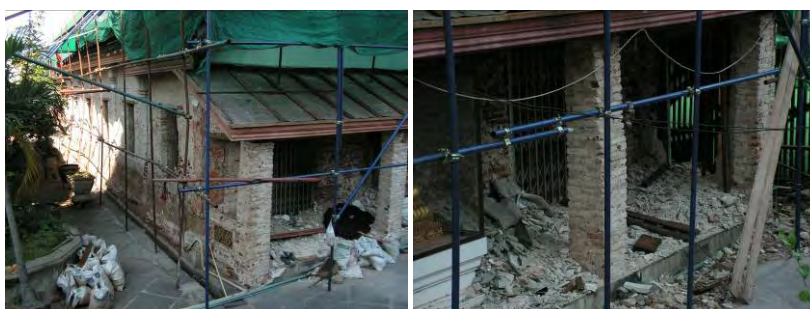
Figure 211 & 212:
Repairing of
brickwork by re-
plastering in *Wat*
Phra That
Chaehang, Prae
(taken by Vitul L.,
2/4/06)
