A House Renovation for Cultural Tourism in Trok Baan Chin Community, Tak

Suwicha Benjaporn* and Jutamaht Wongsuwanand

Faculty of Architecture, Rangsit University, Pathum Thani, Thailand

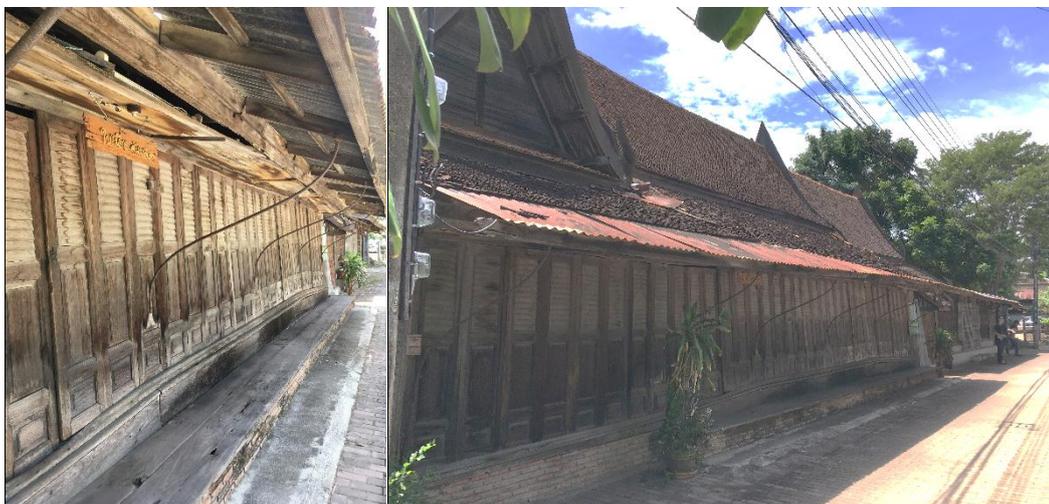
Figure 3 A deterioration of the wooden house's entrance, which was impacted from over live load by a number of visitors

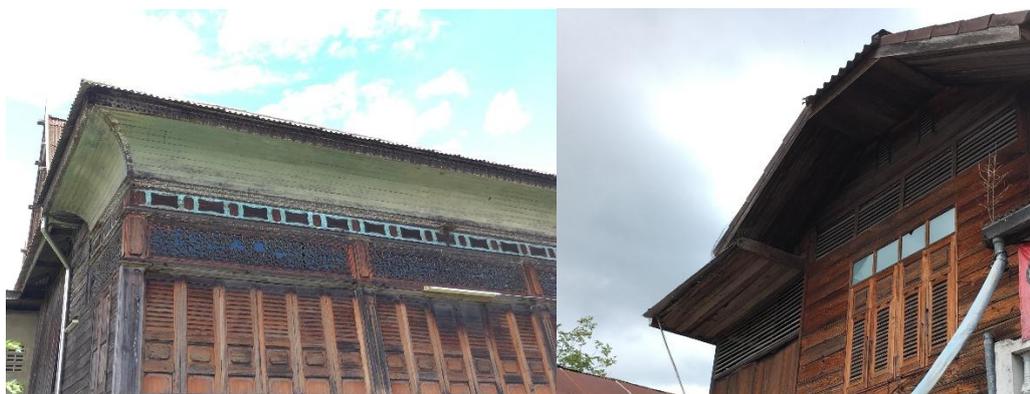
Figure 4 Samples of the Fixed Wooden fretwork and the Ventilated windows which installed on some local residences

Art of architecture and decoration styles of buildings in the Trok Baan Chin community was popular to install a wooden fretwork over the window to utilized natural airflow for ventilation, and the windows were also equipped with wooden louvers as well. (See Figure 4.) Such this technique has represented the wisdom of the tropical architecture as a principle of an adaptive environment for interior thermal comfort (Boonyatikarn, 1999).

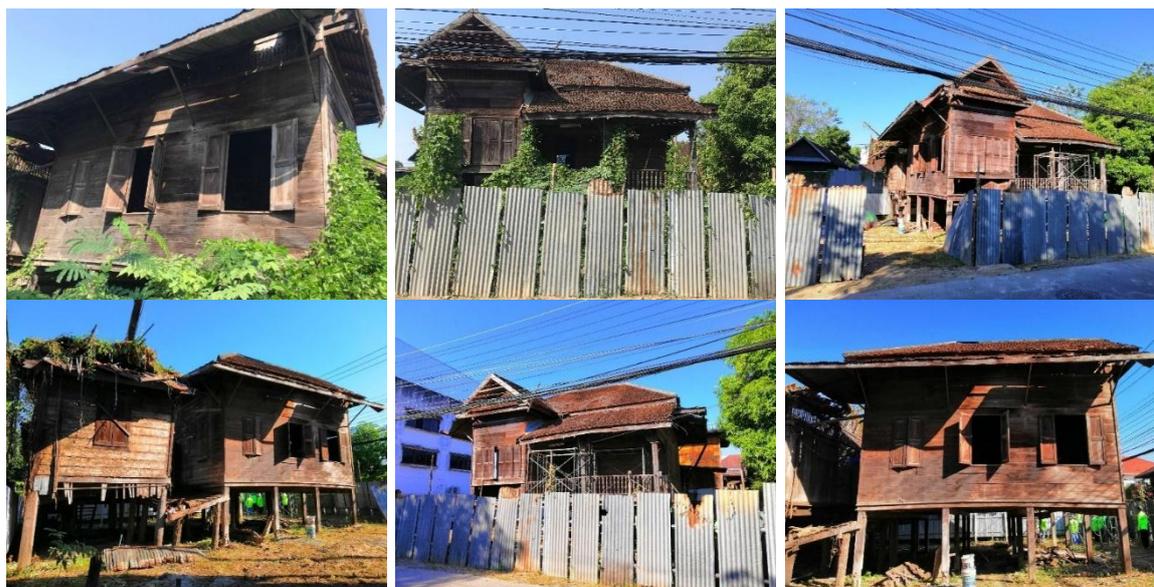
Figure 5 The House originally was abandoned and decayed, then it was on disassembling process

The building survey results found that the condition of the building appeared as Ruan Saranai Building, raise the basement, roof with a gable and hip roof which similar to a western roof style with Saranai wood as a gable decoration. The whole building structure is made of wood. The main residential area on the upper floor supports living activities and can be divided into 2 bedrooms. The front side has a large terrace under the gable mixed with hip roof and a lower wing pinion roof. The walls of the building and the original floor were all wooden. All windows are double open windows. There is the ventilated wooden façade which called Korsong that it was installed on the top of the panel. The wooden fretworks were not only used for decoration but also providing natural ventilation. Particularly, then these fretworks emphasized the unique architectural characteristics of local residential buildings in this historic community. For the kitchen and bathroom building, it was separated as a service area. Furthermore, the evaluated results of the existing wooden structure found high levels of erosion and damage, especially at the base of the

columns (See Figure 5). In addition, the building condition was unsafe and unable to gain impacted loads. According to the requirement of changing the living space to accommodate the tourism activities, the engineer proposed to demolish the building first to make the foundation and the new building pillar, and then reassemble the remaining part of the wall to maintain the appearance of the building as close to the original characteristic as possible, by considering the building condition as follows,

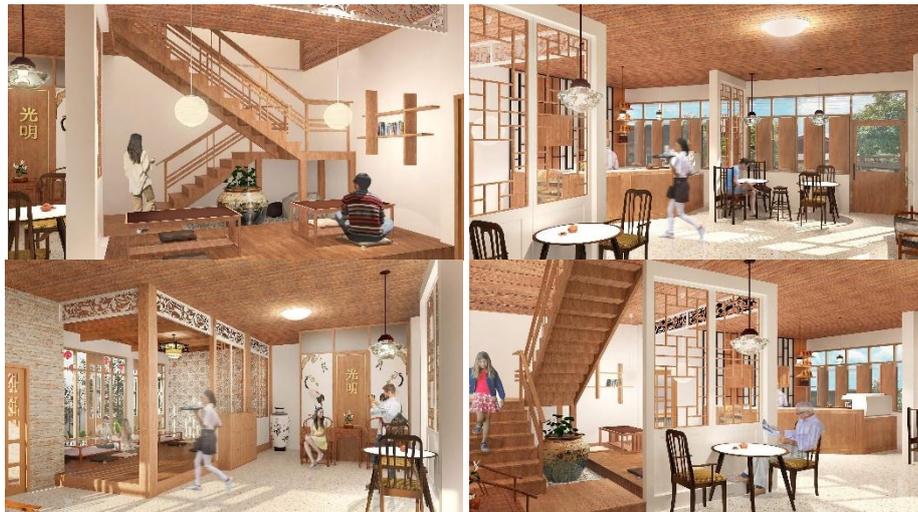
Figure 6 Interior design of the Trok Bann Chin Café (Lower Floor)

Based on the historical background of the people in Trok Baan Chin community, most of the settlers are wealthy people with Thai-Chinese descent. Along with the study about the way of life and culture analyzed from the use of vacant space in many houses in the community, therefore, pushing for the idea to improve the use of the original residential area to become a coffee shop and community learning source

(See Figure 6-7). It was processed by establishing guidelines for creating space to promote the perception of the community's way environment through the form of interior decoration and the external landscape (See Figure 8).

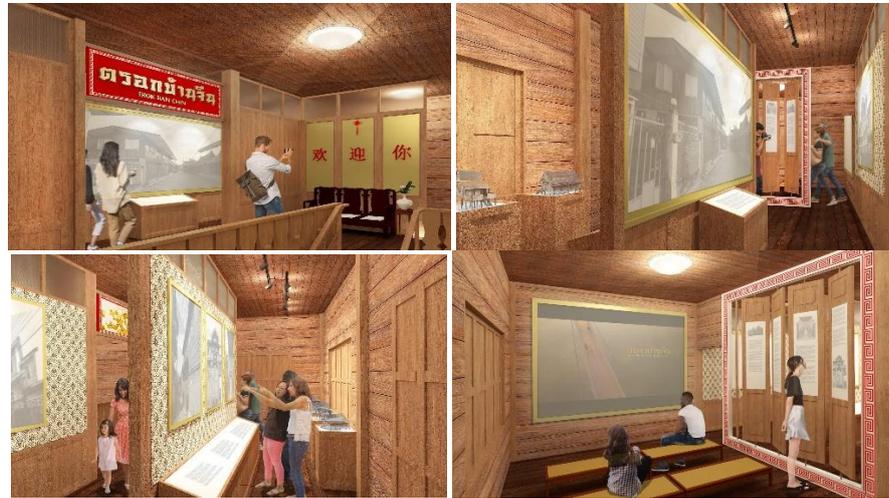
Figure 7 Interior design of the Upper Floor: the Trok Bann Chin Gallery and information center (Upper Floor)

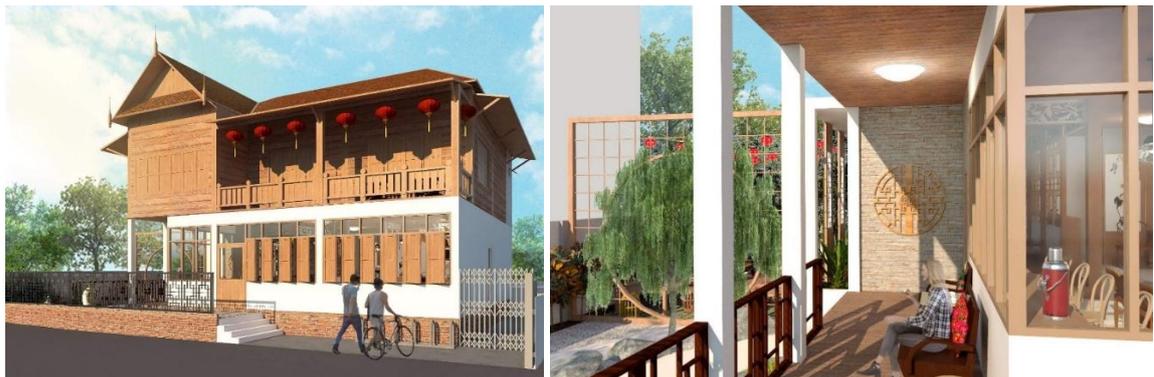
Figure 8 Architectural design: View from the main road (Left). Landscape design: View of the main entrance (Right)

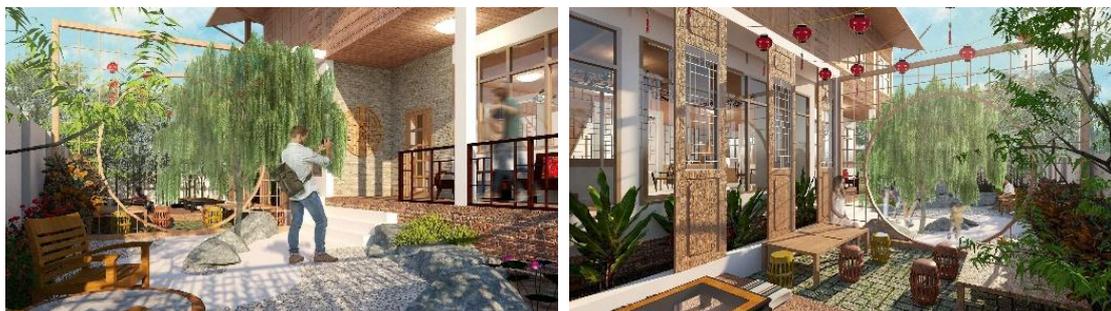
Figure 9 Landscape design: View of a Chinese garden with a moon gate

The concept of designing and renovating residential buildings in Trok Baan Chin community not consider only the historical, social and economic issues, but also the design guidelines that take into account the environment as well. The building renovation process sets out the elaborate framework for the removal of the original building elements in order to be able to apply the original materials for reuse. It is one of the principles of building design with environmentally friendly. In addition, the idea of creating an outdoor landscape that combines the style of a Chinese garden with the selection of plants suitable for the climate can also promote the environment in the community by adding green areas into space (See Figure 9).
