EXPERIMENTAL RESULTS AND VERIFICATION

Experimental Results

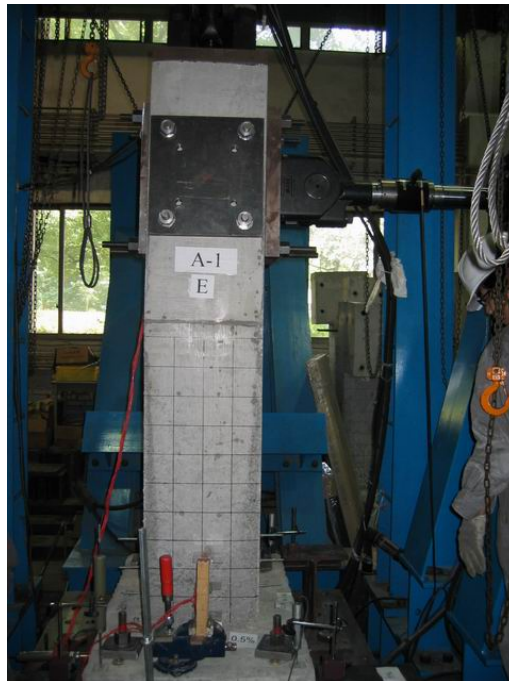
Figure 32 Specimen A1 test setup

Fig. 32 shows the test setup of the specimen A1. Specimen A1 was subjected to an axial force of 384 kN where the axial force index was $0.074 f'_c A_g$. The cyclic displacement loading was applied in the west (W) and east (E) direction alternately. The displacement loading history started from drift ratio at 0.05% until failure at 6.5% as shown in Fig. 33.

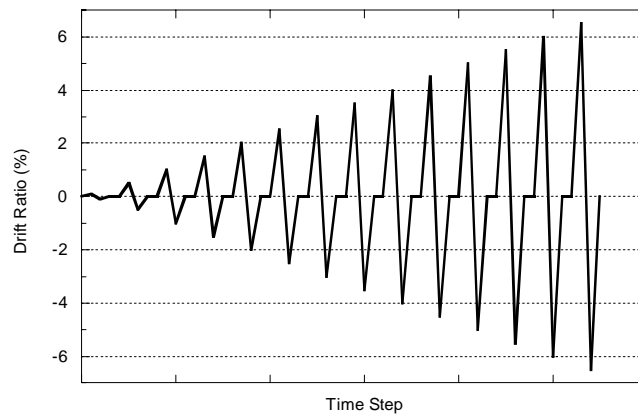
Figure 33 Displacement loading histories for specimens A1, A2, B1 and B2

Fig. 47 shows the test setup of the specimen A2. Specimen A-2 was subjected to eccentric load by axial force and cyclic displacement loading. This eccentricity (e) equals 60 mm in north (N) side measured from the centre of the column to the point which applied axial load. The cyclic load was applied in perpendicular direction to the eccentricity. The applied axial force was 384 kN where the axial force index was $0.074 f_c A_g$. The cyclic displacement loading was applied in the west (W) and east (E) direction alternately and perpendicular direction to the eccentricity. Similar to specimen A1, the displacement loading history started from drift ratio at 0.05% until failure at 6.5% as shown in Fig. 33.

Specimen B-1 was subjected to an axial force of 384 kN where the axial force index was $0.081 f_c A_g$. The cyclic displacement loading was applied in the west (W) and east (E) direction alternately. Similar to specimen A1, the displacement loading history started from drift ratio at 0.05% until failure at 6.5% as shown in Fig. 33.

Specimen B-2 was subjected to eccentric load by axial force in eccentric loading and cyclic displacement loading. This eccentricity (e) equals 60 mm ($0.15D$) in north (N) side measured from the centre of the column to the point which axial applied load. The cyclic load was applied in perpendicular direction to the eccentricity. The applied axial force was 384 kN where the axial force index was $0.081 f_c A_g$. The cyclic displacement loading was applied in the west (W) and east (E) direction alternately and perpendicular direction to the eccentricity. Similar to specimen A1, the displacement loading history started from drift ratio at 0.05% until failure at 6.5% as shown in Fig. 33.

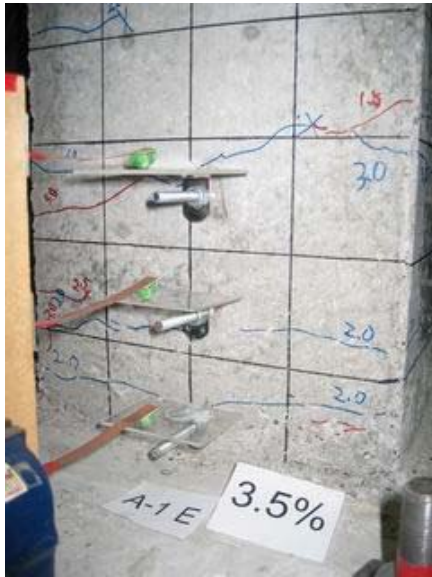
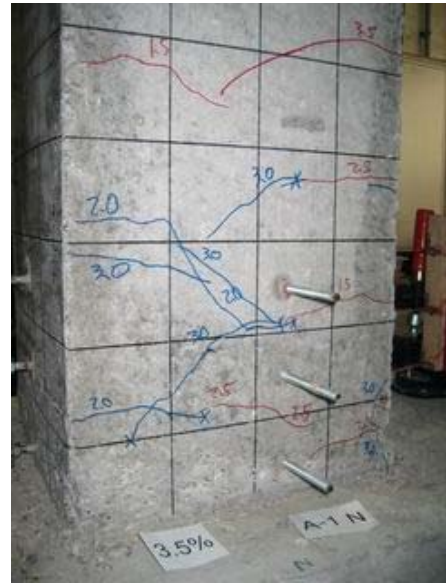
a.) Perpendicular side with lateral force

b.) Parallel side with lateral force

Figure 34 Specimen A1 at 3.5 % drift ratio

After flexural cracks appeared, vertical reinforcement strain measured was yielded at 0.76% drift ratio reached while the average measured R was 124.49 kN and Δ_y was 11.75 mm. The hysteresis under the displacement loading reached at its average maximum strength of 151.76 kN. When the drift ratio was 3%, the cover concrete surface started to spall off on the compression side. Then the cover concrete lump at the bottom spalled off increasing rate at 4.5 % drift ratio. When the drift ratio was 5.5 % at east side all vertical bars buckled and tie bars exposed outward completely. Then all vertical bars buckled followed by tie bars exposed completely at W side when drift ratio was 6 %. Finally, when the specimen was pushed of 6.5 % drift ratio, the core concrete was crushed and ten vertical bars totally were buckled. The severely damaged zone was 30 cm from the base.

Fig. 34 through Fig. 36 show the development during of the test and Fig. 37 shows the sketch of the progress of failure in the specimen A1.

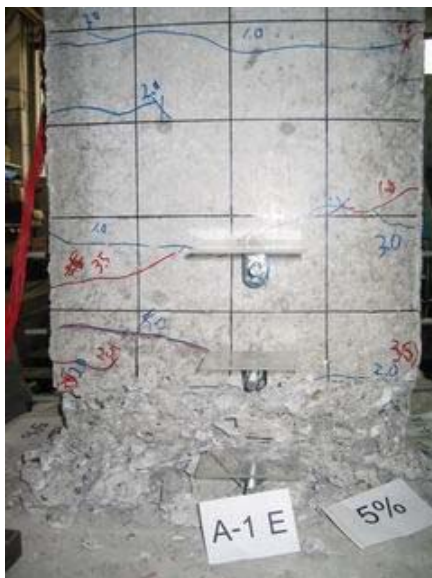
Figure 35 Specimen A1 at 5 % drift ratio

a.) Perpendicular side with lateral force

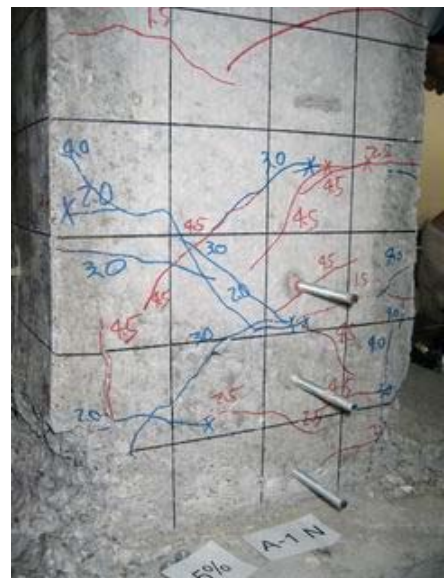
b.) Parallel side with lateral force

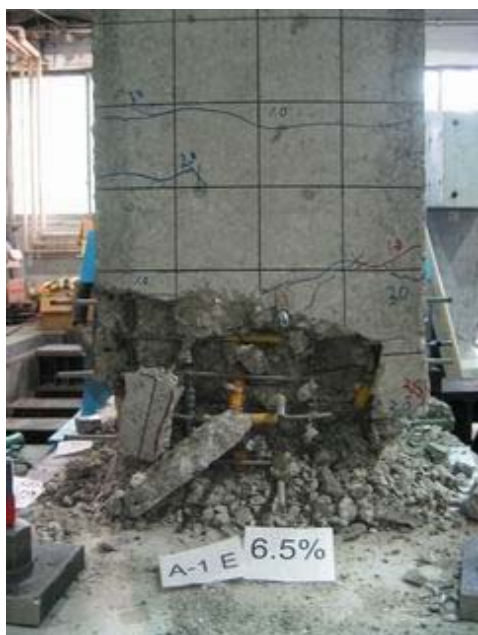
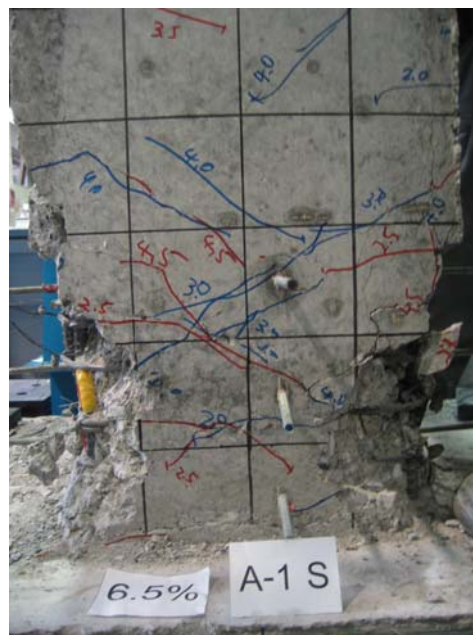
a.) Perpendicular side with lateral force

b.) Parallel side with lateral force

Figure 36 Specimen A1 at the end of test (drift ratio = 6.5 %)

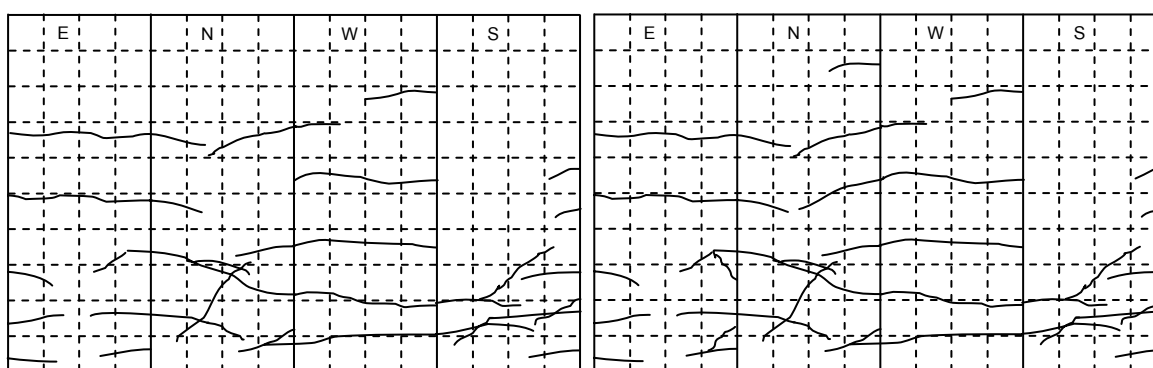
(a) Drift ratio at 3%

(b) Drift ratio at 4%

Figure 37 Progress of failure of specimen A1

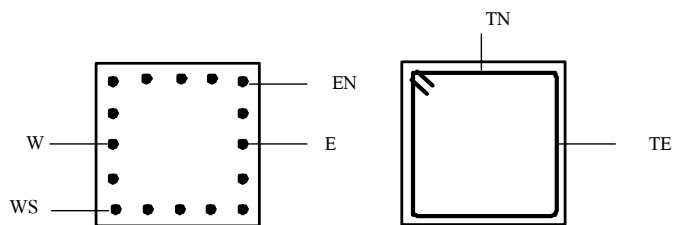
Figure 38 Attached strain gages of axial reinforcements and confinement steels of specimen A1

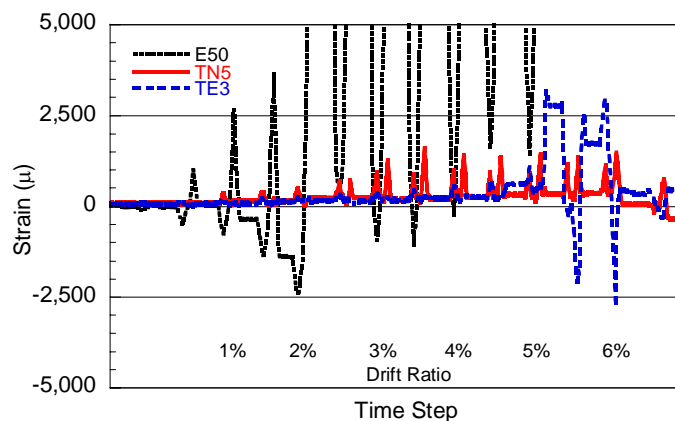
Measured strain in vertical reinforcement (E) and confinement (TE and TN) are shown in Fig. 39. After spalling of cover concrete, yielding of the tie rebar at the east side and west side was reached. The strain measured of tie rebar at N side (TN) and E side (TE) yielded at 3 % and 5% drift ratio respectively.

Figure 39 Measured strain of specimen A1

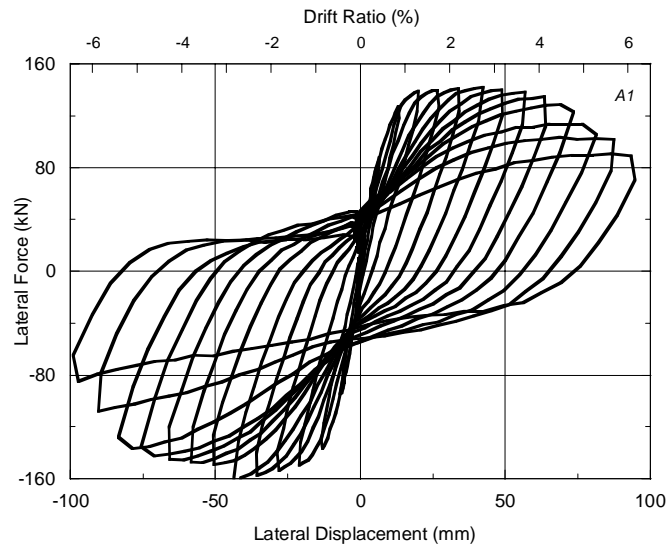
Fig. 40 presents the measured lateral force and lateral displacement hysteresis for specimen A1.

Figure 40 Lateral forces vs. lateral displacement hysteresis of specimen A1

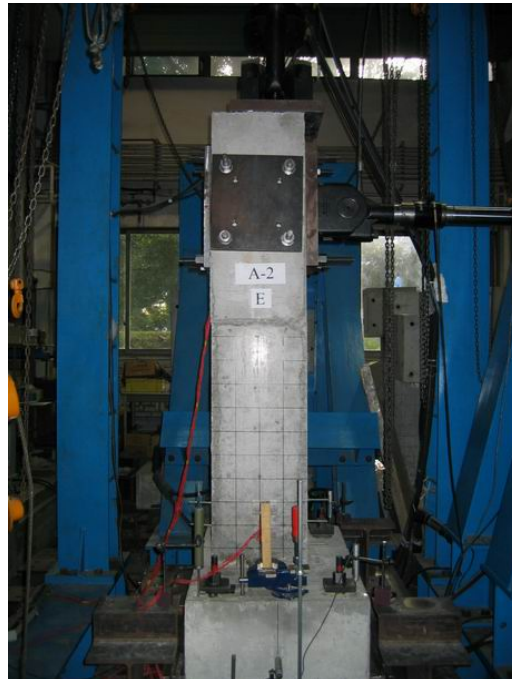
Figure 41 Specimen A2 test setup

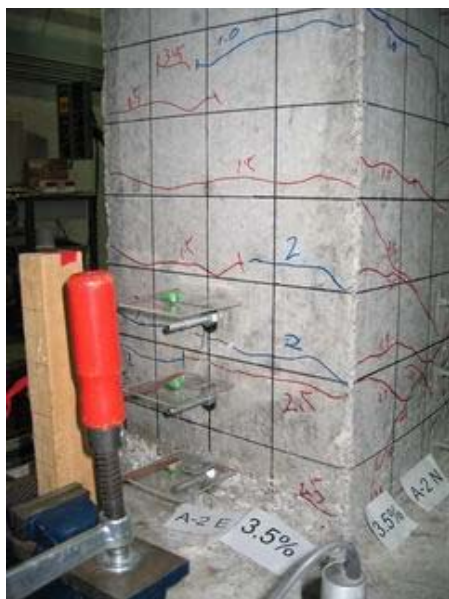
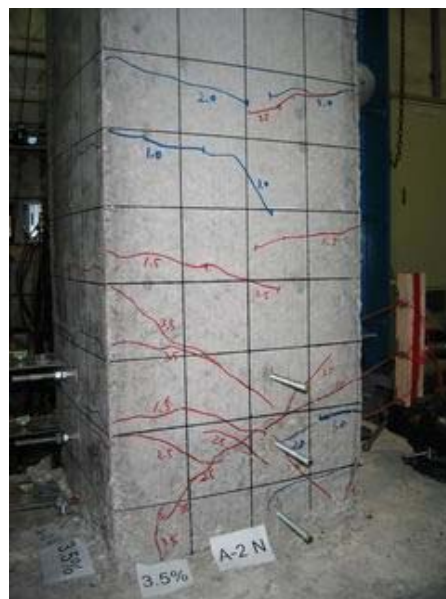
a.) Perpendicular side with lateral force

b.) Parallel side with lateral force

Figure 42 Specimen A2 at 3.5 % drift ratio

After flexural cracks appeared, vertical bar strain measured was yielded at 0.79% drift ratio reached while the average measured R was 121.13 kN and Δ_y was 12.19 mm. The hysteresis under the displacement loading reached at its average maximum strength of 141.11 kN. When the drift ratio was 3%, the cover concrete surface started to spall off on the compression side. Then the cover concrete lump at the bottom spalled off increasing rate at 4.5 % drift ratio. When the drift ratio was 5.5 % at E side all vertical bars buckled and tie bars exposed outward completely. Then all vertical bars buckled followed by tie bars exposed completely at W side when drift ratio was 6 %. Finally, when the specimen was pushed of 6.5 % drift ratio, the core concrete was crushed and ten vertical bars totally were buckled. The severely damaged zone was 31cm from the base.

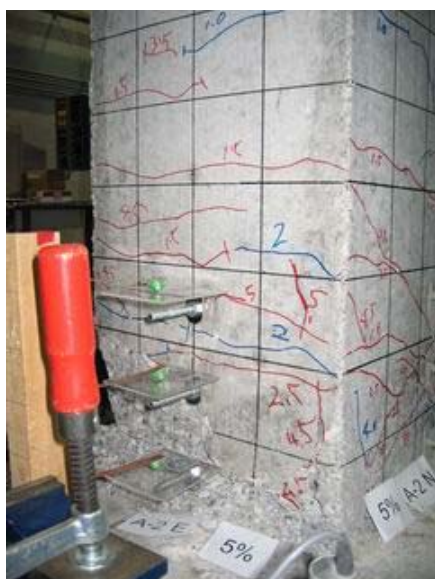
a.) Perpendicular Side with lateral force

Figure 43 Specimen A2 at 5 % drift ratio

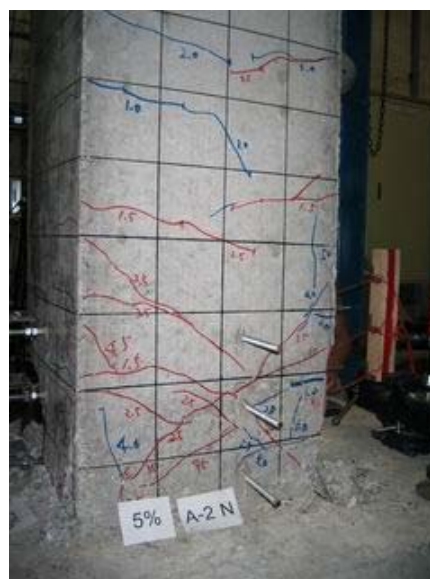
b.) Parallel side with lateral force

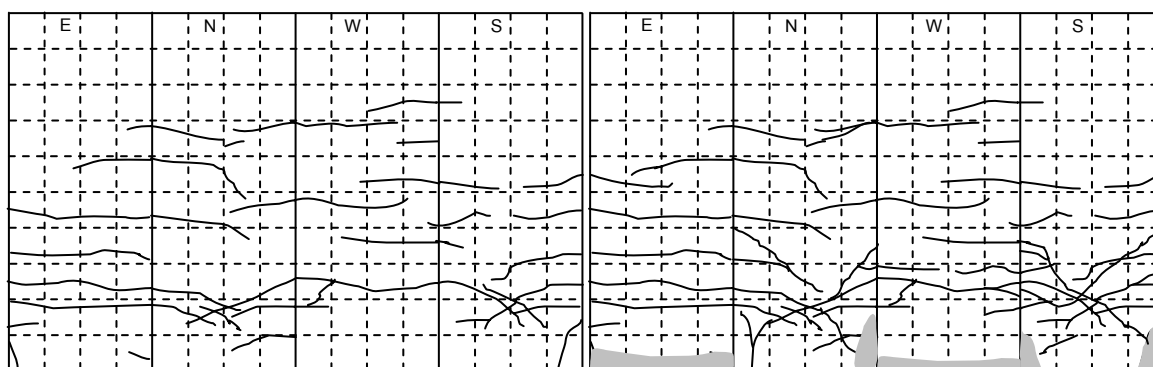
(a) Drift ratio at 3%

(b) Drift ratio at 4%

Figure 45 Progress of failure of specimen A2

(c) Drift ratio at 5%

(d) Drift ratio at 6%

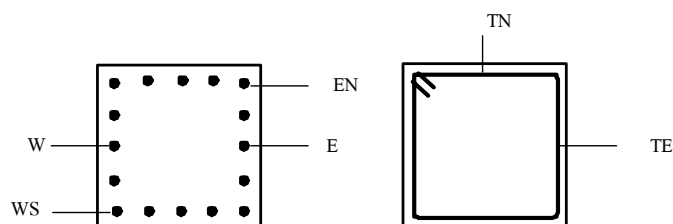
Figure 46 Attached strain gages of axial bars and confinement steel of specimen A2

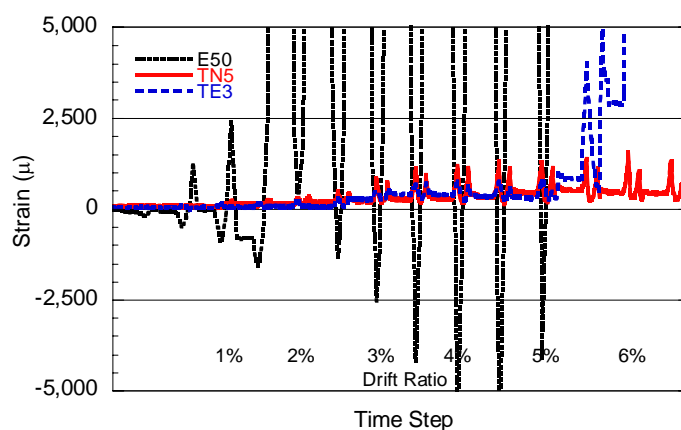
Measured strain in vertical reinforcement (E) and confinement (TE and TN) are shown in Fig. 47. After spalling of cover concrete, yielding of the tie rebar at the east side and west side was reached. The strain measured of tie rebar at N side (TN) and E side (TE) yielded at 4.5 % and 5.5 % drift ratio respectively.

Figure 47 Measured strain of specimen A2

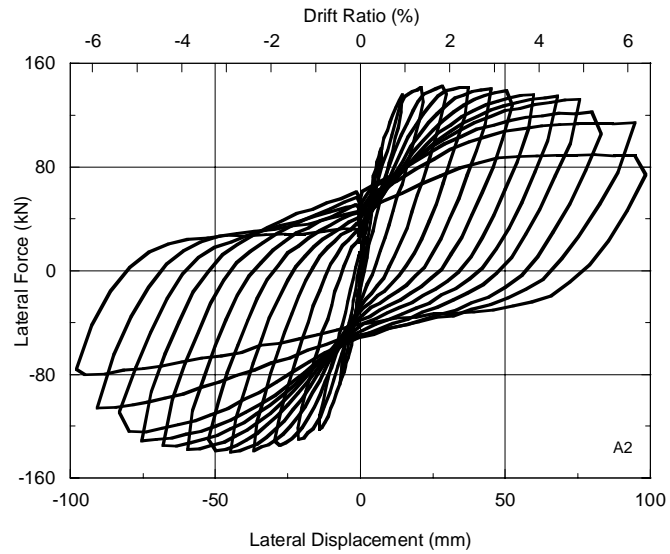
The lateral force and lateral displacement hysteresis for specimen A2 is shown in Fig. 48.

Figure 48 Lateral force vs. lateral displacement hysteresis of specimen A2

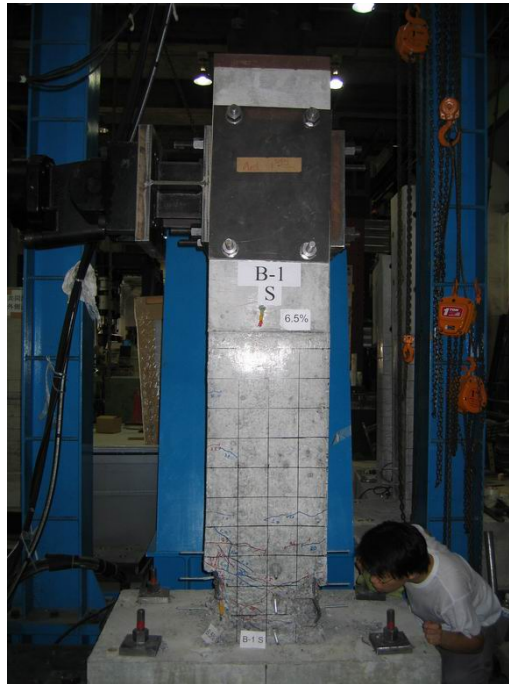
Figure 49 Specimen B1 test setup at failure

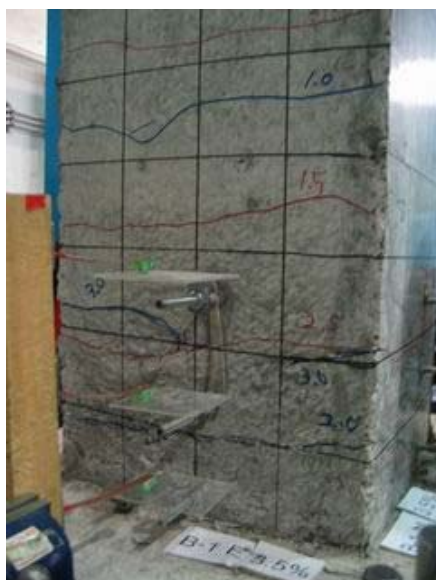
a.) Perpendicular side with lateral force

Figure 50 Specimen B1 at 3.5 % drift ratio

After flexural cracks appeared, vertical bar strain measured was yielded at 0.67% drift ratio reached while the average measured R was 121.17 kN and Δ_y was 10.40 mm. The hysteresis under the displacement loading reached at its average maximum strength of 154.1 kN. When the drift ratio was 3.5%, the cover concrete surface started to spall off on the compression side. Then the cover concrete lump at the bottom spalled off increasing rate at 4% drift ratio. When the drift ratio was 4.5%, the cover concrete started to spall off and vertical bars at E/W corner buckled and exposed. When the drift ratio was 5.5% vertical bars at all corners buckled and tie bars exposed outward. Then all vertical bars buckled followed by tie bars exposed completely at W side and E side when drift ratio was 6%. Finally, when the specimen was pushed of drift ratio = 6.5%, the core concrete was crushed and ten vertical bars were buckled and also two vertical bars were fractured. The severely damaged zone was 26 cm from the base.

Fig. 50 through Fig. 52 show the development during of the test and Fig. 53 shows the sketch of the progress of failure in the specimen B1. The lateral force and lateral displacement hysteresis for specimen B1 is shown in Fig.56.

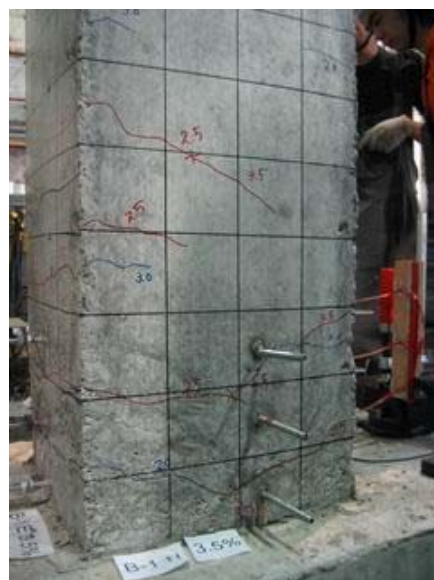
b.) Parallel side with lateral force

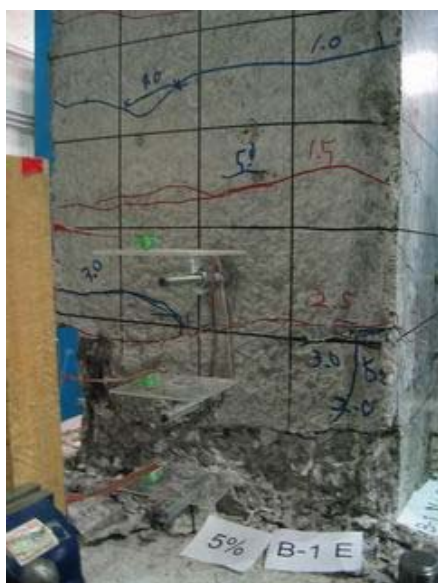
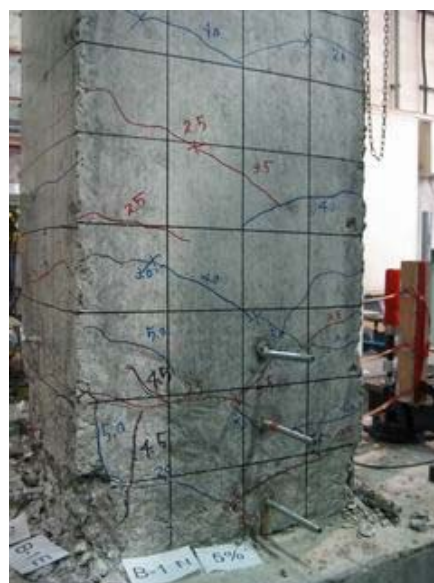
a.) Perpendicular side with lateral force

b.) Parallel side with lateral force

Figure 51 Specimen B1 at 5 % drift ratio

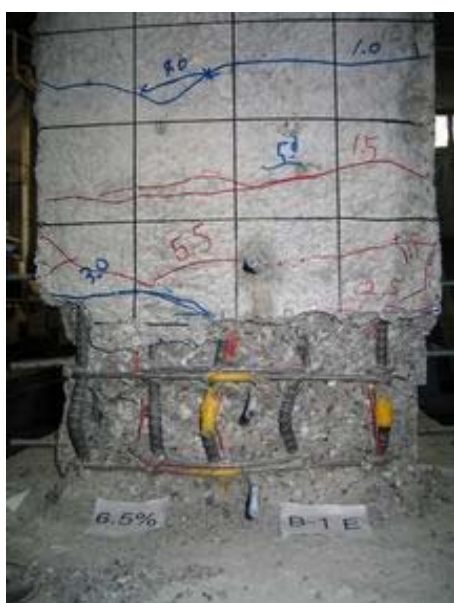
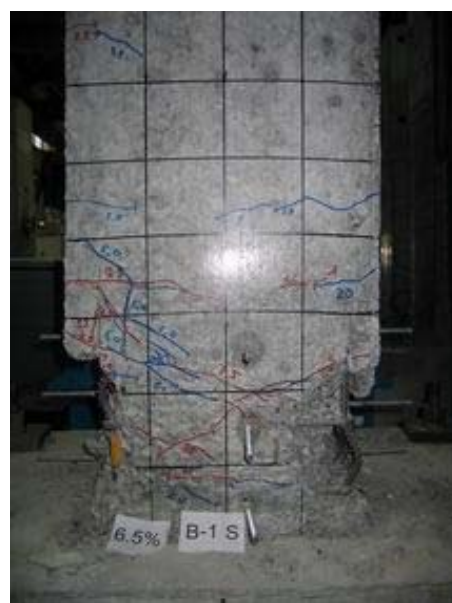
a.) Perpendicular side with lateral force

b.) Parallel side with lateral force

Figure 52 Specimen B1 at the end of test (drift ratio = 6.5 %)

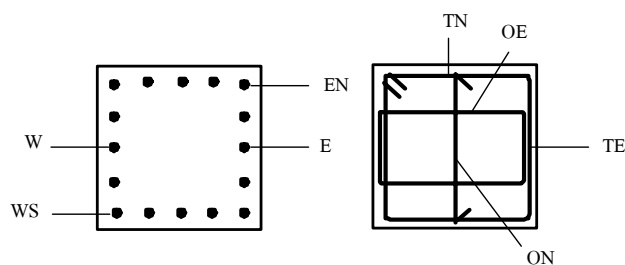
Figure 54 Attached strain gages of axial bars and confinement steel of specimen B1

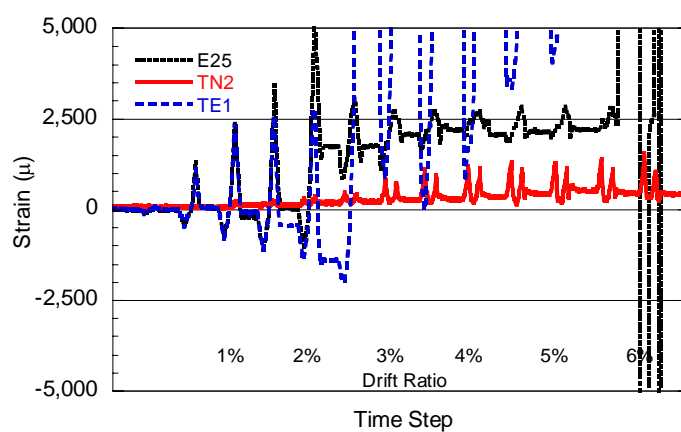
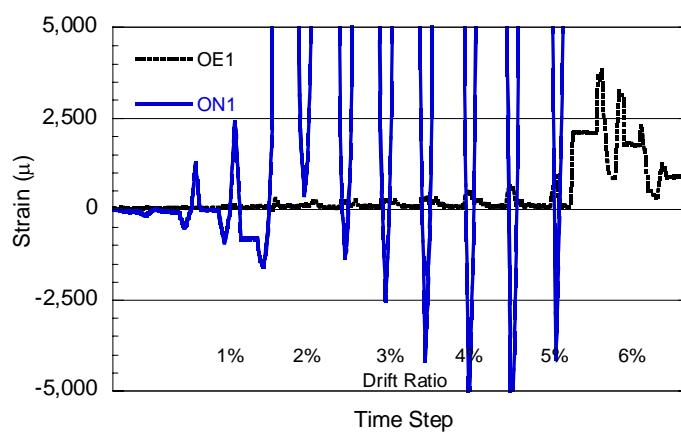
Measured strain in vertical reinforcement (E) and confinement (TE and TN) are shown in Fig. 55. After spalling of cover concrete, yielding of the tie rebar at the east side and west side was reached. The strain measured of outer ring of tie rebar at N side (TN) and E side (TE) yielded at 5 % and 1 % drift ratio respectively while inner ring of tie rebar at N side yielded at 5.5 % drift ratio.

a) Vertical reinforcement and out ring of confinement steel

b) Cross tie and inner confinement steel

Figure 55 Measured strain of specimen B1

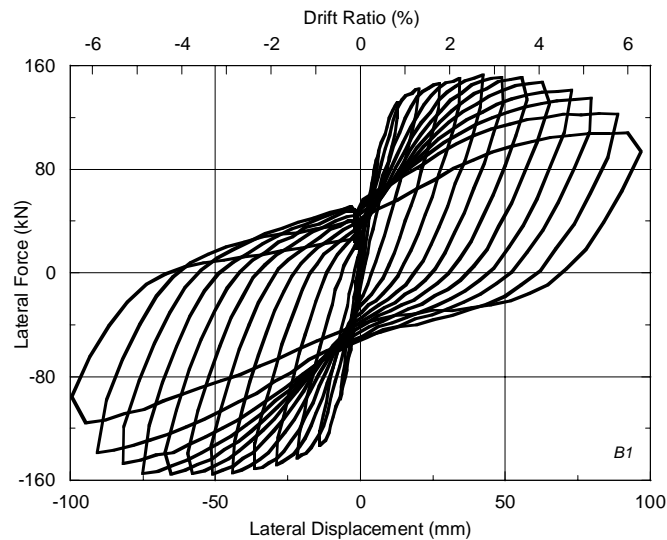
Figure 56 Lateral force vs. lateral displacement hystereses of specimen B1

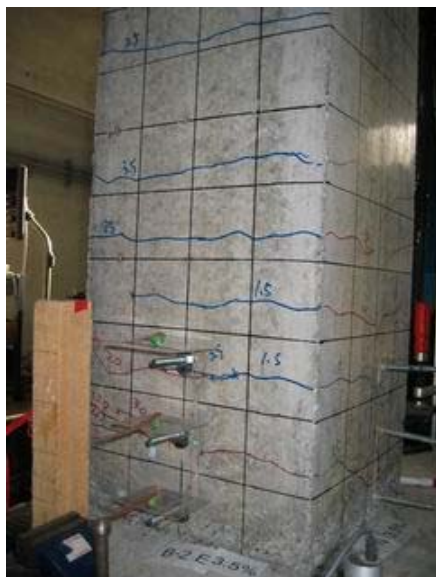
a.) Perpendicular side with lateral force

Figure 57 Specimen B2 at 3.5 % drift ratio

After flexural cracks appeared, vertical bar strain measured was yielded at 0.69 % drift ratio reached while the average measured P_H was 113.1 kN and Δ_y was 10.66 mm. The hysteresis under the displacement loading reached at its average maximum strength of 141.23 kN. When the drift ratio was 4%, the cover concrete surface started to spall off on the compression side. Then the cover concrete lump at the bottom spalled off increasing rate at 4.5 % drift ratio. When the drift ratio was 5 % vertical bars at all corners buckled and tie bars exposed outward. When the drift ratio was 5.5 % at W side, all vertical bars buckled and ties bar exposed outward. Then all vertical bars buckled followed tie bars exposed completely at east side when drift ratio

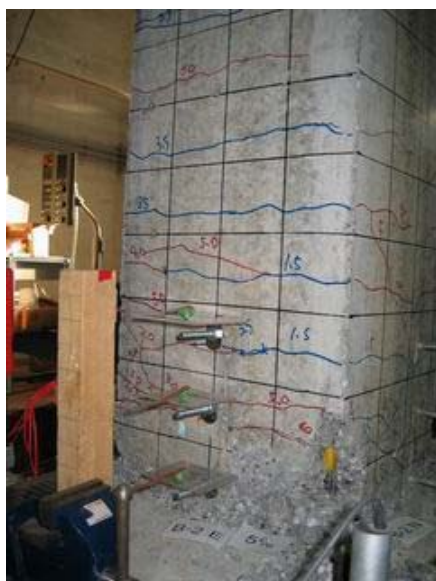
a.) Perpendicular side with lateral force

Figure 58 Specimen B2 at 5 % drift ratio

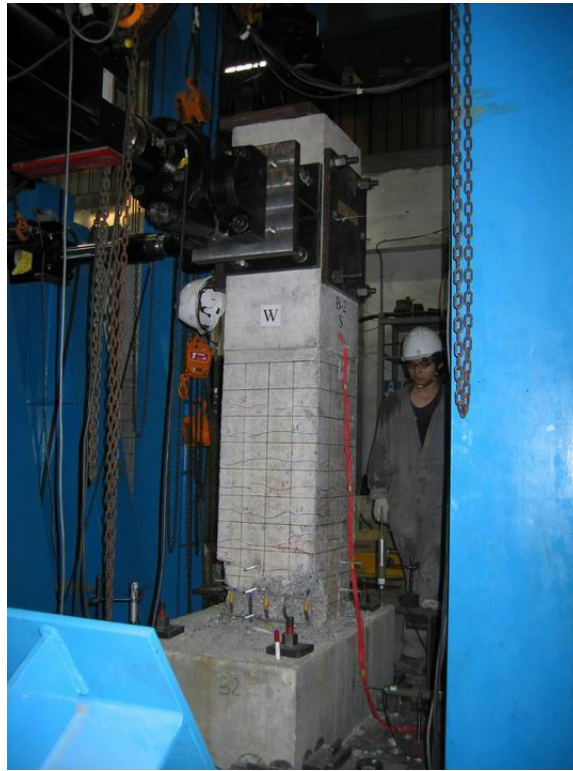
was 6 %. Finally, when the specimen was pushed of drift ratio = 6.5 %, the core concrete was crushed and twelve vertical bars were buckled. The severely damaged zone was 28 cm from the base.

Figure 60 Specimen B2 test setup at the end of test

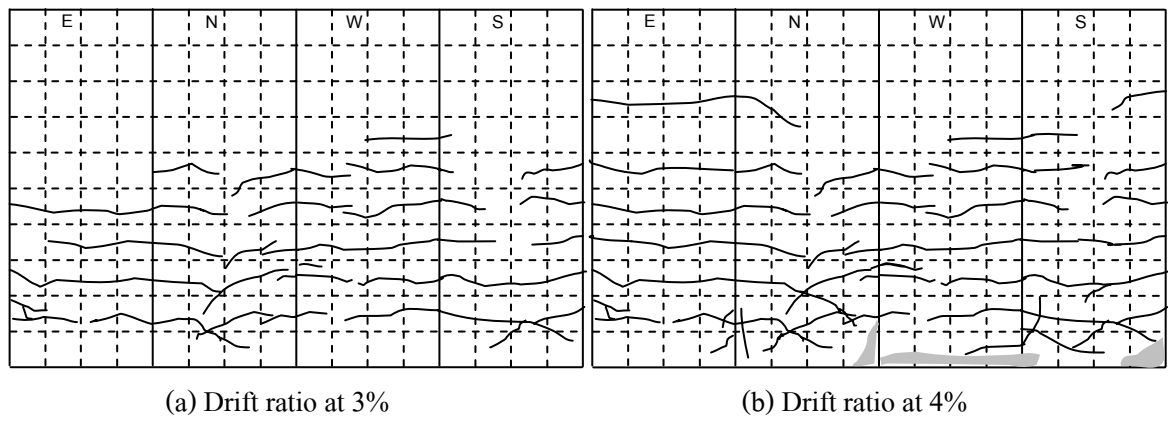
Figure 61 Progress of failure of specimen B2

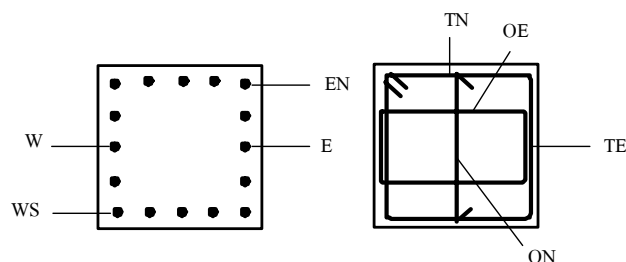
Figure 62 Attached strain gages of axial bars and ties bars of specimen B2

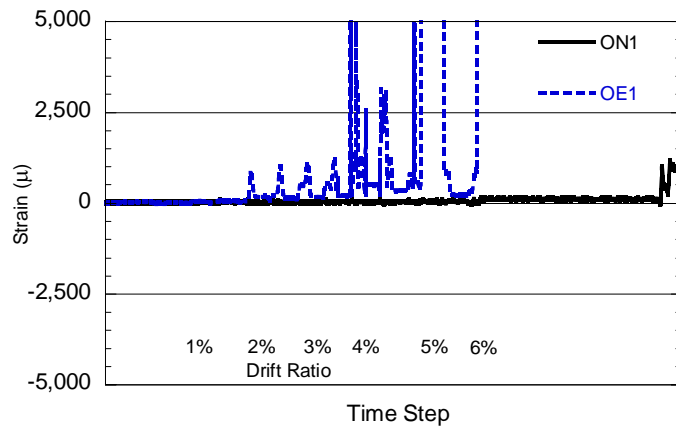
Measured strain in vertical reinforcement (E) and confinement (TE and TN) are shown in Fig. 63. After spalling of cover concrete, yielding of the tie rebar at the east side and west side was reached. The strain measured of outer ring of tie rebar at N side (TN) and E side (TE) yielded at 3.5 % and 5.5 % drift ratio respectively while inner ring of tie rebar at N side yielded at 4 % drift ratio.

Figure 63 Measured strain of specimen B2

b) Cross tie and inner confinement steel

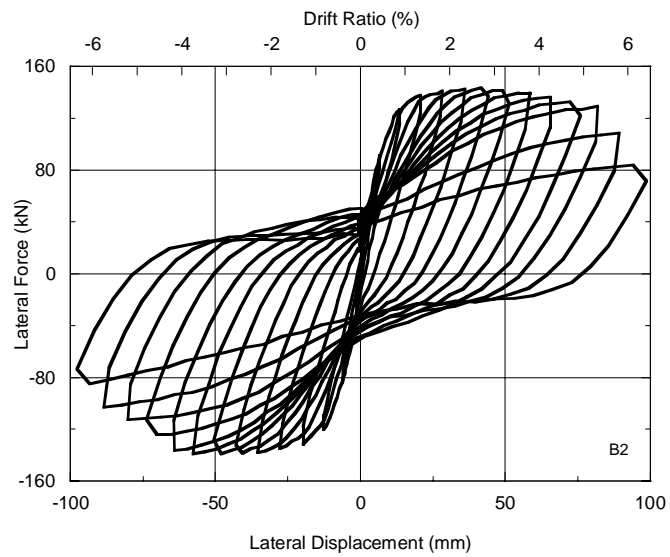
Figure 64 Lateral force vs. lateral displacement hystereses of specimen B2

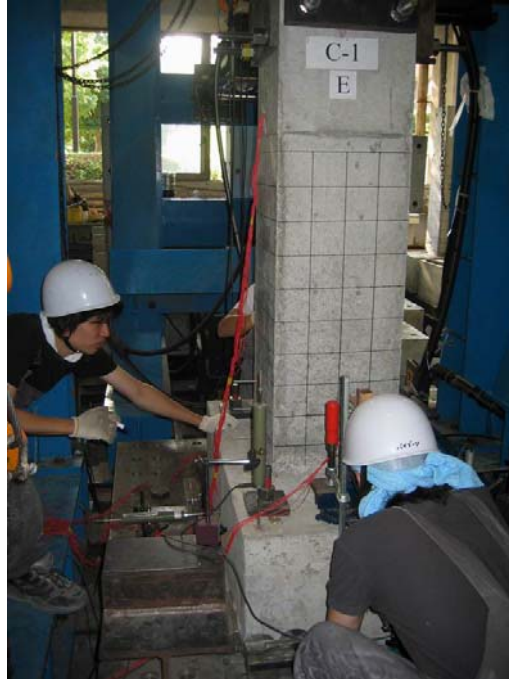
Figure 65 Specimen C1 test setup

Specimen C-1 was subjected to an axial force of 384 kN where the axial force index was $0.074 f'_c A_g$. Fig. 65 shows the test setup of the specimen C1. The cyclic displacement loading was applied in the west (W) and east (E) direction alternately. The displacement loading history started from drift ratio at 0.05% until failure at 5% as shown in Fig. 66.

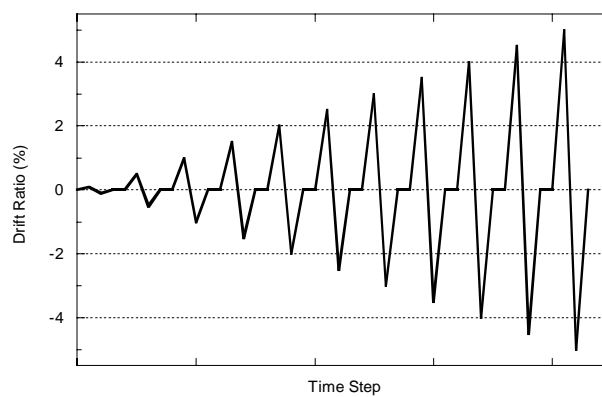
Figure 66 Displacement loading histories for specimens C1

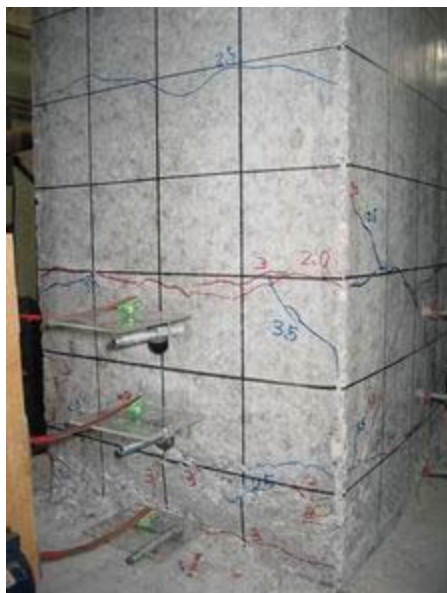
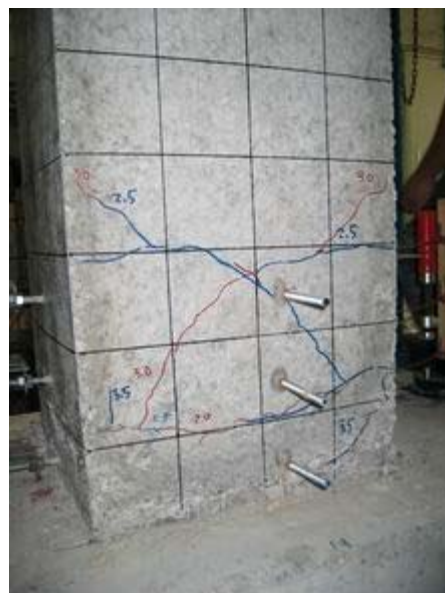
a.) Perpendicular Side with Lateral Force

b.) Parallel side with Lateral Force

Figure 73 Specimen C1 at 3.5 % drift ratio

After flexural cracks appeared, vertical bar strain measured was yielded at 0.76% drift ratio reached while the average measured R was 132.41 kN and Δ_y was 13.51 mm. The hysteresis under the displacement loading reached at its average maximum strength of 144.52 kN. When the drift ratio was 3%, the cover concrete surface started to spall off on the compression side. Prior to 4 % drift ratio the cover concrete plate spalled off and vertical bars and ties bar exposed completely at E side followed. When the drift ratio was 4.5 % the vertical bars at all corners buckled and ties bar exposed outward. Then all vertical bars totally buckled followed by tie bars at W side and E side when drift ratio was 5 %. Finally, brittle flexure-shear failure occurred. The severely damaged zone was 43 cm from the base.

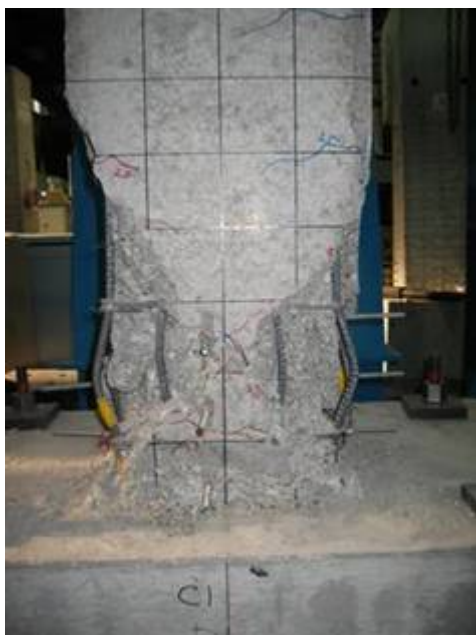
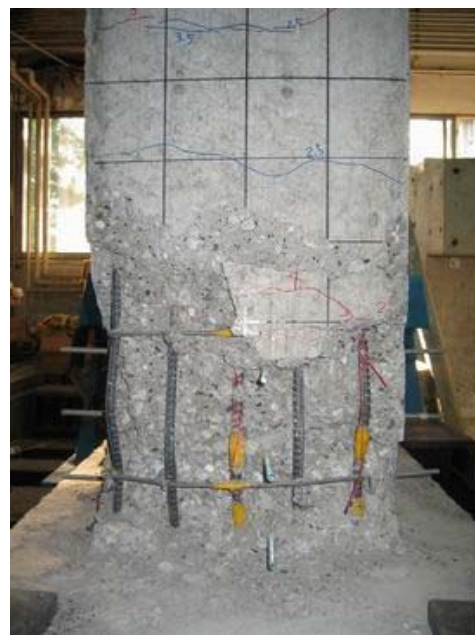
a.) Perpendicular Side with Lateral Force

b.) Parallel side with Lateral Force

Figure 68 Specimen C1 at the end of test (drift ratio = 5 %)

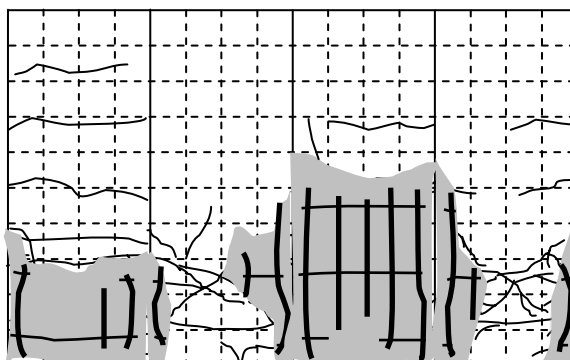
Figure 69 Progress of failure of specimen C1

(c) Drift Ratio 5%

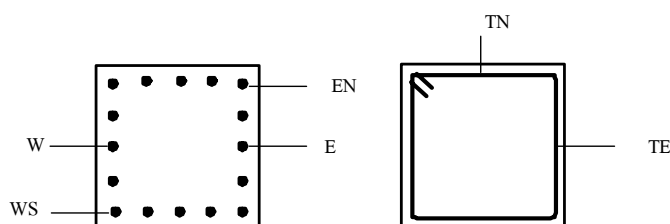
Figure 70 Attached strain gages of axial bars and confinement steel of specimen C1

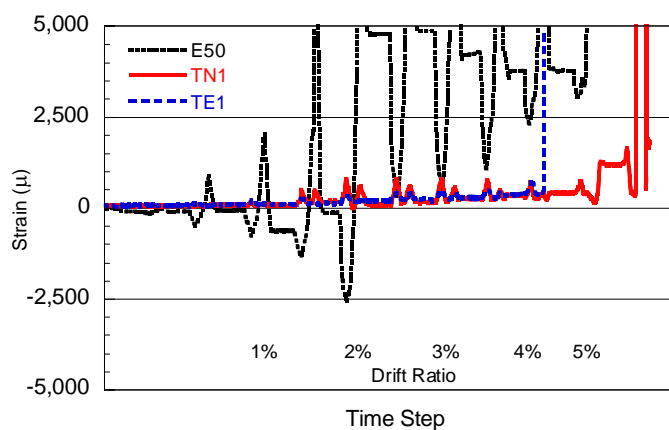
Measured strain in vertical reinforcement (E) and confinement (TE and TN) are shown in Fig. 71. After spalling of cover concrete, yielding of the tie rebar at the east side and west side was reached. The strain measured of tie rebar at N side (TN) and E side (TE) yielded at 3 % and 5% drift ratio respectively.

Figure 71 Measured strain of specimen C1

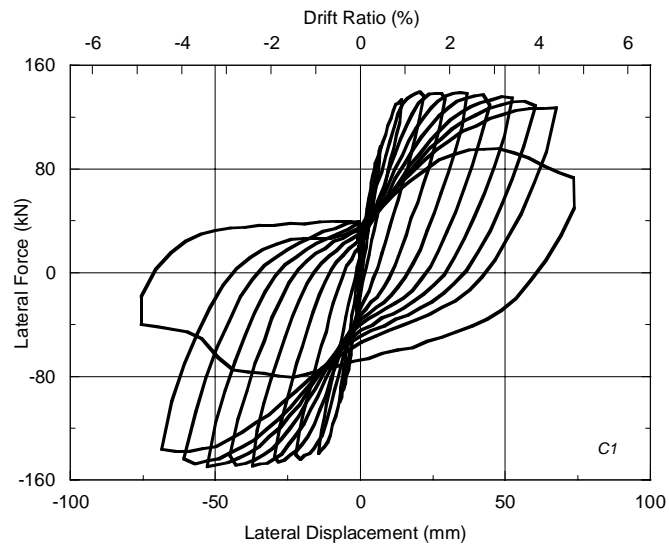
Figure 72 Lateral force vs. lateral displacement hysteresis of specimen C1

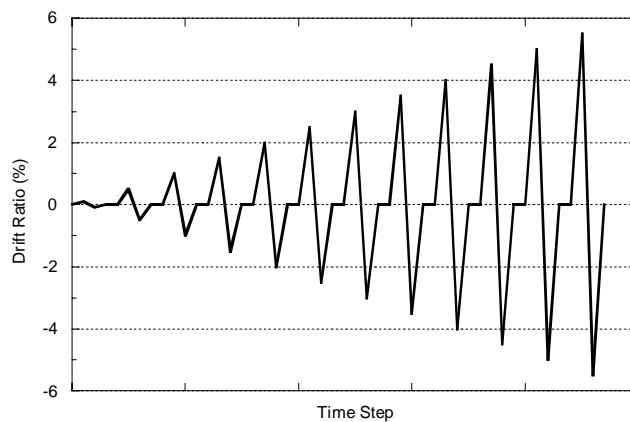
Figure 73 Displacement loading histories for specimens D1

Specimen D-1 was subjected to an axial force of 384 kN where the axial force index was $0.081 f_c A_g$. The cyclic displacement loading was applied in the west (W) and east (E) direction alternately. The displacement loading history started from drift ratio at 0.05% until failure at 5.5% as shown in Fig. 74.

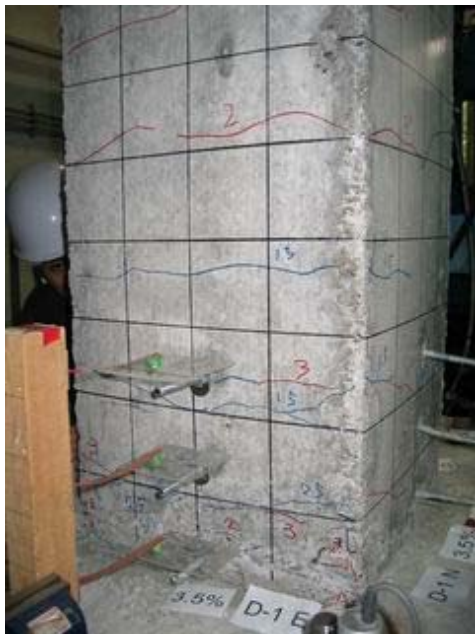
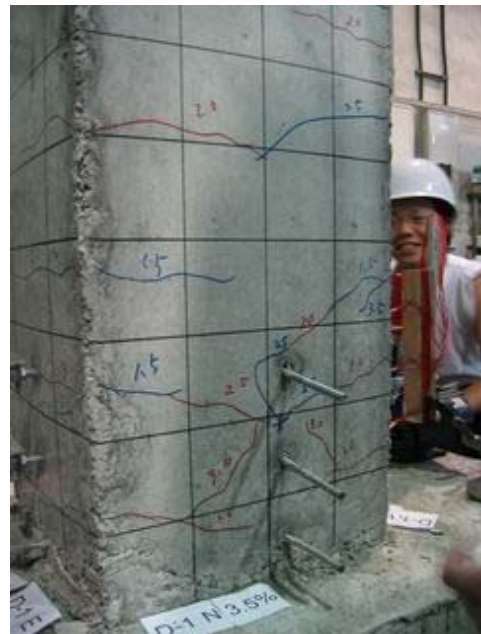
a.) Perpendicular side with lateral force

b.) Parallel side with lateral force

Figure 74 Specimen D1 at 3.5 % drift ratio

After flexural cracks appeared, vertical bar strain measured was yielded at 0.71% drift ratio reached while the average measured P_H was 126.95 kN and Δ_y was 11.04 mm. The hysteresis under the displacement loading reached at its average maximum strength of 126.95 kN. When the drift ratio was 3% the cover concrete surface started to spall off on the compression side. Then the cover concrete lump at the bottom spalled off increasing rate at 3.5 % drift ratio. When the drift ratio was 4 % the vertical bars at the corners buckled and tie bars exposed outward. Then all vertical bars buckled and ties bar exposed completely at E side when drift ratio was 4.5 %. Then all vertical bars buckled and ties bar exposed completely at W side followed with significant stiffness degradation when drift ratio was 5 %. Finally, when the specimen was pushed of 5.5 % drift ratio, the core concrete was crushed and twelve vertical bars were buckled. The severely damaged zone was 35 cm from the base. The strain measured of tie bars at N side and E side yielded at 2 % and 5 % drift ratio respectively.

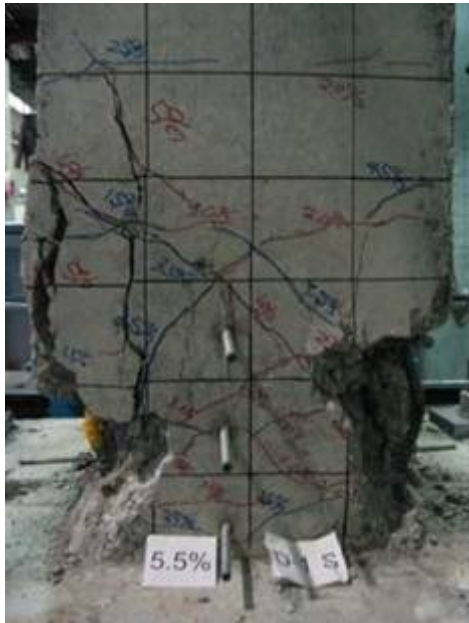
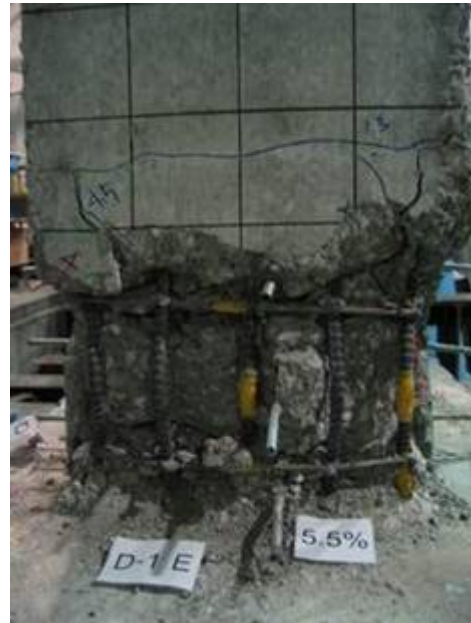
a.) Perpendicular side with lateral force

b.) Parallel side with lateral force

Figure 75 Specimen D1 at the end of Test (drift ratio = 5.5 %)

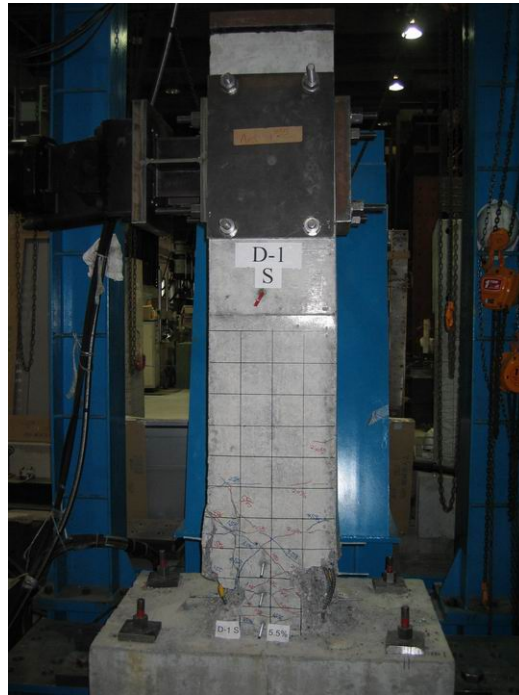
Fig. 73 and Fig. 75 show the development during of the test and Fig. 77 shows the sketch of the progress of failure in the specimen D1. Fig. 76 shows the test setup of the specimen D1 at the end of test.

Figure 76 Specimen D1 test setup at the end of test

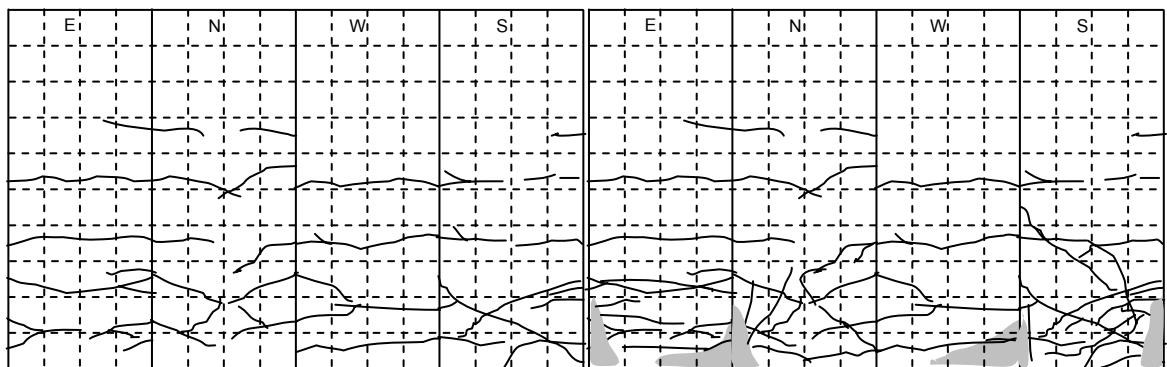
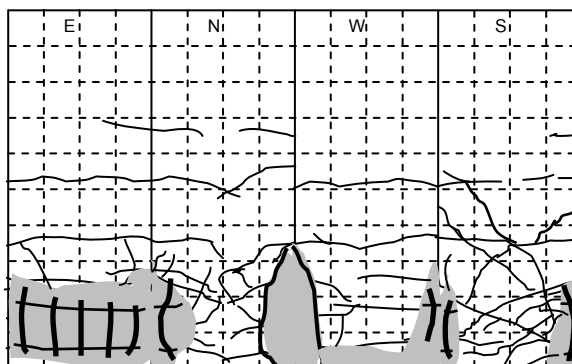
(a) Drift ratio at 3%

(b) Drift ratio at 4%

Figure 77 Progress of failure of specimen D1

(c) Drift ratio 5%

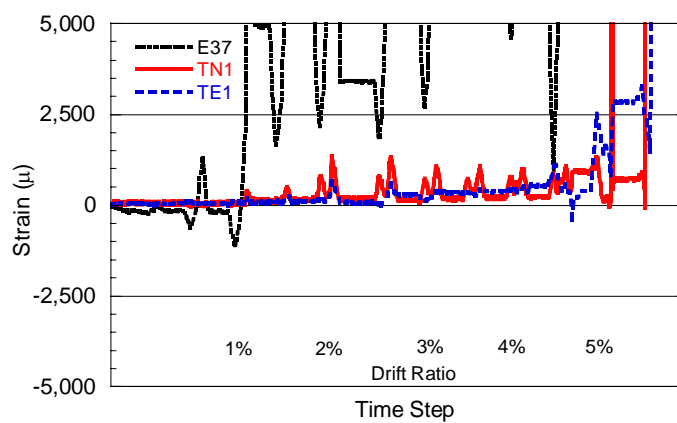
Figure 79 Measured strain of specimen D1

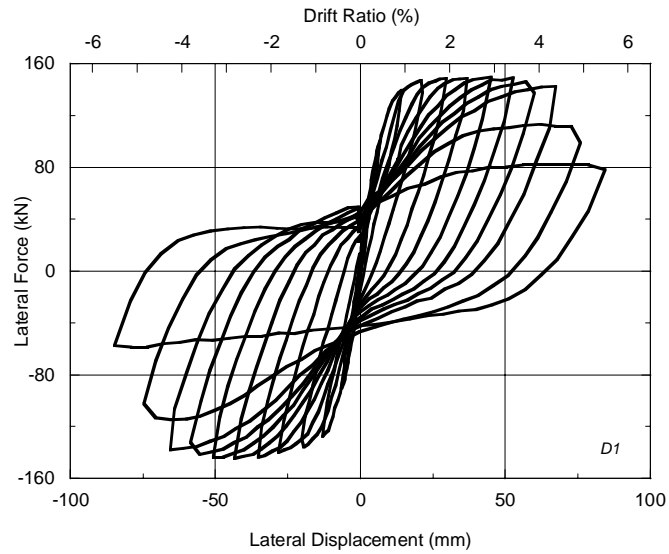
Figure 80 Lateral force vs. lateral displacement hysteretic curves of specimen D1

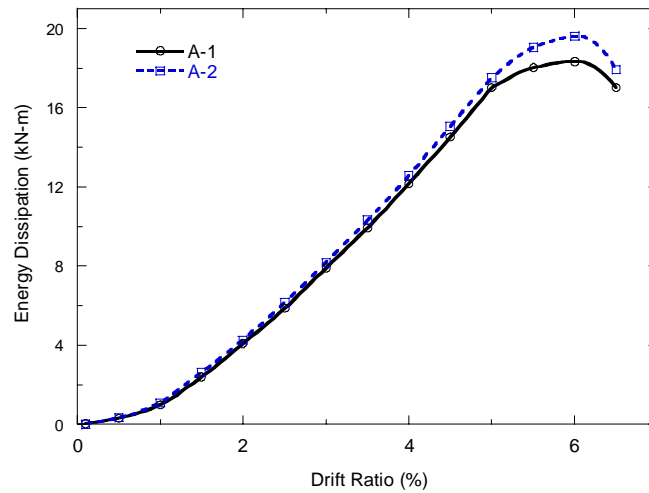
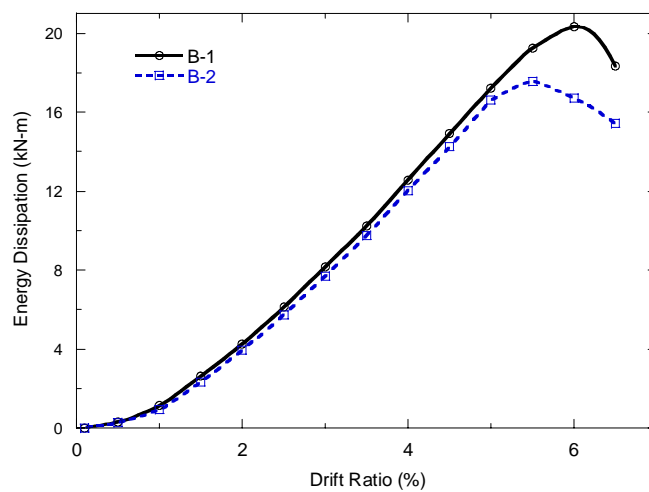
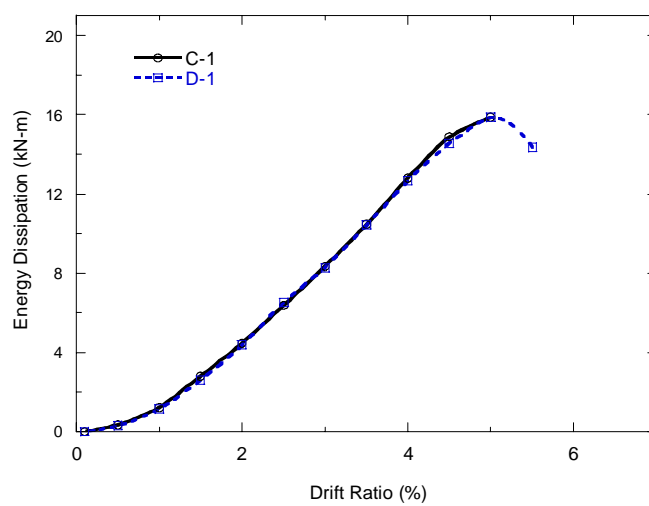
The dissipation energy (ΔW_i) in one loop of hysteresis displacement is determined by integrating the area bounded by the hysteresis loop as indicated by Equation (40). The accumulated dissipation energy (ΔW) in the column specimens is determined by Equation (41).

where $F_l(u)$ and $F_{ul}(u)$ are the forces at displacement, u during loading and unloading process. Fig. 87 shows the dissipated energy vs. drift ratio of the test specimens.

Figure 81 Energy dissipation vs. lateral displacement of specimens
