EXPERIMENTAL RESULTS AND VERIFICATION

Experimental Results

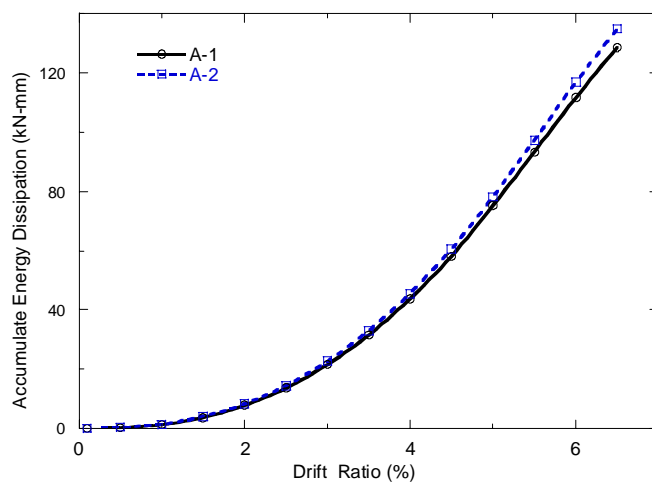
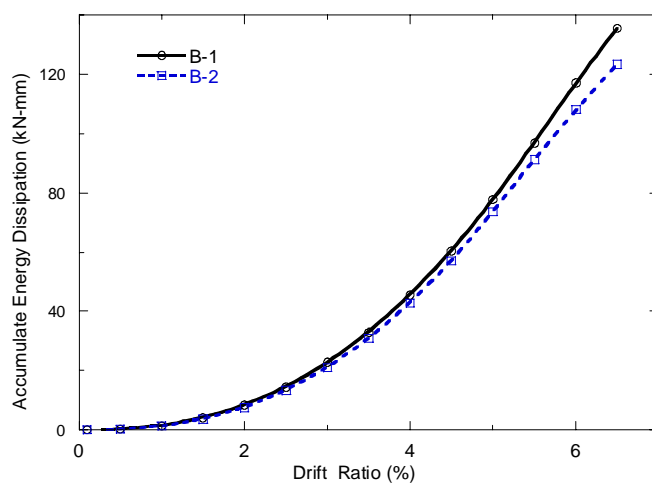
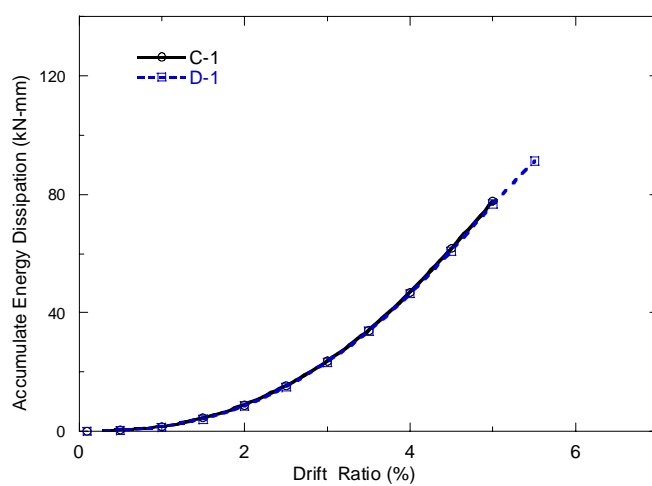
Fig. 82 shows the accumulate energy dissipation calculated by Equation (41).

Figure 82 Accumulate energy dissipation vs. lateral displacement of test specimens

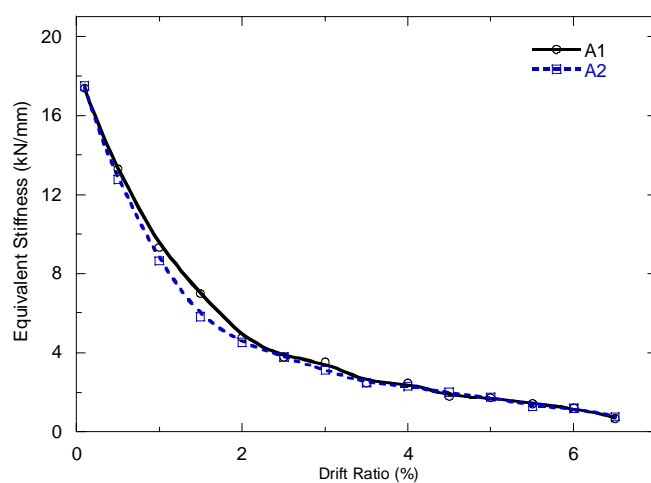
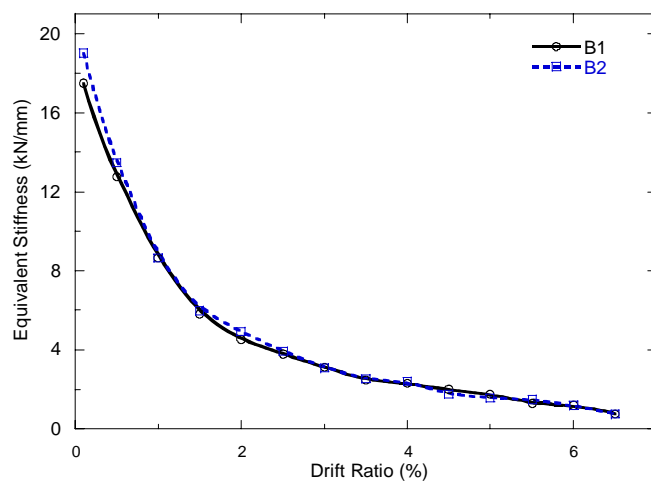
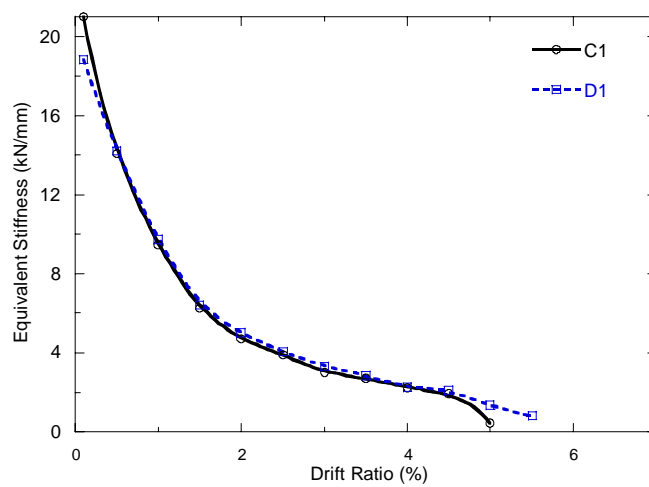
The equivalent stiffness was determined by the ratio between the horizontal force and displacement range in each loading step. Fig. 89 shows the equivalent stiffness vs. drift ratio of the test specimens.

Figure 83 Equivalent stiffness vs. lateral displacement of test specimens
