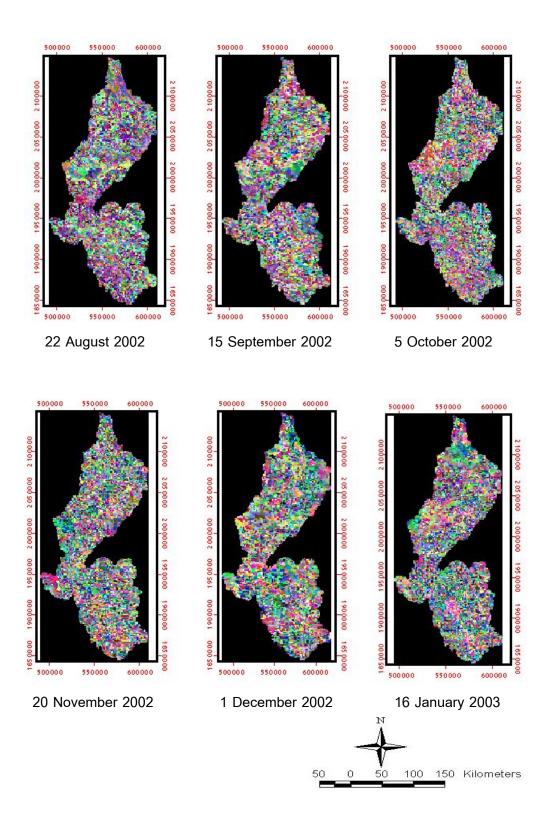
<u>Figure 27</u> Estimation evapotranspiration (ETest) in Sukhothai paddy field and Lampang teak plantation during August 2002-January 2003.

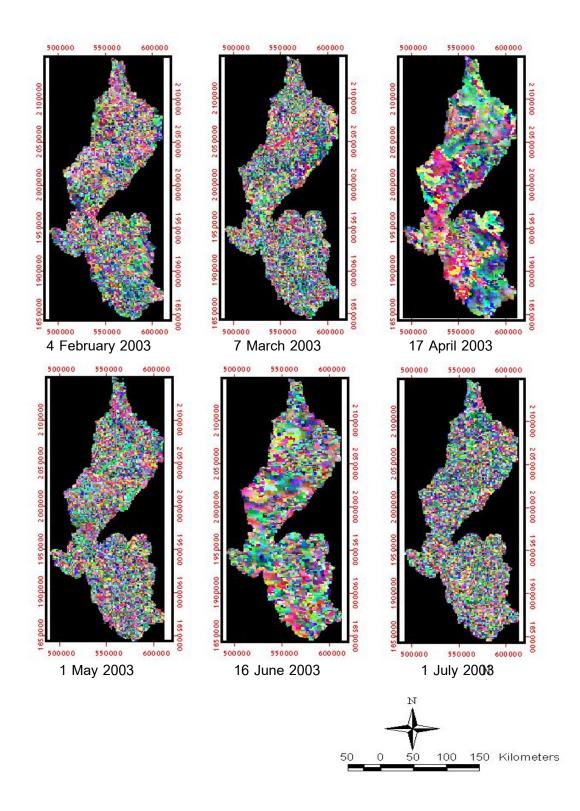
<u>Figure 28</u> Estimation evapotranspiration (ETest) in Sukhothai paddy field and Lampang teak plantation during February 2003-July 2003.

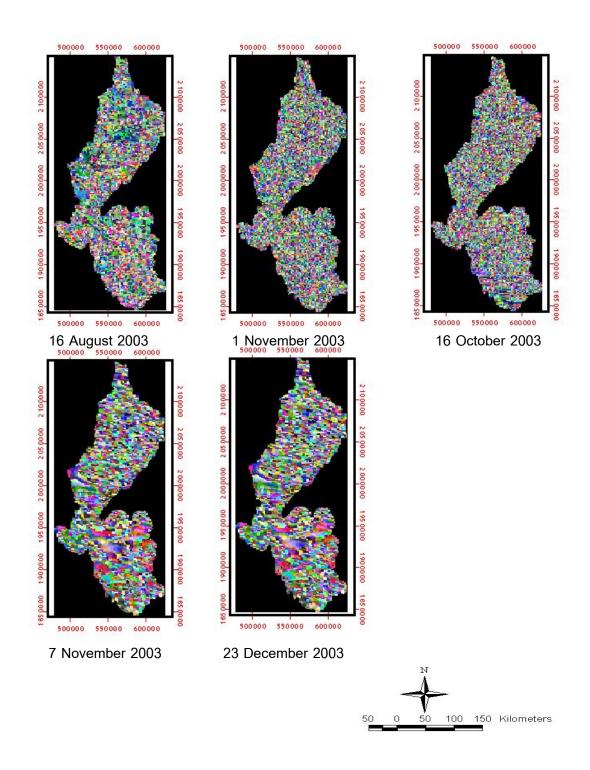
<u>Figure 29</u> Estimation evapotranspiration (ETest) in Sukhothai paddy field and Lampang teak plantation during August 2003-December 2003.
