Stability Analysis of an Overall Failure Excavation Case in Hang Zhou

T. N. Do¹

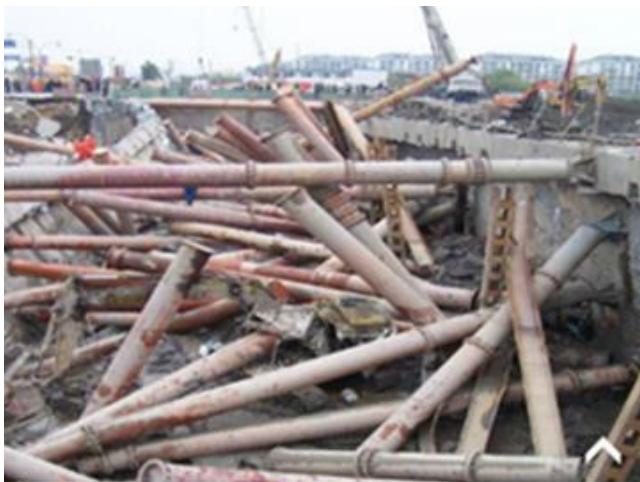
Figure 2 Failure of excavation (source: internet)

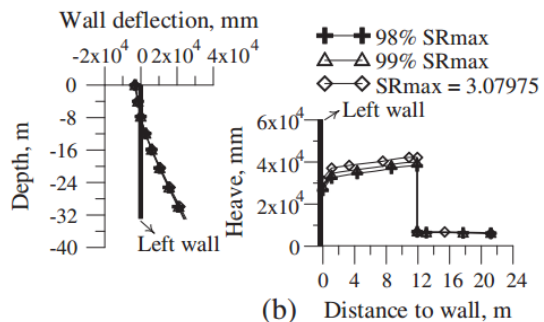
Figure 4 Wall deflection and soil heave in stability analysis as using the: (a) elastoplastic support systems, and (b) elastic support systems

When the elastic support system was employed, the final excavation stage was computed completely and the SRmax value was 3.07975. The wall deflection and the soil heave corresponding to 98%, 99%, and 100% of SRmax are plotted in Figure 4(b). As shown in the figure, when SR was increased, the wall deflection remained constant and the maximum wall deflection, about 3×10^4 mm, happened at the wall toe. On the other hand, the soil heave developed gradually with the maximum soil heave occurring at the center of the excavation, up to 4×10^4 mm. It is observed that the
