# Development of IoT Slope Monitoring System and its Applications for Kratu-Patong Road Landslide in Phuket, Thailand

**ABSTRACT:** This paper presents an on-going development of Internet-of-Things (IoT) slope monitoring for landslide early warning system in Thailand. The current system employs a variety of sensors, namely MEMs-based tensiometers, piezometers, soil moisture sensor, tiltmeter, in-placed inclinometer and tipping bucket raingauge, all connected to Arduino-based microcontroller which relied on Narrowband, NB-IoT, protocol for data transmission to the cloud server. A specially designed application platform was developed to convert the sensor readings to engineering unit and ultimately geotechnical parameters, such as factor of safety, which enable engineers to readily understand the situation and make an informed-decision based on such parameters. A weighted approach was proposed in calculating the overall landslide hazard level based various kinds of sensor readings. A case history of Kratu-Patong Road Landslide in Phuket, Southern Thailand, taking place in Year 2022 was presented to demonstrate how the developed IoT system was used real-time together with geotechnica

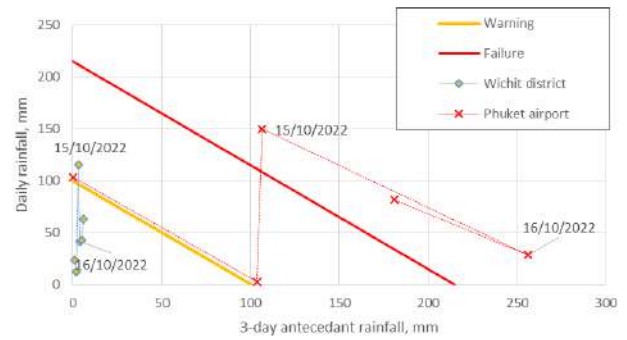
Figure 3 Critical rainfall envelope for Kratu-Patong road 2022 landslide in Phuket

The rain pattern, plotted as daily rainfall versus antecedent rainfall (accumulated rain in previous few days), can provide a useful tool for roughly estimating when slope failure is likely to occur, as suggested by many previous researchers (e.g., Lumb, 1975, Crozier & Eyles, 1980, Mairaing et al., 2012). An example of such plot for a case history of Kratu-Patong road landslide in phuket, presented thereafter, is shown in Figure 3. The failure critical rainfall envelope demarcates the rainfall patterns that induced major landslide from the others that do not. The warning rainfall envelope sets the boundary of rain pattern that induce minor landslide.

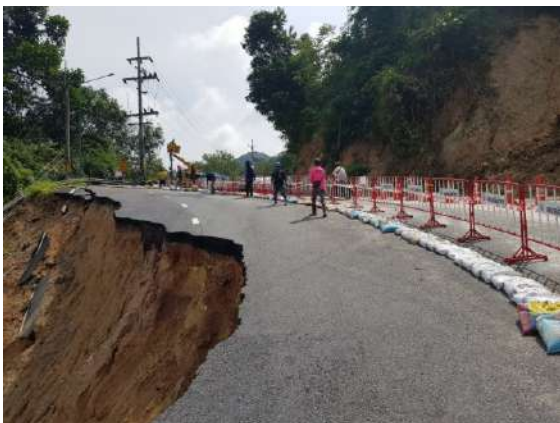
**Figure 5 Road damage due to Kratu-Patong 2022 landslide in Phuket**

The Kratu-Patong Road landslide occurred on October 16, 2022, triggered by prolonged and heavy rainfall. The rainfall data from the closest weather station revealed a daily rainfall exceeding 150 mm, with a 3-day cumulative total surpassing 200 mm, as illustrated in Figure 3. This intense precipitation led to a slope failure, resulting in the complete collapse of one of the road lanes, as depicted in Figure 5.

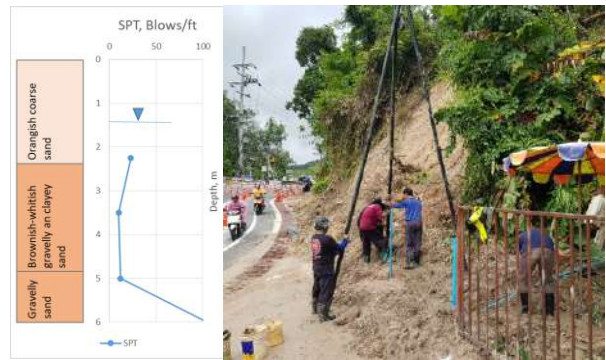
**Figure 6 Soil investigation**

A rapid site investigation revealed that the depth to bedrock extended to approximately 6 meters, with the groundwater table positioned at a depth of 1.5 meters (as illustrated in Figure 6). The upper layer of soil was derived from biotite-muscovite granite and classified as brownish-to-whitish grey clayey sand. Previous study (Jotisankasa & Vathananukij, 2008) showed this granitic residual soil was prone to landslide and typically contained 3% gravel, 39% sand, 21% silt, and 37% clay. Our subsequent actions included the deployment of a piezometer at the 6-meter depth, a tensiometer at 2.67 meters, and two soil moisture sensors at depths of 0.1 meters and 0.5 meters. Additionally, three tiltmeters were strategically positioned on the back slope and along the water channel further upslope, along with the installation of a tipping bucket rain gauge. It's worth noting that although the most suitable location for sensor installation would have been on the lower side of the slope, closer to the failed soil mass, operational constraints compelled us to install the sensor arrays on the upper side of the road, as visualized in Figure 7.

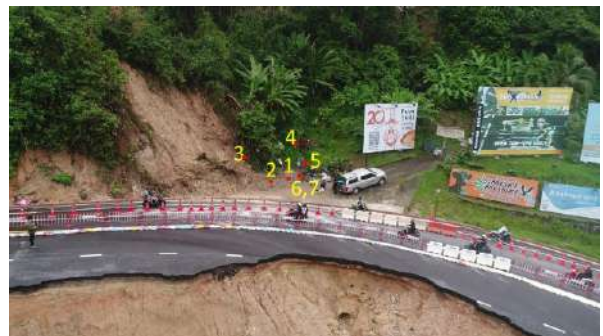
**Figure 7 Location of installed sensors; 1: Piezometer (6 m), 2: Tensiometer (2.67 m), 3: Tiltmeter (back slope), 4: Tiltmeter (upper channel), 5: Tiltmeter (water channel), 6: Soil moisture (0.1 m), 7: Soil moisture (0.5 m) and 8: Rain gauge**

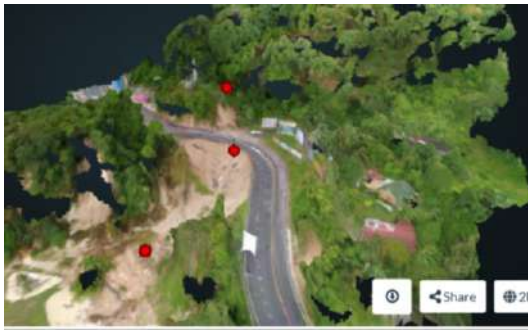
Figure 8 3D-model of the slope based on UAV survey

An unmanned aerial vehicle (UAV) survey was conducted with the objective of creating a three-dimensional model of the slope, employing the photogrammetry method. The resulting 3D model, as depicted in Figure 8, highlights the critical cross section that was then utilized for subsequent slope stability analysis. A uniform soil profile was specified based on in-situ SPT tests, with the strength parameters set as follows, effective cohesion,  $c' = 10 \text{ kPa}$ , angle of shearing resistance,  $\phi' = 28^\circ$  and unit weight,  $\gamma = 18 \frac{\text{kN}}{\text{m}^3}$ . Figure 9 presents the findings of the slope stability analysis, incorporating data from the monitored pore-water pressure profile alongside the assumed pore-water pressure values.

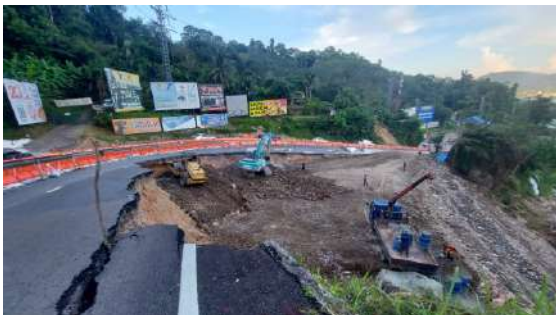
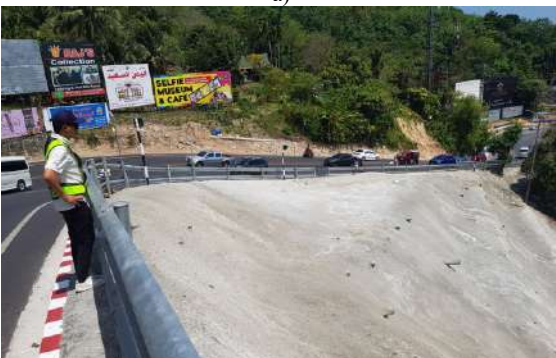
Figure 15 Slope condition in a) 28<sup>th</sup> November 2022; b) February 2023

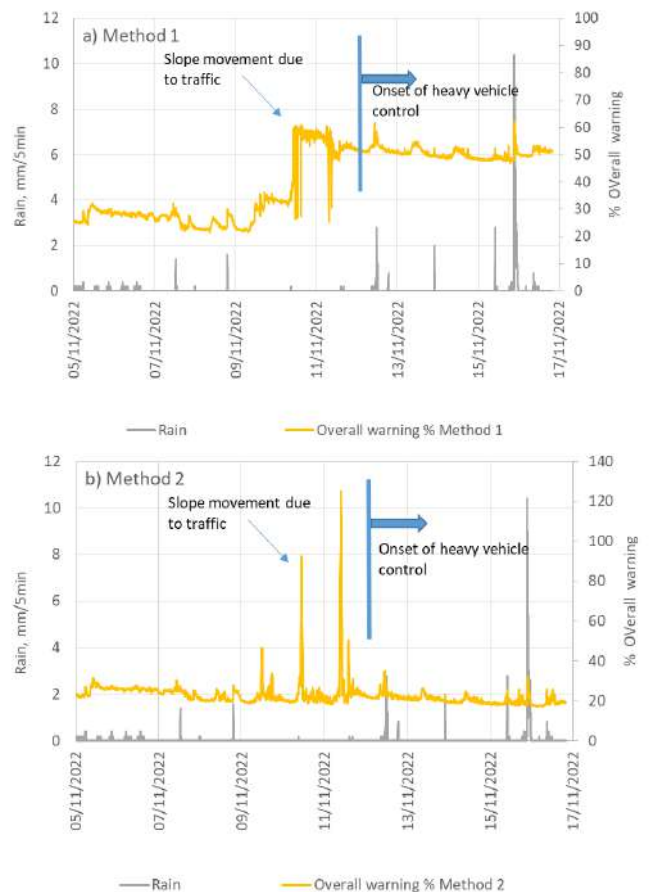
Figure 16 Overall warning index calculated using a) Method 1 and b) Method 2

Upon comparing the warning indices derived from Methods 1 and 2, it becomes evident that Method 1, relying on tilting magnitude, offers a continuous warning message. In contrast, Method 2, based on tilting velocity, issues a brief warning pulse lasting 1-2 hours, activated only when the velocity surpasses the predetermined threshold. The transient nature of Method 2's warning could

potentially be overlooked if not promptly addressed. Based on the warning event in this study using Method 1, the first alarm threshold for over warning could be set at 50% as indicated in Figure 16a.

In the context of Method 1, the warning message persists even after the slope has apparently returned to a safe condition, as observed from 12/12/22 onwards. This continuous alert will endure unless the tiltmeter's zero reading is manually reset, necessitating human intervention. It is clear that expert oversight in data presentation and reporting remains essential for ensuring the accurate representation of slope safety. The automated warning system is useful when no personnel could remain at their post all the times. To issue warning, panel discussion and expert judgement are still needed.

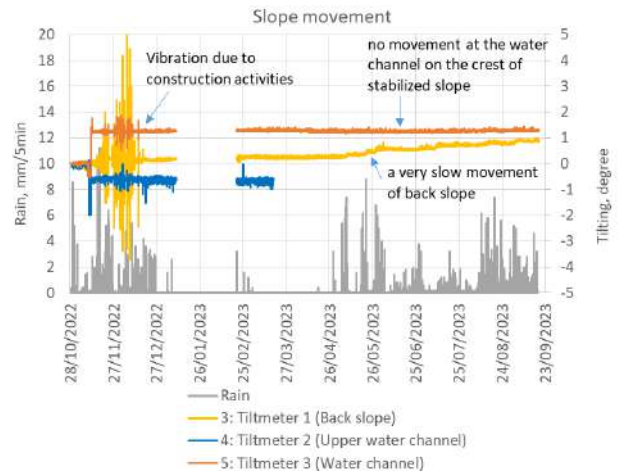
Figure 20 Slope movement and 5 min rainfall from Oct 2022 to Sep 2023

The slope movement throughout the entire monitoring period is illustrated in Figure 20, indicating a cessation of movement in the water channel at the crest of the stabilized slope (Sensor 5: Tiltmeter 3). This cessation persists despite heavy rainfall observed in the year 2023, underscoring the effectiveness of the stabilization efforts. However, noticeable movement is evident in the upper back slope, which remains unstabilized. By the end of September 2023, the tilting degree reached approximately 0.9 degrees. The average movement rate for the back slope was calculated at 0.126 degrees per month, equivalent to 0.000175 degrees per hour, categorizing it as a very slow movement according to Sheikh et al. (2021).

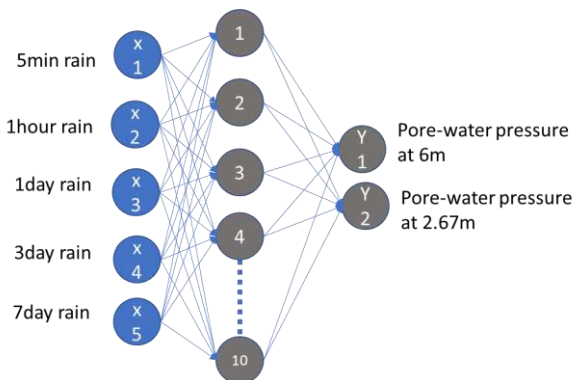
**Figure 21 ANN model architecture used in this study**

The neural network was constructed using the Sequential API, a straightforward way to build a linear stack of layers. This architecture is a type of feedforward neural network, where information flows unidirectionally from the input layer through the hidden layers to the output layer. The model comprises two dense (fully connected) layers. The first dense layer processed the input data using the rectified linear unit (ReLU) activation function. The first layer had 10 nodes, and each node was connected to the 5 input nodes. The second dense layer with a linear activation refined the representation obtained from the previous layer. This layer had 2 nodes, suitable for tasks requiring a 2-dimensional output. The model addresses the varying influences of rainfall on pore-water pressure at different depths by incorporating two separate output nodes for depths of 6 and 2.67 meters. This approach recognizes that the travel distance of the wetting front differs for each depth, impacting the response of pore-water pressure. To accommodate these differences, distinct weight factors and activation functions were utilized for each depth. The choice of ReLU activation in the first layer and a linear activation in the second layer aligned with common practices for regression tasks. The model was configured for training using the Adam optimizer with a custom learning rate of 0.01. The mean squared error loss function was employed for optimization.

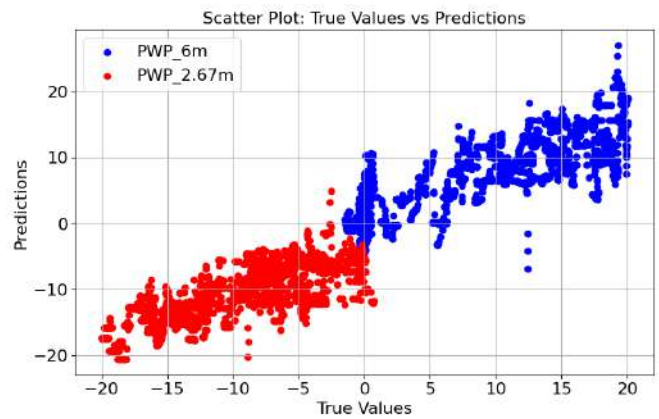
**Figure 22 Comparison between the ML predictions and true values of pore-water pressure (in kPa) from two measurements at depths of 6 and 2.67 m**

The predictive accuracy of the model is visualized in Figure 22. Key evaluation metrics, including the coefficient of determination ( $R^2$ ) and root-mean-squared error (RMSE), were derived as 0.644 and 3.637 kPa, respectively. This level of fitting is deemed satisfactory for an initial phase, laying the foundation for future advancements in Artificial Neural Network (ANN) modeling within the Internet of Things (IoT) framework.
