# Failure of Riverbank Protection Structure and Remedial Approach

**ABSTRACT:** This paper presents the case study of the collapsed riverbank protection structure along the Pasak river in Saraburi province, Thailand. The site investigation and finite element analysis using PLAXIS 2D results show that the failure occurred in sliding mode due to the natural forces. During the rainy season, water flow from the farmlands to the river by crossing the backfill of the retaining wall. Hence, seepage force was developed in the direction of the flow and induced the stability of the riverbank protection. Furthermore, the rivers and streams continuously scour the banks and undermined the natural slope, which caused the soil erosion in passive zone and resulted in instability. Based on these causes of failure, a new reinforced retaining wall structure using bored pile, geocomposite, and riprap at the front of retaining wall to protect the circular failure mechanism, seepage forces, as well as soil erosion and sedimentation, respectively was designed. The finite element verification on the new retaining wall structure showed that this structure had a sufficient factor of safety against the exte

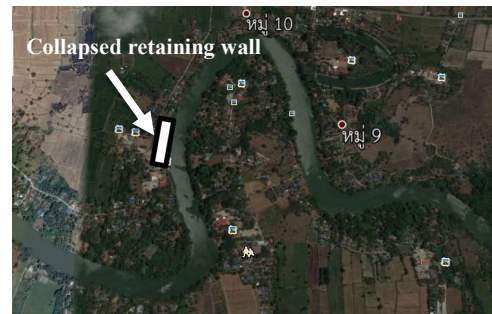
Figure 1 The location of the collapsed retaining wall

The retaining wall construction consists of 400 m long and locates along the Paksak River in Sao Hai District, Saraburi Province. The collapse of 68 m embankment occurred at the curvature of the watershed area, which probably caused by the high flow velocity of the river (See Figure 1).

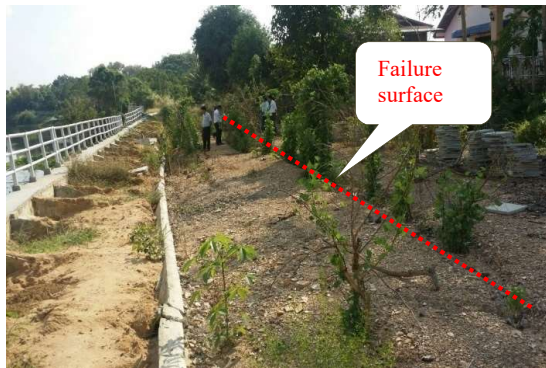
Figure 3 Failure surface in plan (lateral moment)

Figure 3 obtained during the side investigation evidently confirmed that the massive lateral movement of the embankment occurred in the lateral direction and tilted to the riverside. This can be contributed to the extreme lateral force of the embankment, which exceeded the resistance of the retaining wall structure. As a result, the retaining wall was damaged from the reinforced beams as shown in Figure 4.
