# Geo-disasters in Japan in the Context of Climate Change

K. Yasuhara<sup>1</sup>, S. Kawagoe<sup>2</sup> and K. Araki<sup>3</sup>

**ABSTRACT:** Japan is an area affected strongly by land surface upheaval and by climate change instability. Background evidence of increasing and magnifying geo-disasters includes the following: (i) frequent and extremely severe torrential rainfall; (ii) high and increasing frequency of strong earthquakes (5+ and 6- as the Japan Meteorological Agency seismic intensity scale); and (iii) typhoons with magnified damage effects. Based on a review of that information stated above, an attempt has been made to overview the present situation and future trends of geo-disasters in the context of climate change and to present possible adaptive measures against disasters. Particularly, emphasis is assigned to the importance of the combined effects of plural events, which increases the probability of extreme events, sometimes triggering devastating consequences. Adaptive measures against climate change-associated geo-disasters are presented by classification into software and hardware. Special emphasis is devoted to the availability of information and communicati

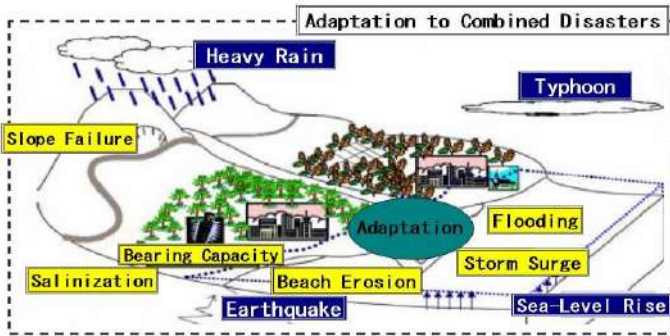
While referring to Figure 1, let us consider the nature of compound disasters. The following should be included: (i) a second disaster occurs immediately after or before a major disaster, generating catastrophic consequences; (ii) damage is compounded through a combination of the disaster with a vulnerable background or human and social situations (see Figure 2); and (iii) the psychological aftermath multiplies the damage. This classification accords well with that proposed by Kokusho (2005).

Figure 1 Examples of compound natural disasters (Yasuhara et al., 2012:2013)

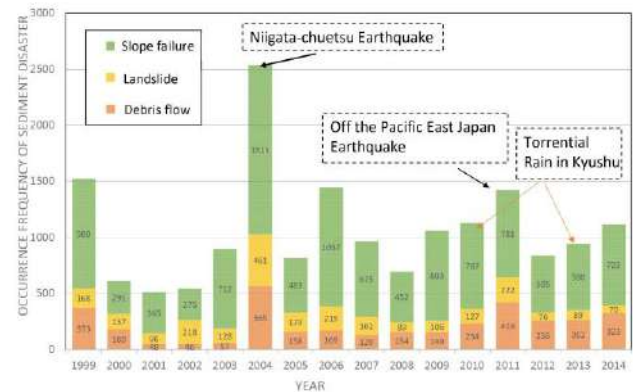
Figure 4 depicts variations of sediment disaster occurrence over time during the 15 years of 1999–2014. Sediment disasters include

slope failure, landslides, and debris flow. The yearly occurrence frequency of torrential rainfall of over 50 mm/yr. is shown for the last 35 years in Figure 5. Both figures show gradually increasing tendencies of both in recent years.

Figure 4 Sediment disasters occurring in various years (JMA, 2014)

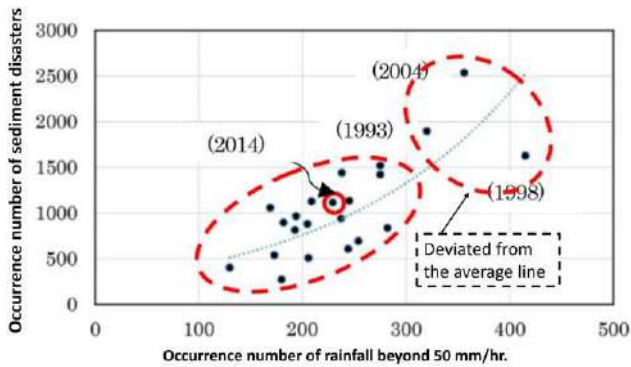
When the results of sediment disasters and torrential rainfalls are compared, we obtain Figure 6, which shows a tendency by which the frequency of sediment disasters increases nonlinearly over time.

Figure 6 Sediment disaster and torrential rainfall frequencies

Comparison of Figures 6 and 8 suggests that the sediment disaster frequency is influenced more strongly by torrential rainfall than by large earthquakes.

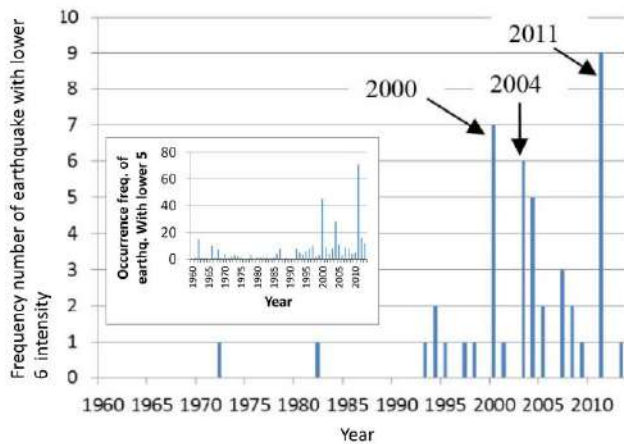
For consideration of whether such a situation as that worst case scenario has actually occurred before, one can investigate the tendencies of large earthquakes over the last few decades. Figure 7 portrays variations of occurrence frequency of earthquakes with an intensity of lower 6 over time from 1960 to the present. All data are those of the Japan Meteorological Agency. Figure 7 clarifies that the frequency of earthquakes with intensity of lower 6 has been increasing over time, particularly since 1995. For that reason, we should take precautions for large earthquakes and heavy rainfalls. Preparation must be made for the worst case in which climate change-induced heavy rainfall and a great earthquake might occur simultaneously or nearly simultaneously, although this worst case might be extremely rare.

Figure 7 Earthquakes with intensity of 6 lower/5 lower over time

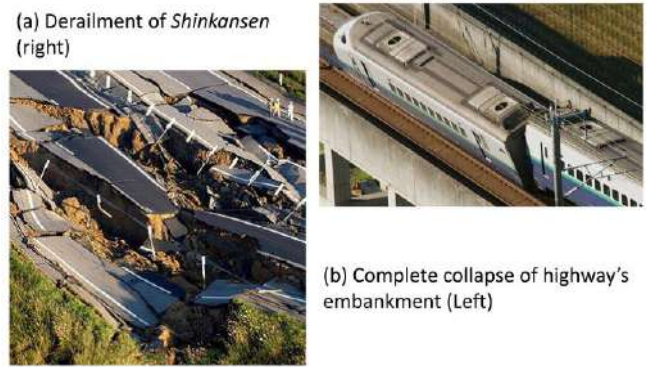
Extensive slope failure damage occurred in Niigata in 2004 because a great earthquake with magnitude 6.8 followed by long-term rainfall of longer than one month is counted as a typical compound geo-disaster. As shown in Photo 1, this disaster induced the collapse of highways and derailment of the *Shinkansen*, its first such accident, completely leading to slope failure at around 4000 locations. Many slope failures are caused mainly by the following:

Photo 1 Damage to a railway and a highway

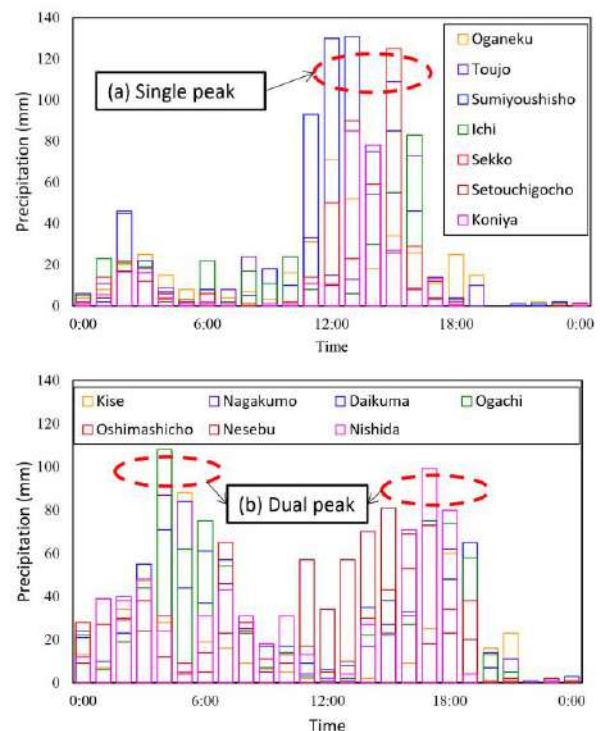
Through analysis of the precipitation characteristics observed in the sediment disasters in Amami Peninsula, Yasufuku et al. (2011) pointed out that the rainfall pattern is divided into single-peak and dual-peak torrential rainfalls. Figure 13 presents an example observed on October 20, 2010 which belongs to the single-peak in Figure 13(a) and the dual-peak in Figure 13(b).

Figure 13 Two-precipitation patterns triggering sediment disasters

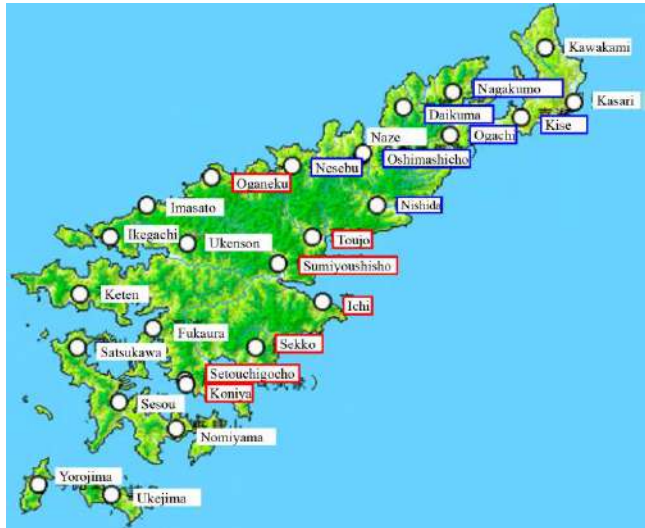
Subsequently, Araki and Ishii (2015) noticed that there was a boundary line that can be used to divide single-peak and the dual-peak patterns, as shown in Figure 14. They also found that cliff failure and debris flows were respectively predominant in the northeast and in the southwest of the peninsula, which implies that precipitation with the single-peak pattern is associated with debris flow and precipitation with the dual-peak pattern is associated with landslides and cliff failure. However, they concluded that this tendency had nothing to do with the geological situation and that sediment disasters occurred only at the surface parts of slopes.

(a) Observation locations and boundary line of rainfall patterns

(b) Sediment disasters and boundary line of rainfall patterns (Kagoshima prefectural government, 2015)

Figure 14 Rainfall pattern and sediment disasters as determined from measurements and investigations.

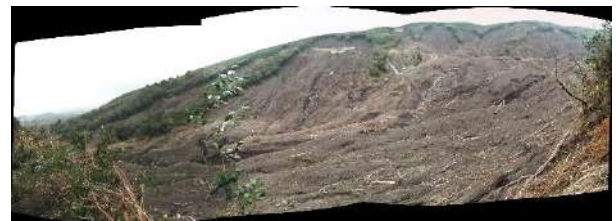
Sediment transportation from debris flow is shown in Photo 2 with slope failure. Slope failures led to debris flow, which is closely correlated to the single-peak precipitation pattern as found for the sediment disaster in the Amami Ohshima. Some similarities are apparent for Amami Ohshima and Izu Ohshima sediment disasters:

Photo 2 Slope failure and damage (November 9, 2013)

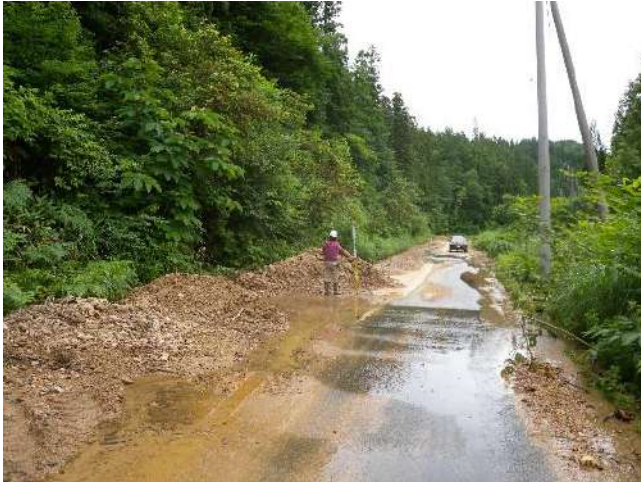
Particularly near the Oizawa Observatory where the largest amount of rainfall (212 mm/day) observed since the start of recorded observations in 1979. Frequent slope failure caused the disruption of roads and subsequently led to the isolation of numerous locations in town and villages, as shown in Photo 3. This was one reason preventing transportation of water resources to residents.

Photo 3 Sediments transported by slope failure

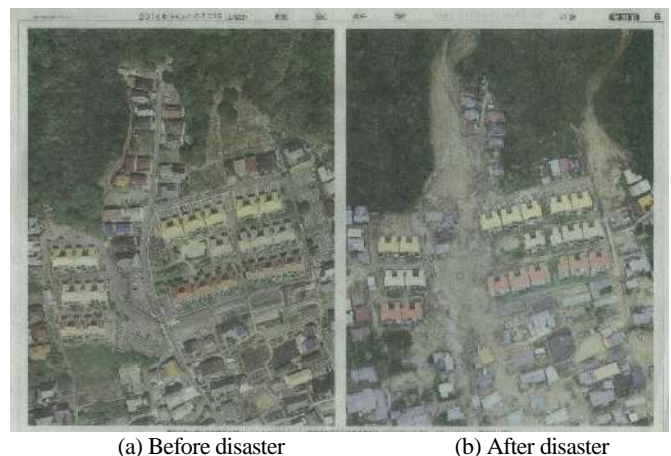
Unexpected and locally torrential rainfall struck the mountainous slopes leading to production of debris flows that severely damaged the residences at the foot of mountains (Figure 18).

Figure 18 Damaged site (Asa-minami district in Hiroshima city (Yomiuri shimbun, 2014))

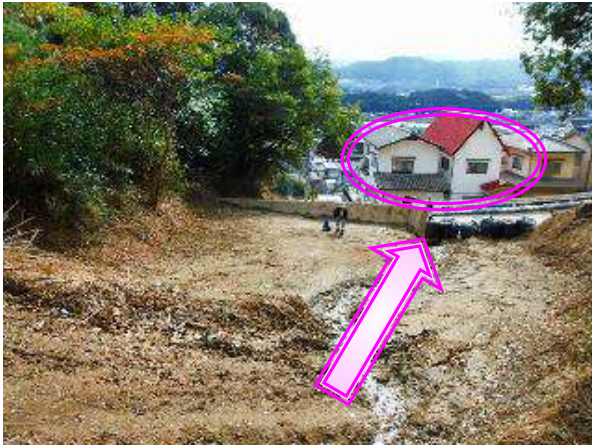
Photo 4 is a scene from the mountain stream outlet to residences in the Asa-minami district, showing that both are very close. This evidence shows that residents have no choice but to live close to the dangerous area for their convenience. A typical scene of damaged residences is shown in Photo 5.

Photo 4 Relation between mountain stream outlet and residences in debris flow in Hiroshima

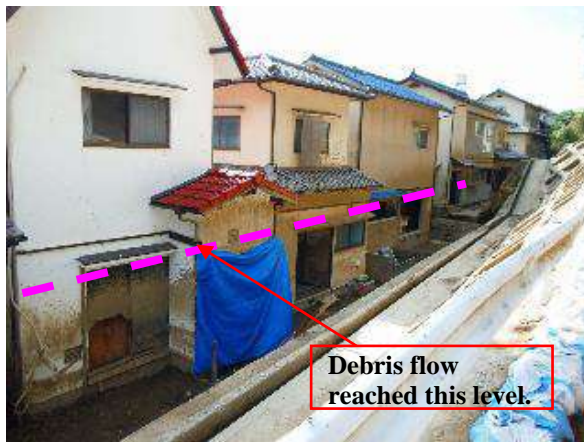
Photo 5 Damaged residences in debris flow in Hiroshima

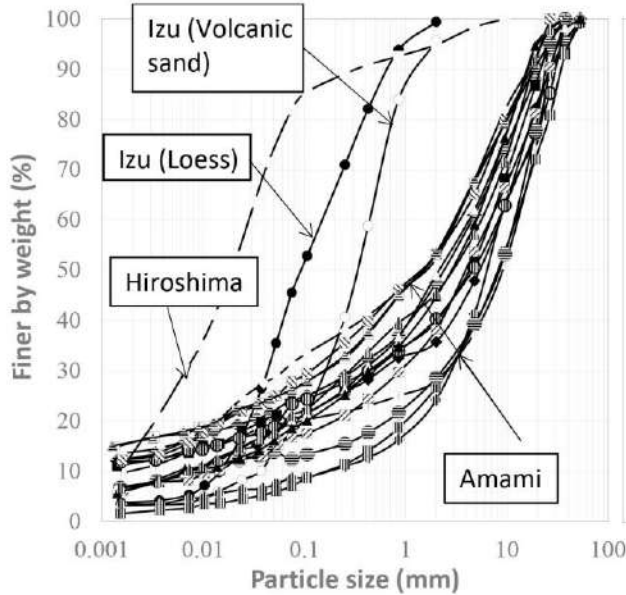
An attempt was made to ascertain whether common fundamental geotechnical characteristics exist among soils related to previously stated geo-disasters. Figure 19 presents a summary of grain size distribution curves of soils from four geo-disasters in Amami (2010) (Kyushu University's Amami Oshima heavy rain disaster survey team, 2011), Izu (2013) (JSCE, JGS, JSEG and JLS (2014)) and Hiroshima (2014) (Araki et al., 2015).

Figure 19 Grain size distribution curves of soils in heavily geo-disaster damaged regions

Soils at Izu and Hiroshima are silt-rich, whereas soils at Amami are sand-rich, which suggests that torrential rainfall induces devastating sediment disasters independently of the soil type on natural slopes.

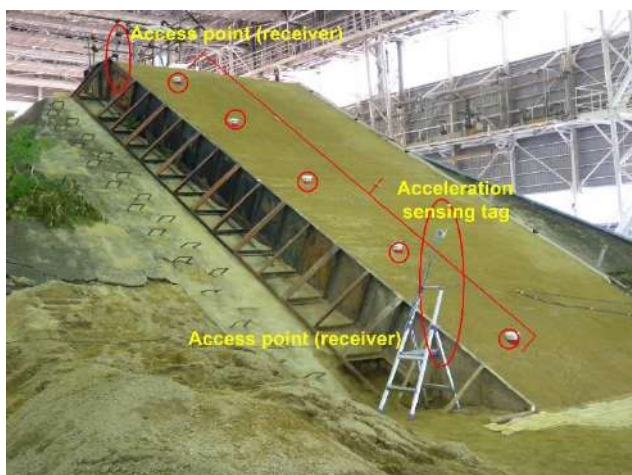
Large-scale model tests for slope failure caused by rainfall were conducted at the National Research Institute for Earth Science and Disaster Prevention (NIED) (Dairaku et al., 2014). Figure 23 shows a slope outline with 30 degrees for a gradient, which consists of masa soil with initial water content of around 7.9%. Masa soils used for the model tests closely resemble soils constituting debris flow that occurred in Hiroshima in August 2014. To ascertain how variation of acceleration in sloping ground with intensity of rainfall is correlated with slope failure, sensing IC-tags called MEMS were installed as shown in Figure 24 together with equipment to measure variations of volume moisture content.

Figure 23 Outline of model tests on slope failure caused by rainfall

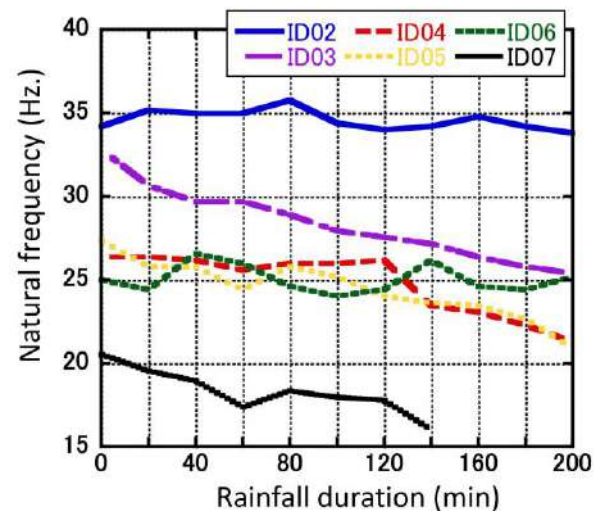
Figure 25 and Figure 26 portray the variations of natural frequency measured from the IC-tags and the variations of volume moisture content with elapsed time starting from falling rain water above from the model testing equipment under the rainfall intensity of 15 mm/hr to 40 mm/hr. Results of both figures show that the predominant frequency decreases concomitantly with increasing volume moisture content in the sloping ground. This tendency suggests that either or both of the parameters should be clues for determination of when we should give alarms to citizens.

Figure 25 Variation of natural frequency with rainfall duration.

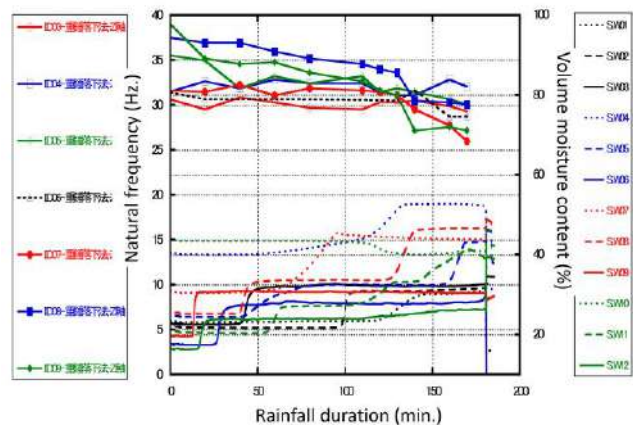
Figure 26 Variation of volume moisture content with rainfall duration.

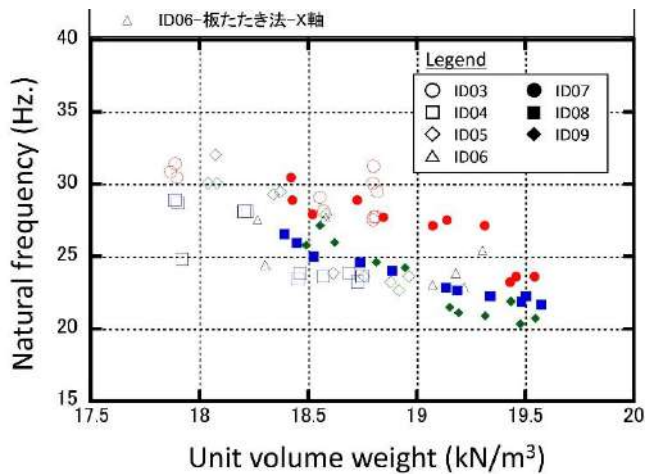
A design chart like that depicted in Figure 27 can assist local governments to establish early warning systems following the instructions. Differences of thresholds of natural frequency or critical volume moisture content in Figure 28 are ascribed to differences of sensitivity to rainfall and water retention depending on the kind of soil: sand, silt, or clay.

Figure 27 Relationship between natural frequency and unit volume weight of soils measured at large-scaled model tests (Dairaku et al., 2014)
