# Performance Monitoring of Bridge Foundations under Multi-hazards

**ABSTRACT:** In an effort to proactively monitoring the safety of bridge foundations so as to probe the possible performance of bridge foundation during natural hazards such as floods, debris flows, rainstorms, and typhoons, an intelligent monitoring system was developed by the authors and had applied to several bridges. In this paper, theoretical background and development will be firstly described. Two case histories will then be presented to describe performance of bridge foundation during natural hazards. Such information will be also further discussed by integrating environment factors such as rainfall amount and flow velocity. Research progress presented in this paper is hoped to be helpful in understanding performance of bridge foundation during hazards so as to provide insights of pre-warning of bridge safety.

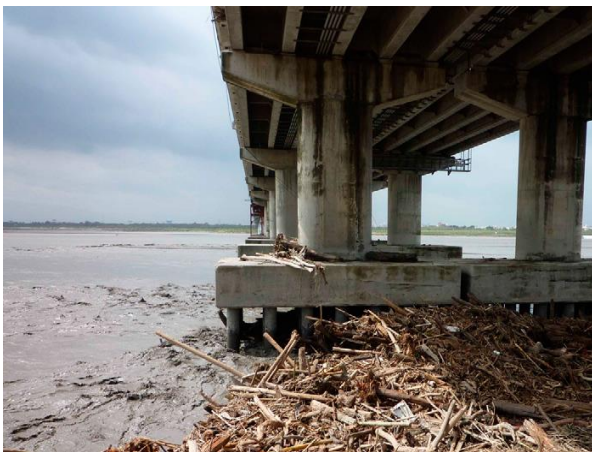
Figure 1 A highway bridge threatened by scour and debris during 2009 Typhoon Morakot (Lee et al, 2010)

Recent climate change had induced large-scale natural hazards such as floods, debris flows, rainstorms, and typhoons, and caused destructive threats to transportation infrastructures. During 2007 to 2010 in Taiwan, there were numbers of highway bridges seriously damaged by such natural hazards resulted in casualties. The most dreadful event was Typhoon Morakot, which had caused failures of total 52 highway bridges (Figure 1). Morakot strolled through Taiwan during the period from August 7th to 9th of 2009. Enormous precipitation was brought into south-western Taiwan by Morakot. Accumulated rainfall exceeded 2500mm over a larger area in southern Taiwan; while the maximum rainfall intensity went beyond 70mm/hr and reached 100mm/hr for the most affected area down south over 24hours period. Forensic investigation on bridge failures concluded that combination of foundation scouring and over scaled flood (debris) force was the major reason causing destructive structure failure of bridges (Lee et al. 2010).

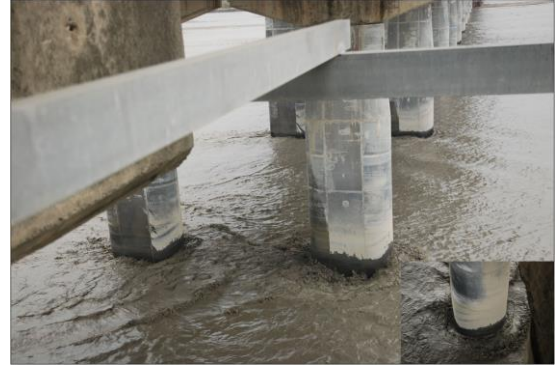
Figure 7 Scour occurring to Pier 42 during Typhoon Morakot

figures, vibration amplitude of Pier 36, which had already suffered from scour, increased as water level rose. Record amplitudes have reasonable good agreement to water level indicating water pressure acting on the scoured bridge foundation. Moreover, as flow volume rate increased to certain threshold values, 2,500m<sup>3</sup>/sec and characteristic frequencies started to descend indicating initiation of scour on Pier 42, even no visual observation is available.

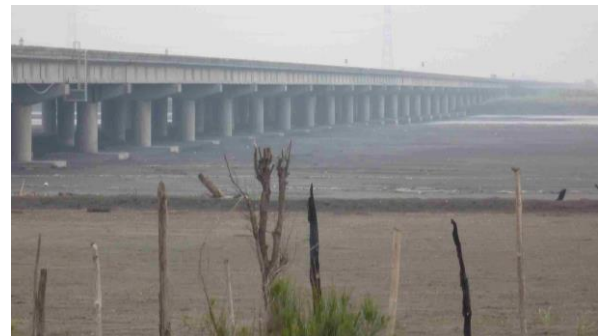
(a) Cross section

(b) Longitudinal section

(c) Xibin Bridge

Figure 12 Structural details and photo of Xibin Bridge

Xibin Bridge is located on Highway 17 crossing Jou Swei River and is the final bridge before the river enters the ocean. The bridge was constructed in 1995. It is a three-span continuous I-girder pre-stressed bridge. Total length of the bridge is 2,730 m across 78 spans (35 m/span). The foundation is composed of pile groups with a total of 20 (5 x 4) pre-stressed piles. Each pile is 33 m long with a diameter of 60 cm. The height of the pile caps is 2 m; the height of the piers is 5 m; and the height of the pier caps is 1.8 m. The total height from the bottom of the pile cap to the top of the pier cap is 8.8 m. Figure 12 shows structural details in schematic drawings and photo of Xibin Bridge.

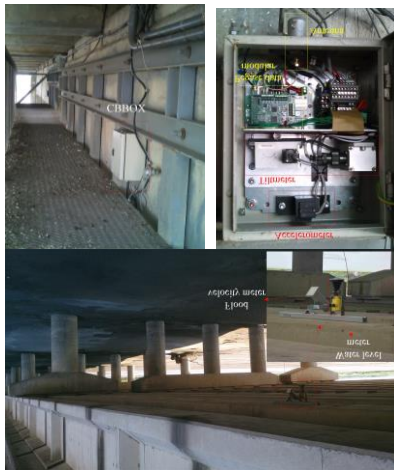
Figure 14 Installation of the intelligent performance monitoring system on Xibin Bridge

installed between Piers 26 and 27. Figure 13 shows the structure of the designed monitoring system. Monitoring data of the systems is firstly collected and analysed within the monitoring boxes located on Piers 21 and 26. A local network was then set up using wifi communication and optical fiber landline for real time display at internet server. Figure 14 shows photos of contents of the monitoring box and installation of system on Xibin Bridge.

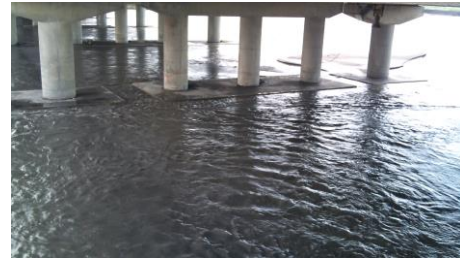
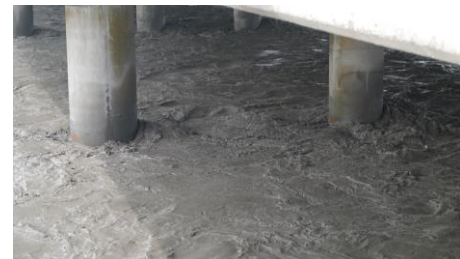
before the event, 2012/6/8

during the event, 2012/6/13

Figure 15 Condition of Xibin Bridge during the reported event

After installation of the developed intelligent performance monitoring system for bridge foundations, there was a heavy rain event during the period of June 9th to 17th 2012, as shown in Figure 15. The developed monitoring system made complete recordings of the acceleration, inclination, water level, flow velocity and scour depth changes during event. Figure 16 shows the relationship between time histories of acceleration amplitude and the water level, flow rate and scour depths recorded at piers P21 and P26. As shown in the figures, water level was increasing constantly to about 4.1m at its highest level, yet flow rate went up and down as a result of combination of river condition and precipitation distribution during the event. Amplitudes of accelerations of Piers 21 and 26 did not just agree to measurements of water level and flow rate in certain aspects, but also gave clear indications of appearances of scours, prior to measurements of scour indicators. The response amplitudes of acceleration of both Piers 21 and 26 increased as water level and flow rate increased combining appearance of scours; they decreased as water level and flow rate descended back to normal flow condition
