Geotechnical Measures for Uttarakhand Flash Flood-2013, India

ABSTRACT: Many “Run of the River” projects in the North West part of Himalaya have been frequented by “Cloud Burst” induced flash flood in since 2009, which is primarily attributed to climate variability and land use pattern changes due to unregulated developmental perspectives against the rising demand of tourist related establishments. Given the ageing population of vulnerable constructions along the hilly terrains, safety issues require more attention in the form of technical auditing cum inspections, routine monitoring, emergency drills, surveillance systems, and regularly updated emergency action plans. Added to this accelerated events of “cloud burst” induced flash flood in the hilly region has opened up Dam safety issues, which are rather debated in the court of law for which geo-professional intervention are to be looked into. This paper explains the climatic and other geo-morphological changes that might have caused Uttarakhand Flash Flood-2013. Damages to the geotechnical structures in the form of excessive erosion, landslides, siltation of catchment area of several Dams in Uttarakhand state of India are descr

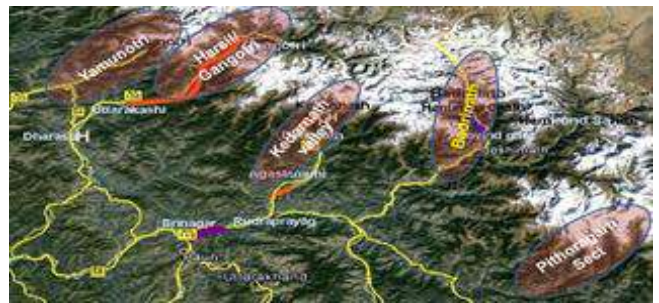
Figure 1 Flash flood induced damages in Uttarakhand where massive reconstruction work is under way

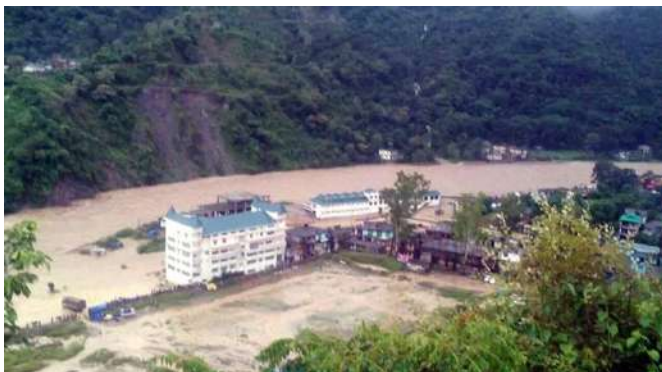
Figure 2 Flooded Dharampur market and bus station after a cloudburst in Mandi district, Himachal Pradesh in August 2015 (Photo: The Indian Express)

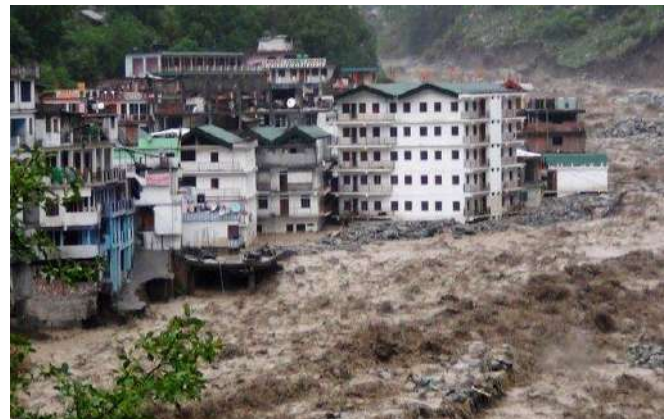
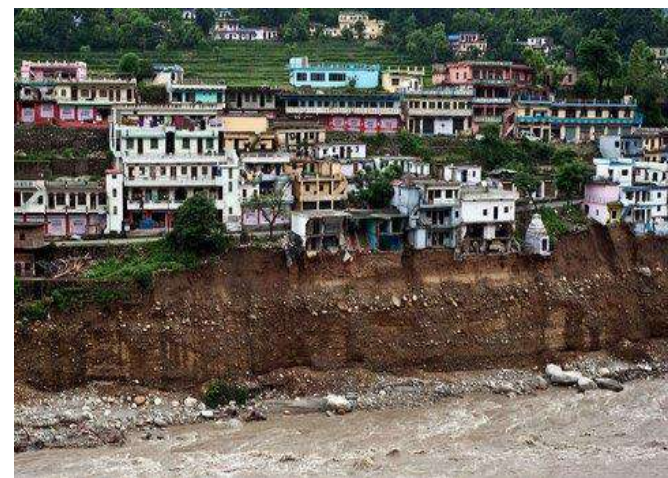
Figure 3 Human settlements affected by flash flood in state of Uttarakhand in June 2013, (a) Destruction of tourism infrastructure built over river bed (b) Buildings in steep hill slope in danger due to flash flood induced river bank erosion

The damage potential of flash floods is confined to the direct neighbourhood of the river (Figure 3), where the total damage usually is not very extensive in spite of the high flow velocity. The individual damage to structures or persons in such floods is very high. In recent times, flash floods have caused large losses of life only of people unfamiliar with the potential hazard, such as tourists, who camp in the mountain canyons. In some areas, flash floods can be avoided to some extent by flood control reservoirs (Plate, 2002).

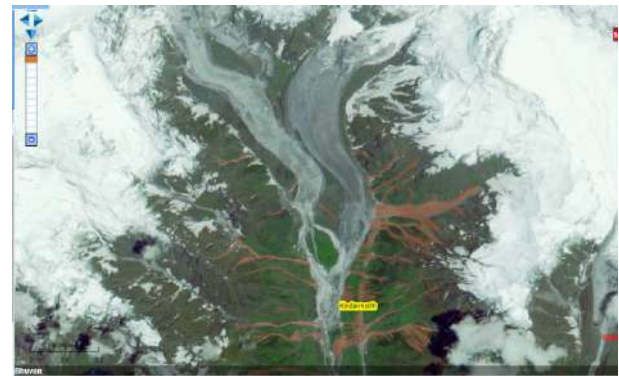
(b)

Figure 5 Geo-spatial view of Flash flood area and its vulnerable surroundings before the flash flood of June 17, 2013 (ISRO, “Bhuvan” image)

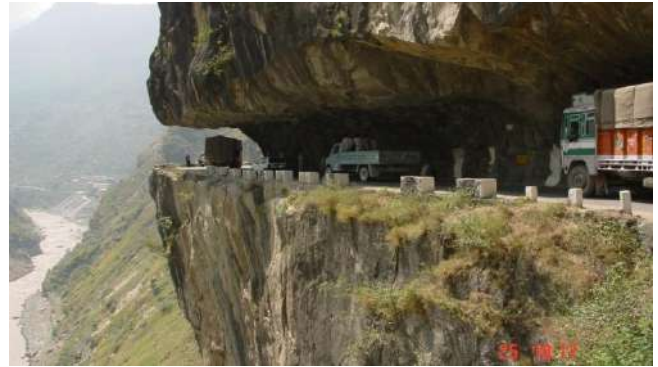
Figure 8 Road construction on rocky mountain in Himachal Pradesh, India remain undisturbed till stability of the rocks are tested by earthquakes and other hazards in the vicinity

While in the neighboring state of Himachal Pradesh in India, Himalaya, taking advantage of the hard rocky strata, roads infrastructure created decades ago (Figure 8) have been functioning well, the long term performance of these roads requires continuous monitoring. Geotechnical intervention in such road networks are minimal and hence in the reconstruction phase of the post-flash flood due importance are to be accounted for.

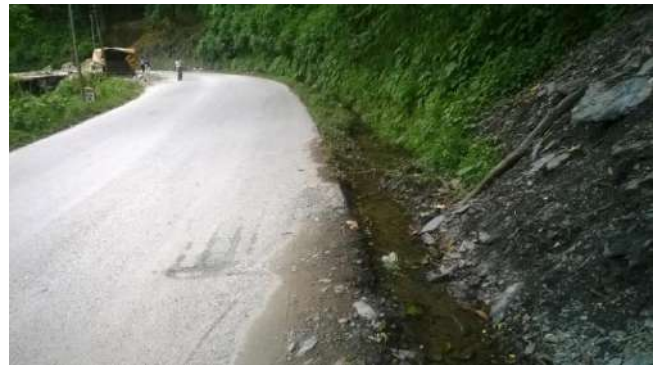
Figure 9 Incipient cross drainage due to heavy rain fall during Uttarakhand flash flood (2013) and suggested simple correction measures by inclined drain. Inset image showing application site of the same

Figure 9a shows one of the many roads in the hilly areas that goes out of order due to poor drainage resulting that they require proper geotechnical measures. In many cases such problems, can be mitigated by providing perforated drains as shown in Fig. 9b and the drained water can be tapped for other uses (inset Figure 9b).

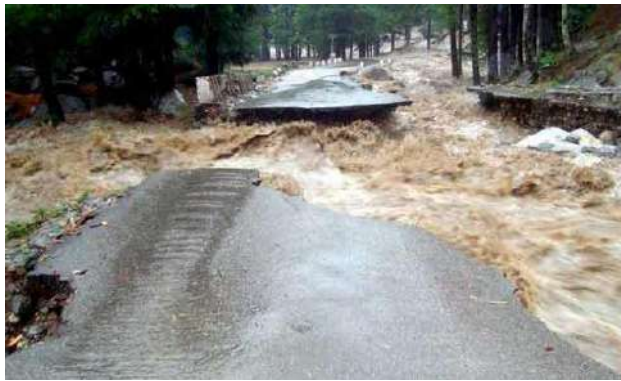
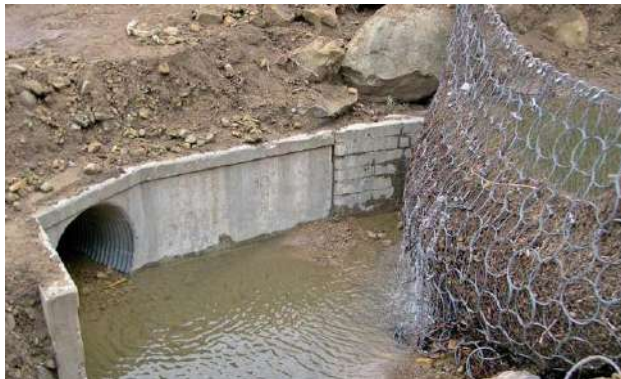
Figure 10 Torrential water flow severed the road link thus disrupting the communication. Lots of debris and muck formed out of flash flood might have caused such problems, for which adequate culvert or aqueduct were not in place. Suggested restoration measures with Geo-net protecting the culvert

Figure 10a shows the disruption of the roads in Uttarakhand and defying the role of proper placement as well as proper maintenance of cross drainage. As a recovery measure for such situation, Figure 10b, shows one of the ways to look into such problems.

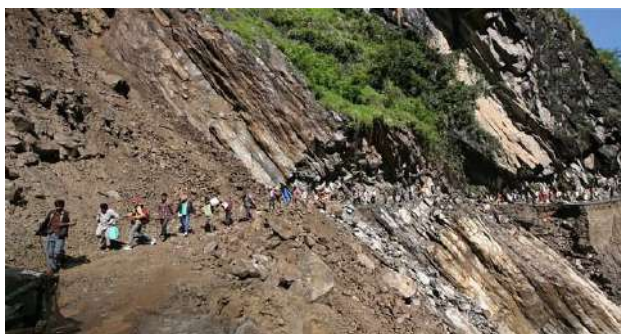
Figure 11 (a) Typical facets of fragile slope in Uttarakhand state and multi-purpose and (b) multi-objective of typical slope stabilization in Japan (Source: Ministry of Land, Infrastructure, Transport)

Figure 11a, shows one of the severe landslides in Uttarakhand state that remained unsolved by simple measures of slope protection, e.g. retaining walls, gabion mat, soil nailing, etc. The reality mitigating such slopes by multi agency and multi-objective control measures is shown in the Figure 11b.

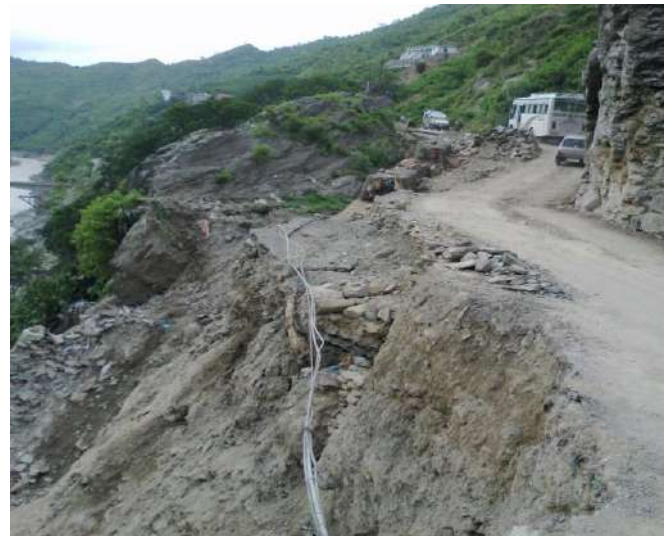
Figure 12 Conventional method of Stone masonry wall (a) vs. Soil nailing (b) that typically used for stabilizing slopes

Use of rubble masonry is a routine practice in the hill roads (Figure 12a) and vulnerability of such type of protection measures especially during heavy rainfall requires no special mention. However, typical soil nailing option as shown in Figure 12b or for some of the ongoing National Highways construction in the neighbouring state of Himachal Pradesh, where massive rubble masonry wall constructions are followed (Figure 13a), application of nailing technique followed elsewhere (Fig. 13b), can be adopted for the reconstruction hill slopes ravaged the flash flood in Uttarakhand. In Figure 14a, slope protection measures taken as such can be made performing better during heavy rain fall by application of geonet or geogrid as typically shown in Figure 14b. Even in some of the convention rubble masonry slope protection walls as shown in Figure 15, the inclination of the weep hole pipes, go out of order due to poor maintenance. In such cases composite geosynthetic layers can be used to keep drainage operational during extreme weather events.

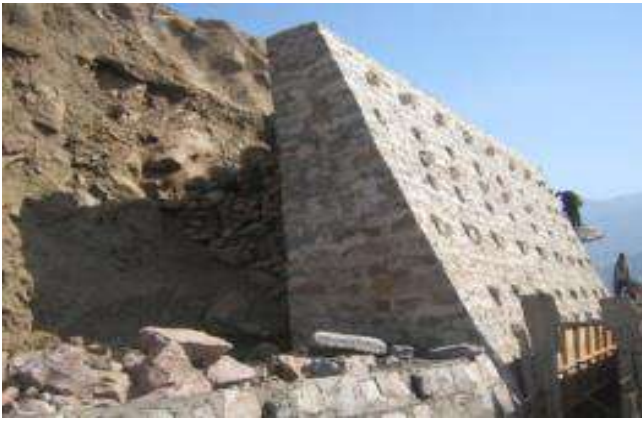
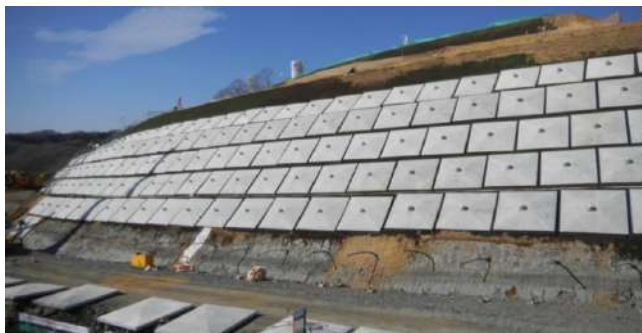
Figure 13 Typical road side hill slope protection measure in hilly areas vs. Nailed slope in Japan

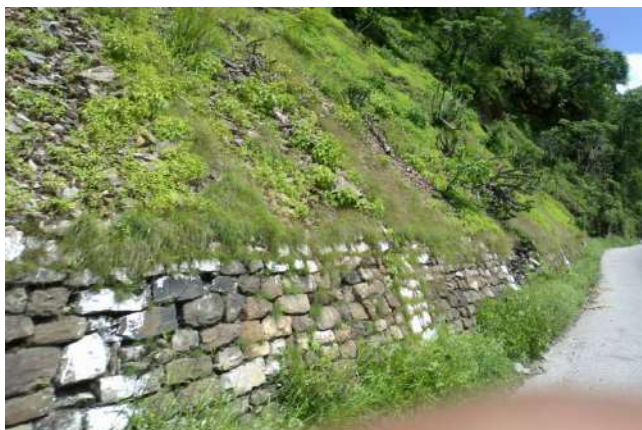
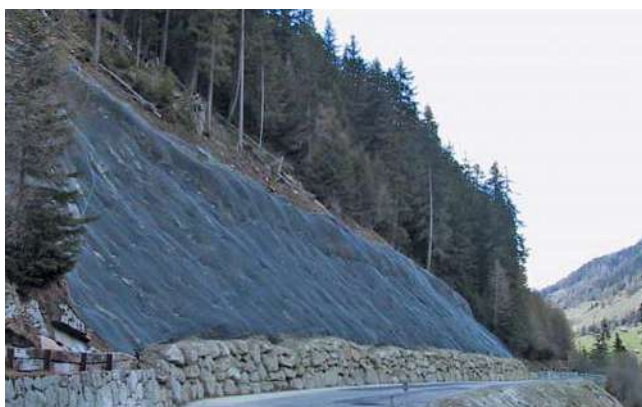
Figure 14 Unprotected slope vs. Protection by geo-net

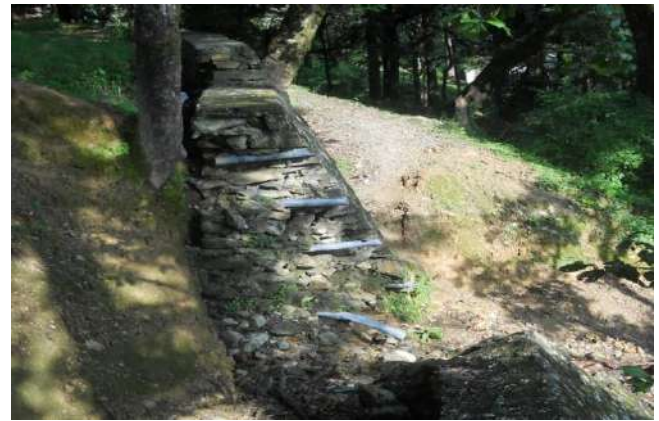
Figure 15 Provision of weepholes in normal construction and ill performance due to poor maintenance

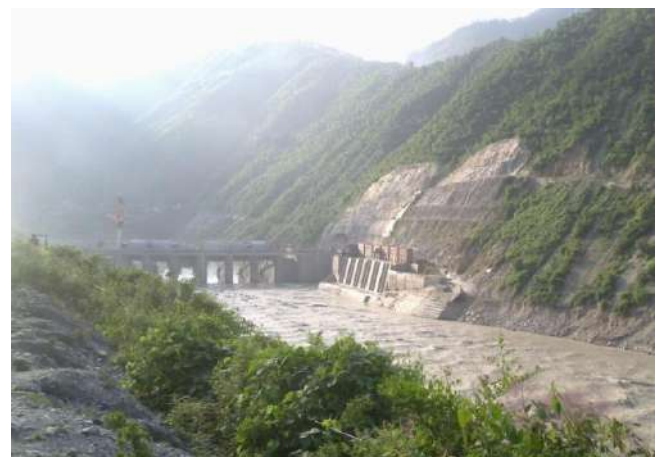
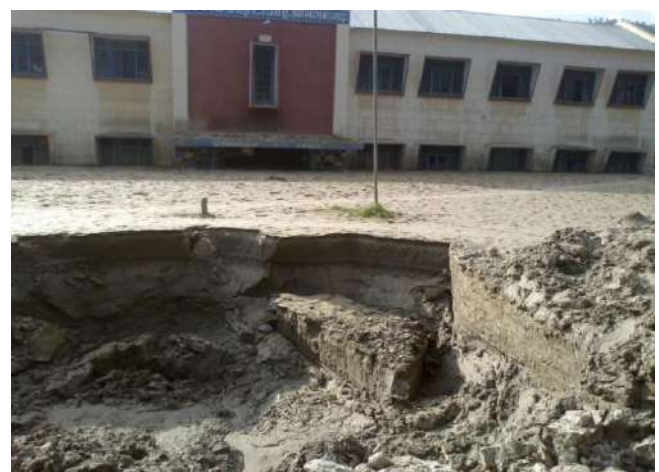
Figure 16 Silt deposit at Srinagar, Uttarakhand due to water release by the Dam

Many Dams during flash flood, went out of order due to excessive erosion and water currents. The documentation of the damages and loss has not been done yet but in the case of one Dam, which was newly built and yet to start operation (Figure 16a) at the Srinagar town of Uttarakhand, it has removed the silts deposit about 200m away downstream due to release of water through sluice gate and thus filled up valley town with 2 to 5m thick silt load as shown in Figure 16b. As many of the existing building in the Srinagar town, came under silt, during reconstruction densification of the same can be achieved by geosynthetic vertical drains.

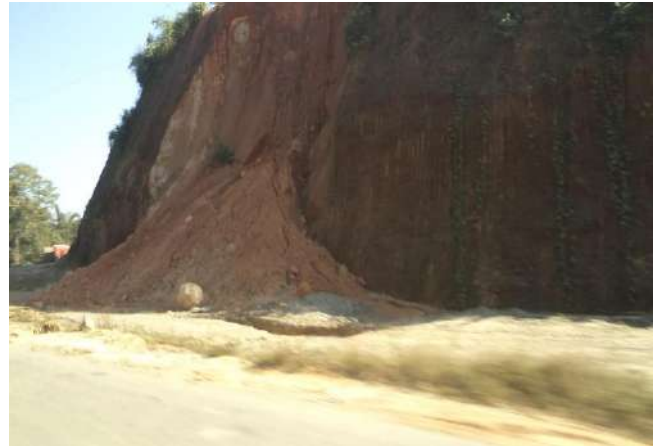
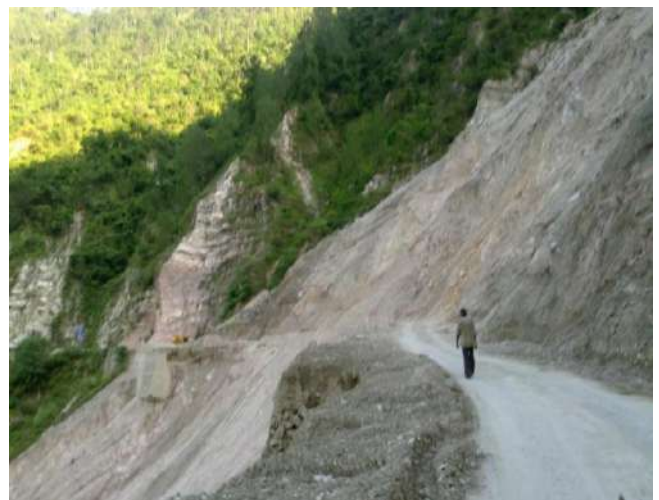
Figure 17 Stabilisation measures for natural and man-made cut slope in hill areas in Uttarakhand await geotechnical intervention

Typical man-made slope instability problems created during hill road widening process, for which conventional solution is not either possible or economically feasible (Figures 17a and b) can be stabilized by combination of small height breast wall and Vetiver plantation as shown in Figure 18 a and b.

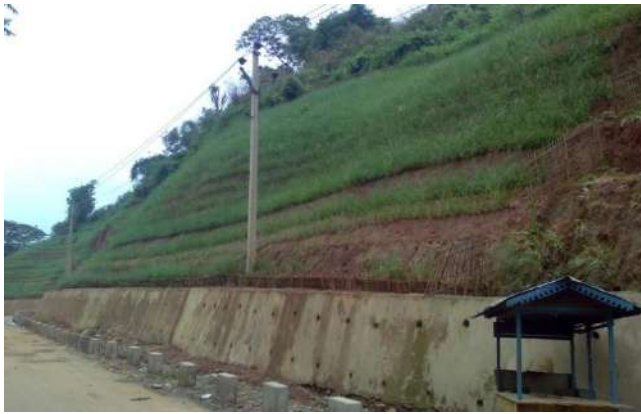
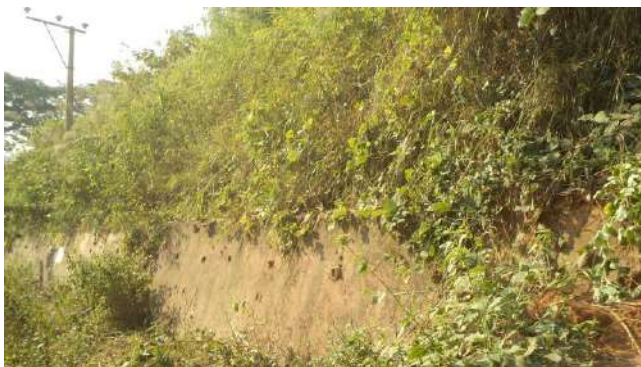
Figure 18 Typical application of Vetiver grass in the State of Assam, India as a viable cost effective alternative for slope stabilization

The feasibility planting vetiver grass even in the 90° angle hill cut is possible and the stability of such slopes are exemplified. In order to propagate this technique, a good deal studies, specially suitability of the Vetiver grass at different geo-climatic conditions are to yet to catch the Geo-professional domain studies and rightful practices to solve many unsolvable slope stability problems by conventional methods. But the wide scale erosion due to flash flood in Uttarakhand (Figure 19a) and potential danger awaiting for the India's highest Dam constructed decades back in the same state (Figure 19b), where hydroelectric power generation is often limited by the fast drawdown induced erosion are yet to be tackled by the current geotechnical practices in the country.

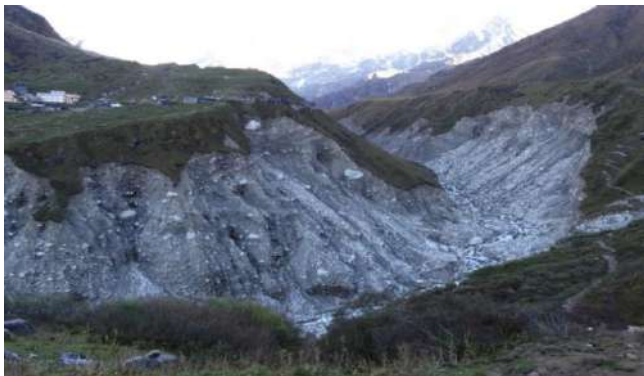
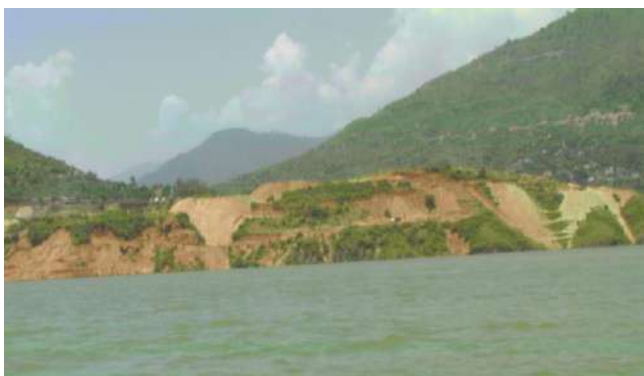
Figure 19 Some of the unsolved slope and erosion areas in Uttarakhand (a) along the Mandakini river and (b) Tehri Dam reservoir
