# Challenges in Improving Slope Safety in Hong Kong through the Landslip Prevention and Mitigation Programme

Ken K.S. Ho<sup>1</sup> and Raymond W.M. Cheung<sup>2</sup>

<sup>1,2</sup>*Geotechnical Engineering Office, Civil Engineering and Development Department,  
Hong Kong SAR Government, Hong Kong*

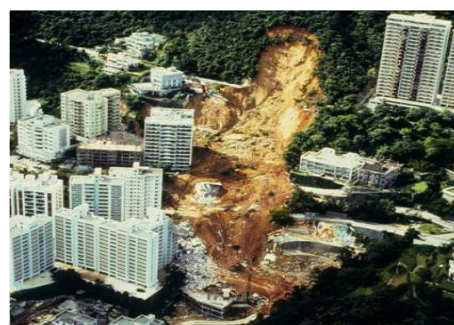
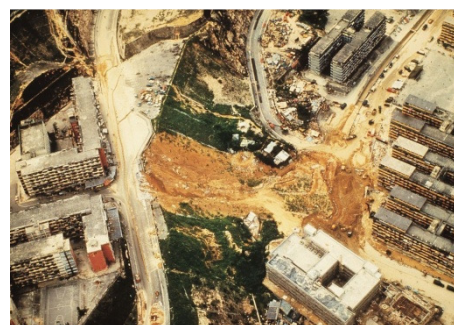
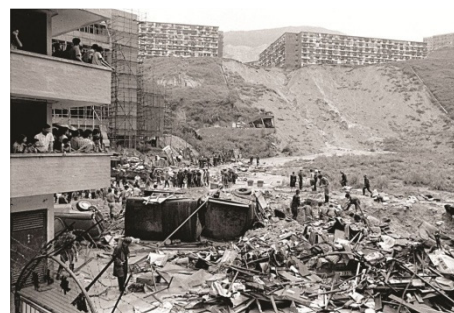
(a) 1972 Po Shan landslide

(b) 1972 Sau Mau Ping landslide

(c) 1976 Sau Mau Ping landslide

Figure 1 The fatal landslides at Po Shan Road and Sau Mau Ping in the 1970s

Some notable landslide incidents with multiple fatalities include the 1972 Po Shan landslide, and the 1972 and 1976 Sau Mau Ping fill slope failures (Figure 1). These landslide disasters culminated in the setting up of the Geotechnical Engineering Office (GEO) (formerly known as the Geotechnical Control Office) in 1977 as a central body to regulate various aspects of slope safety in Hong Kong. Although serious landslides still occur from time to time, the scale and severity of the landslide problem have been reduced considerably as a result of the implementation of a comprehensive slope safety system to manage landslide risk.

Because of the two fatal landslides involving static liquefaction of loose fill at Sau Mau Ping in 1972 and 1976, most of the slopes included in the LPM Programme during the early years of its implementation were fill slopes affecting housing estates, schools and hospitals. Substandard fill slopes were retrofitted primarily by recompacting the top 3m of the fill bodies. Other techniques such as dynamic compaction and installation of sand compaction piles had also been experimented to identify other means of expediting the treatment of loose fill slopes (Lam, 1980) but the trials did not fruitful.

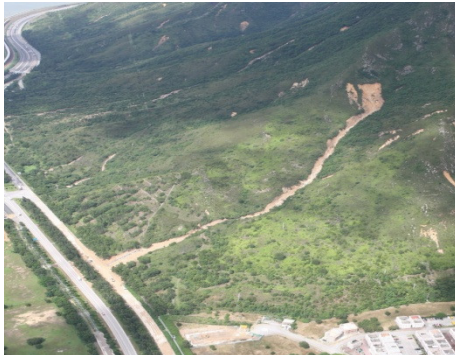
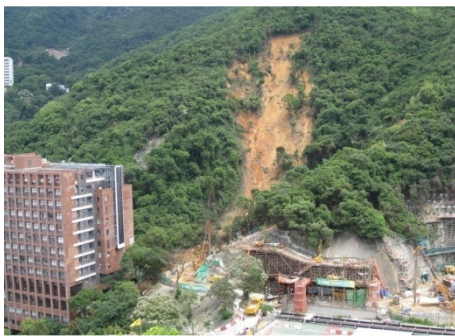
(a) 2008 landslide at Yu Tung Road, Lantau

(b) 2008 landslide at the University of Hong Kong

Figure 2 Some natural terrain landslides during the severe rainstorm on 7 June 2008

However, the natural terrain landslides triggered by the 7 June 2008 rainstorm have provided plenty of additional information and data on debris movement. Back-analysis of selected channelized debris flows triggered by the 7 June 2008 rainstorm carried out by GEO showed that about 1% of the channelized debris flows were more mobile than that predicted using the Voellmy parameters recommended by Ayotte & Hungr (op. cit.). Based on the findings of back analyses, supplementary guidelines on the assessment of mobility of channelized debris flows are promulgated by GEO (2011a, 2013b).

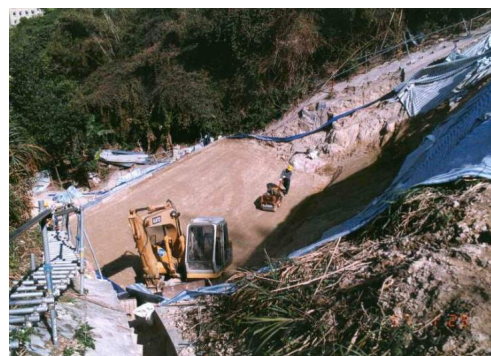
Figure 4 Re-compaction of existing fill

Many of the old fill slopes, typically comprising loosely dumped or end-tipped fill materials without compaction, are susceptible to liquefaction when they become saturated and subjected to shearing. The conventional method of treating these existing fill slopes is to excavate and re-compact the top 3 m of loose fill to a dry density of not less than 95% of maximum dry density. This is based on the recommendations made by the Independent Review Panel for fill slopes (HKG, 1977). Most of the fill slopes under LPM Programme were upgraded by means of this method because of its effectiveness and reliable performance (Figure 4). Other techniques that have been used in some cases include construction of a bored pile wall at slope crest, placement of compacted fill on the existing slope surface, removal of loose fill in conjunction with a crest retaining wall, mini-piles, dynamic compaction, grouting, etc.

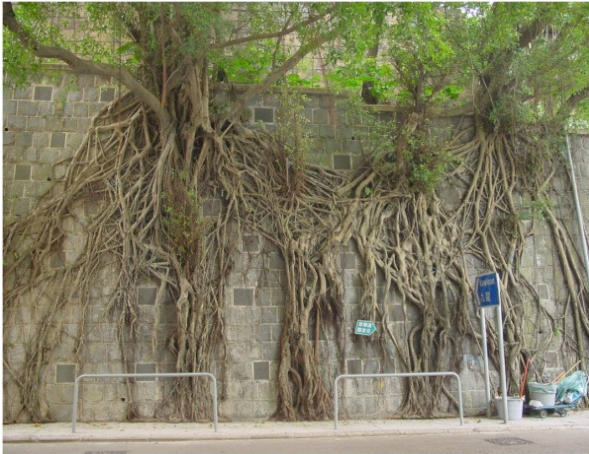
Figure 6 Upgrading of an old masonry wall by soil nails

A special feature found on many old masonry walls in Hong Kong is the presence of "wall trees", which refer to trees (mostly Chinese Banyan) growing from the open joints or crevices between stone blocks. These "wall trees" constitute an important landscape element in the community and should be preserved where at all possible in view of their special amenity value. A study on masonry walls with trees was carried out by Wong & Jim (2011). The study concluded that the roots of wall trees would not induce failure of masonry walls. They would occasionally cause displacement of masonry blocks at the wall crest but the roots would also strengthen the wall face by providing a form of mesh reinforcement. However, wall trees would affect the stability of masonry walls due to its surcharge effect and this should be considered in the stability assessment. The study also identified suitable methods of stabilizing old masonry walls. One of the methods is to use soil nailing, which has the benefit of preserving both the existing wall trees and the original masonry façade (Figure 6). Other methods include the provision of conventional buttresses or flying buttresses in front of the masonry wall, and the construction of hand-dug caissons behind the wall.

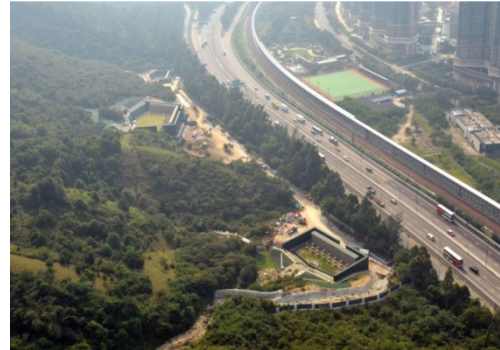
Figure 7 Concrete barriers at the toe of a natural hillside

In most cases, it is impractical and environmentally undesirable to carry out extensive stabilization works at the natural hillside. Instead, defense measures are constructed to contain the landslide debris from the natural hillside above. For example, concrete barriers may be constructed at the toe of the natural hillsides (Figure 7). In order to enhance the design of rigid barriers, a study is being carried out to identify suitable cushioning materials that could reduce the impact load from bouldery debris on the barrier. Large-scale physical impact tests on different potential cushioning materials such as cellular glass, plastic fender and dry sand are being carried out (Figure 8).

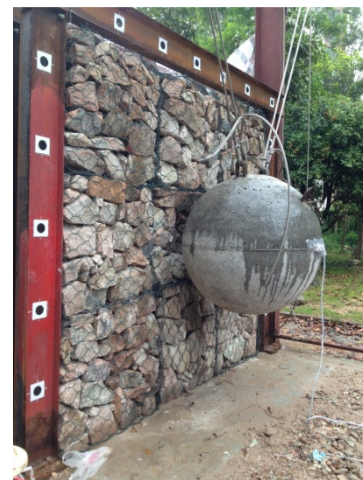
Figure 8 A large-scale physical impact test on a concrete barrier with a gabion cushioning layer

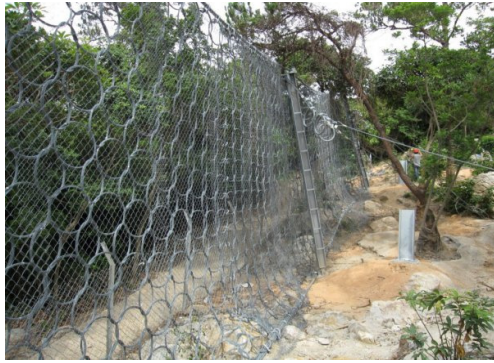
(a) Flexible barrier at the toe of a natural hillside

(b) Dynamic numerical model for a flexible barrier

Figure 9 Flexible debris-resisting barrier

Flexible barriers, which are mainly formed of steel ring nets mounted between horizontal steel ropes spanning between steel posts and anchored into the ground, are one of the techniques that can be used to mitigate natural terrain landslides (Figure 9a). The advantages of flexible barriers are that they are relatively easy to

The design methodology for flexible rock fall barriers is based on energy approach whereby a falling rock or boulder is stopped in one go by the barrier designed to absorb the kinetic energy of the rock or boulder. The design usually entails the use of proprietary flexible barrier systems with specific energy absorbing capacities that are verified by means of full scale field testing in accordance with the relevant national or international standards. The technology involved is relatively mature. In contrast to rock fall, the impact of landslide debris hitting a flexible barrier is delivered in the form of consecutive pulses due to the compressibility and mobility of the debris. Therefore, the design methodology for rock fall barrier is not applicable to the design of flexible barrier as a debris resisting structure. So far, there are no national or international standards for the design of flexible debris-resisting barriers. Suggestions on the design approaches for flexible debris-resisting barriers were made by Kwan & Cheung (2012) based on a review of the present state of knowledge, which would serve as a useful reference for practitioners. Figure 9b shows the establishment of a numerical model for a flexible debris-resisting barrier using a commercial software LS-DYNA in conjunction with the suggested "force approach" for design. As part of the development work, an empirical design methodology of flexible barriers for open hillside landslides has been developed based on a review of the energy capacity of barriers and a probabilistic consideration of the scale and mobility of landslide based on past failure cases in the landslide inventory (GEO, 2013c).

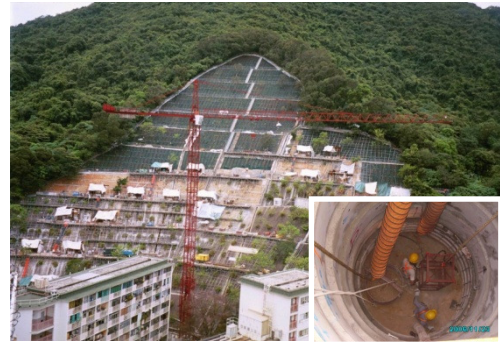
(a) Construction of hand-dug caissons at Sai Wan Estate, Hong Kong

(b) Construction of two drainage tunnels at Po Shan natural hillside, Hong Kong

Figure 10 Innovative slope stabilization schemes

For some sizeable slopes, innovative slope stabilization schemes have been adopted instead of the conventional stabilization measures. For example, 2.5m/3.0m diameter hand-dug caissons have been constructed at a 100 m high man-made slope at Sai Wan Estate as the slope stabilization measure (Figure 10a). Another example is the Po Shan natural terrain where two 3.5 m diameter drainage tunnels were constructed to provide a robust groundwater control system (Figure 10b).

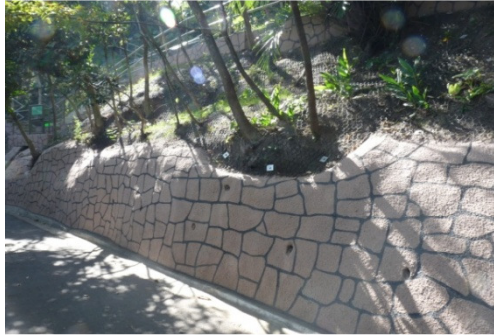
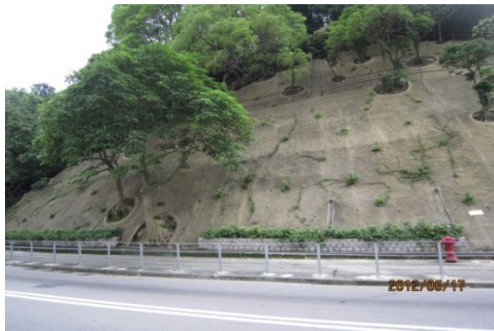
(a) Masonry-like finish on hard slope cover

(b) Provision of planter holes and toe planter

(c) Provision of propriety greening product on hard slope cover

Figure 12 Landscaping to man-made slopes with hard cover

It is Government policy to make slopes look as natural as possible, blending them with their surroundings and minimizing their visual impact on the built environment. To implement this policy, vegetation is used as slope surface cover in the upgrading of existing man-made slopes which are not steeper than 55° (Figure 11). A hard surface cover such as chunam or shotcrete may be used for steeper slopes, but suitable landscape measures such as applying subdued colour, masonry facing, providing planter holes and proprietary greening product on the slope surface for screen planting are adopted to minimize visual impact (Figure 12).

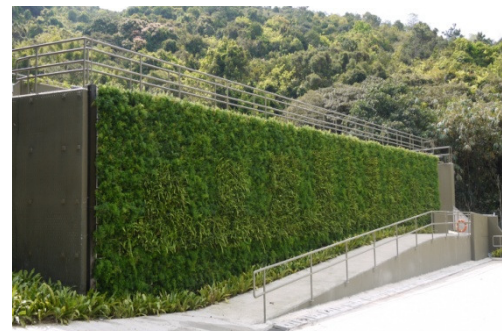
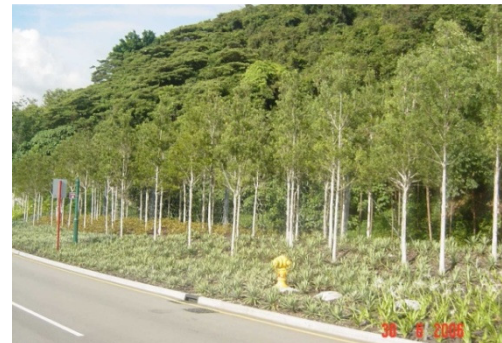
(a) Vertical greening on a concrete barrier

(b) Screening planting in front of a flexible barrier

Figure 13 Landscaping to natural terrain mitigation measures

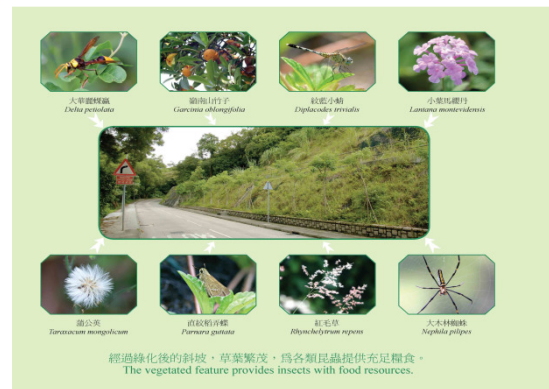
Figure 14 Successful example of landscaping the slopes along South Lantau Road and enhancing the biodiversity

Apart from slope appearance, the GEO is also mindful of the potential ecological impact of slope works. Special efforts are expended to achieve ecological enhancement of slope works by using native species. A good example is the adoption of ecological planting in upgrading 24 man-made slopes along South Lantau Road between 2001 and 2004 (Figure 14). Native species, either planted alone or mixed with exotic species, would attract local wildlife including birds and insects which may act as seed dispersers to enrich the plant biodiversity. A biodiversified vegetation cover is ecologically stable and hence more sustainable in the long run. Good practice on ecological planting for man-made slopes and engineering works for natural terrains with the use of native species is promulgated in GEO Publication No. 1/2011.
