Characteristics and Consequence of Nepal Earthquake 2015: A Review

A S M Fahad Hossain¹, Tuk Lal Adhikari², Mehedi Ahmed Ansary³ and Quazi Hamidul Bari⁴

ABSTRACT: An earthquake is a natural disaster that comes in different parts of the earth every year. Most of them are very weak and unnoticeable. But some of them are too severe to cause a great loss of lives and destruction of properties. A major earthquake happened in Nepal on 25th April 2015. More than 8,000 people died and more than 19,000 people got wounded in this earthquake. People of Nepal had anticipated but never experienced such a devastating earthquake. This paper deals with the Gorkha earthquake in Nepal, its causes and characteristics, previous earthquake history of Nepal, consequences etc.

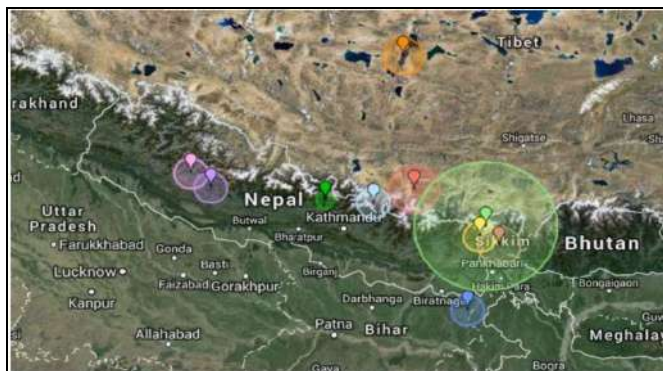
Figure 5 Recent earthquakes near Kathmandu city (Samyog Shrestha)

Nepal and particularly Kathmandu valley are seismically vulnerable, however study of the seismic hazard potential of the valley has not been performed systematically. The map in Figure 5 shows epicenters of earthquakes since 1990 ($M_L > 4.0$) within the collision zone. Note the belt of earthquakes along and south of the Himalaya mountains sweeping through Nepal (yellow outline). Four earthquakes with $M_L > 6.0$ have occurred within 250 km of the April 25 Gorkha earthquake over the past century. The largest ones included a M_w 6.9 in August 1988 and a M_w 8.0 in 1934 which severely damaged Kathmandu. The 1934 earthquake is thought to have caused around 10,600 fatalities. Kathmandu city has been subjected to frequent earthquakes of moderate intensities and about once in a century to disastrous earthquake of higher magnitude. Earthquake was first recorded in Nepal on June 7th, 1255 AD. In that earthquake, one third of the total population in Kathmandu was killed by a 7.7 Richter scale. Recent earthquakes near Kathmandu city are shown in Figure 5. Table 1 shows information of some historical earthquake in and around Nepal.

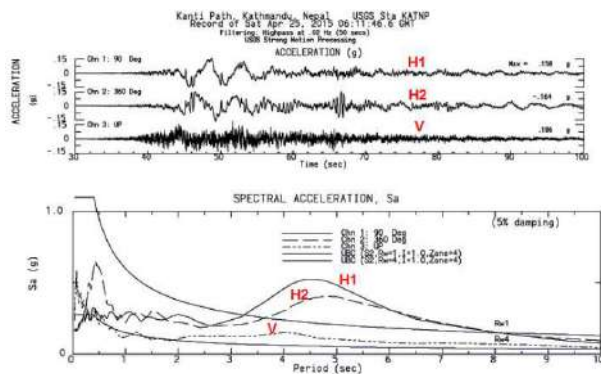
The peak ground accelerations recorded at Kantipath, Kathmandu by USGS KATNP station is presented in Figure 7. The corresponding spectral acceleration shows interesting feature of peaking between 3 to 7 seconds.

Figure 7 Peak Ground Acceleration and Corresponding Spectral Acceleration of Main Shock of Gorkha Earthquake (USGS KATNP)

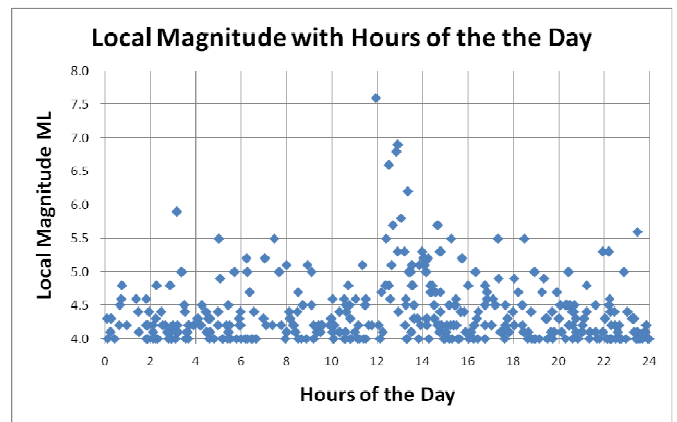
Another interesting feature of Gorkha earthquake and its sequence of aftershocks was that most of the strong quakes above ML 6.0 had occurred within two hours after midday as shown in Figure 14. Similar trend was observed in Great Japan earthquake earlier. More researches are to be made to explain the reason for this behavior.

Figure 14 Recorded Aftershocks with Hours of the Day

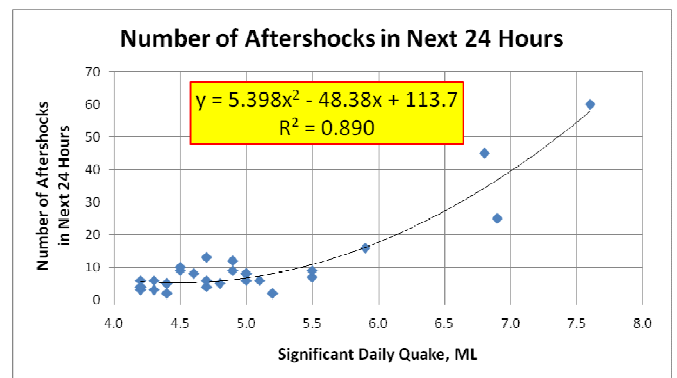
Another observation on number of aftershocks during next 24 hours experienced in Gorkha earthquake is shown in Figure 15. If a significant aftershock (largest during the last 24 hours) is encountered, the number of aftershocks of smaller magnitude during the next 24 hours can be very well estimated using this figure with 89% correlation. This predictive model was found highly useful for the public information during three months of Gorkha earthquake.

Figure 15 Number of Aftershocks in Next 24 Hour

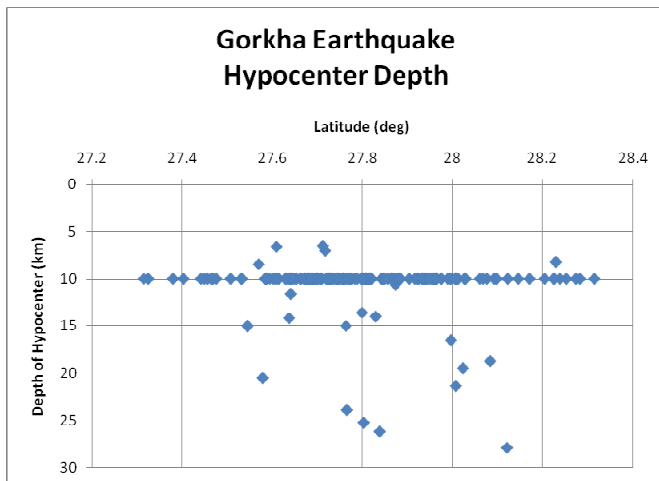
All the shocks of Gorkha earthquake were shallow with hypocentral depths between 5 km and 30 km as per published data from the USGS as plotted in Figure 17. This is understood as one of the major cause for larger scale damages to ground and structures seriously in 14 districts and less severely in another 14 districts.

Figure 17 Hypocentral Depths of Gorkha Earthquake Sequence

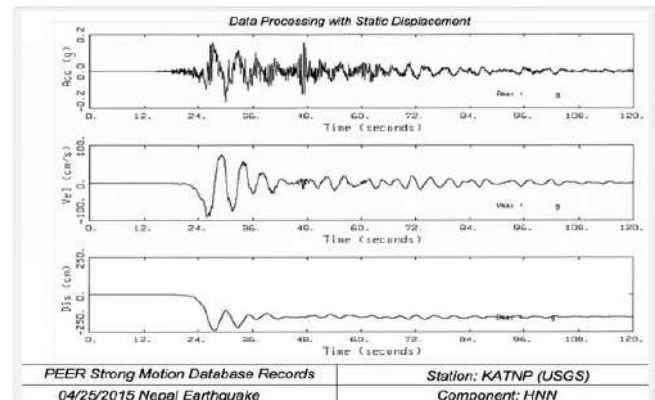
Figure 11. In Figure 19, the upper plot shows acceleration, middle shows velocity, and bottom shows displacement of the ground, revealing motion due to elastic seismic waves, but also the finite net southern shift of 1.5 m.

Figure 19 Strong motion record of Nepal earthquake (PEER Berkeley)

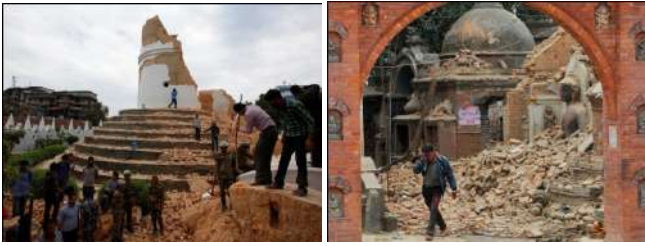
Figure 20 Damages of some historical places (National Post News)

Across many districts of the country, thousands of houses were destroyed with entire villages flattened, especially those near the epicenter. Several of the churches, temples and monasteries in the Kathmandu valley were destroyed. Several pagodas on Kathmandu Durbar Square, a UNESCO World Heritage Site, collapsed, as did the Dharahara tower, built in 1832. The collapse of the latter structure killed at least 180 people. Manakamana Temple in Gorkha district is also destroyed. The northern side of Janaki Mandir in Janakpur was also damaged. Many temples, including Kasthamandap, Panchtale temple, the top levels of the nine-story Basantapur Durbar, the Dasa Avtar temple and two dewals located behind the Shiva Pārbati temple were destroyed by the earthquake. Some other monuments, including the Kumari Temple and the Taleju Bhawani Temple got partially collapsed. The top of the Jaya Bageshwari Temple in Gaushala and some parts of the Pashupatinath Temple, Swyambhunath, Boudhanath Stupa, Ratna Mandir, inside Rani Pokhari, and Durbar High School have been destroyed. In Patan, the Char Narayan Mandir, the statue of Yog Narendra Malla, a pati inside Patan Durbar Square, the Taleju Temple, the Hari Shankar, Uma Maheshwar Temple and the Machhindranath Temple in Bungamati were destroyed by the quake. In Tripureshwar, the Kal Mochan Ghat, a temple inspired by Mughal architecture, was completely destroyed and the nearby Tripura Sundari also suffered significant damage. In Bhaktapur, several monuments, including the Fasi Deva temple, the Chardham temple and the Vatsala Durga Temple of 17th century were fully or partially destroyed.

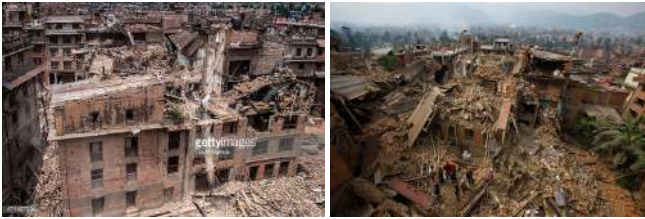
Figure 21 Damages of superstructures (globalnews.ca)

Apart from damages to heritage and historical monuments, a large number of houses have collapsed. The damages to houses have occurred in many districts. In general adobe and brick / stone in mud have collapsed, while properly constructed RCC buildings have mostly survived even in Barpak area, the epicenter of Gorkha earthquake of 25th April 2015.

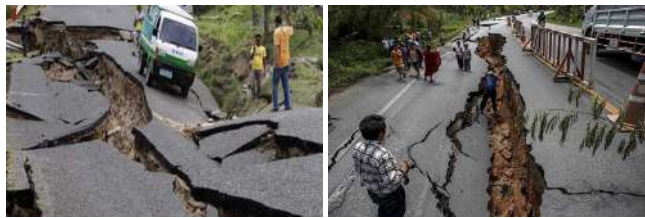
Figure 22 Damages of Transport system (mormonsoprano.com)

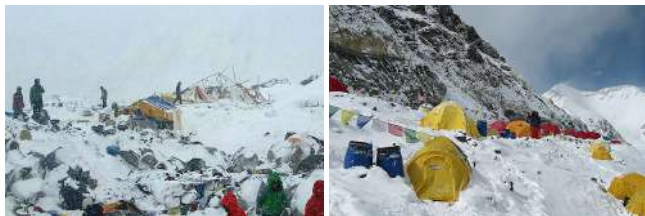
Figure 23 Damages in Everest (www.telegraph.co.uk)
