# Liquefaction Problems in the 21<sup>st</sup> Century

Ikuo Towhata<sup>1</sup>

**ABSTRACT:** This paper concerns liquefaction problems that were not solved in the 20<sup>th</sup> Century. Most of the problems lie in inexpensive structures and existing structures that were out of scope in the past. Efforts are going on to overcome the problems in spite of the imbalance of the required cost and the financial capacity. Seismic performance design is one of the future directions but there are again problems to tackle. It is stressed that qualification of the properties and lands are important because people can recognize the lying hazards and can prepare for the future safety.

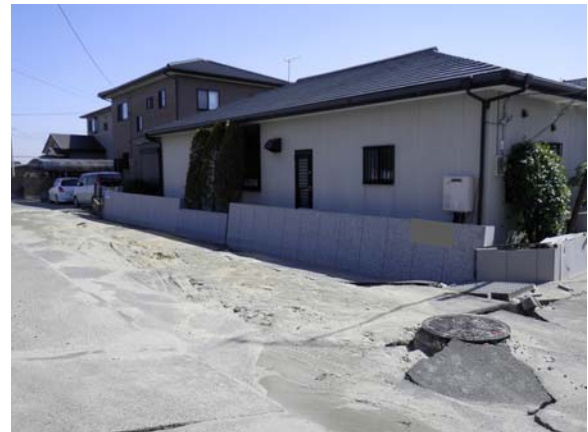
Photo 1 Liquefaction damage of house

The technologies to mitigate liquefaction disasters were developed in the 20th Century for the safety of such important infrastructures as harbors, bridge foundations, energy facilities, dams and big buildings among others. Because those important structures were constructed by public sectors and big industries that were able to provide sufficient funding, the established mitigation technologies were rather expensive, although they are reliable as verified by many earthquake events. As a consequence, those infrastructures that cannot afford the high cost of liquefaction mitigation are left unprotected today. Examples of those “poor” structures are residential house foundations, embedded lifelines and river levees (Photos 1 to 3 taken after the 2011 gigantic earthquake in east Japan).

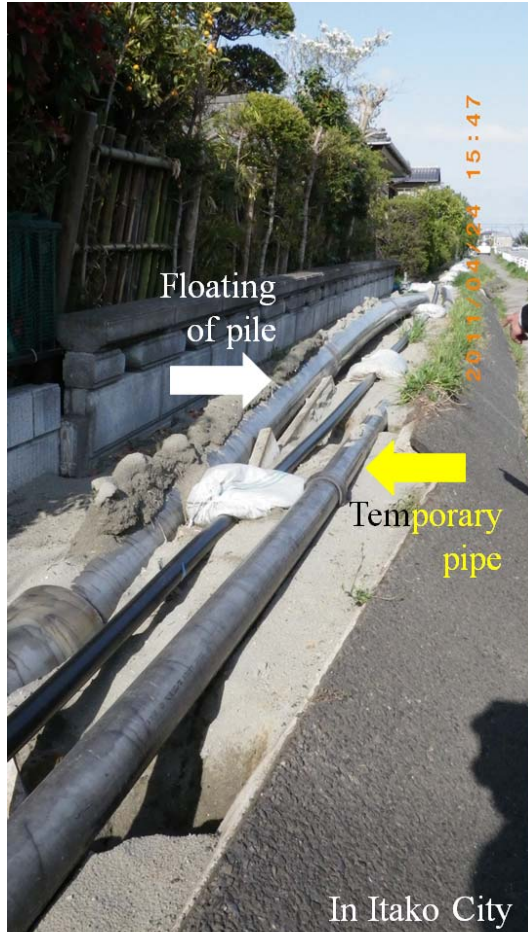
Photo 2 Liquefaction damage of lifeline

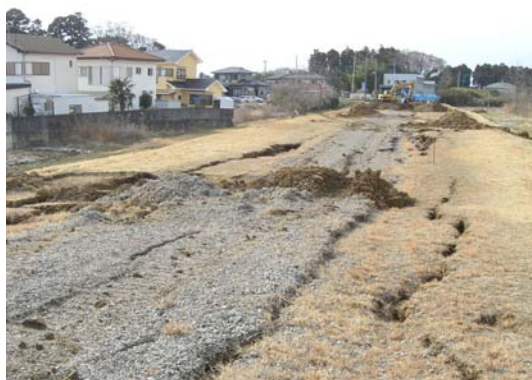
Photo 3 Liquefaction damage of river levee

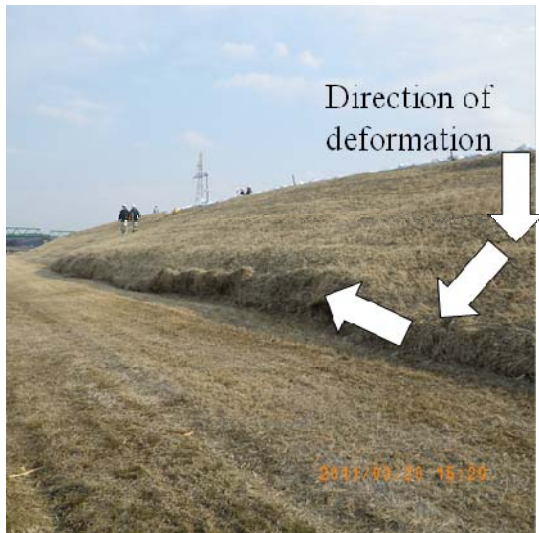
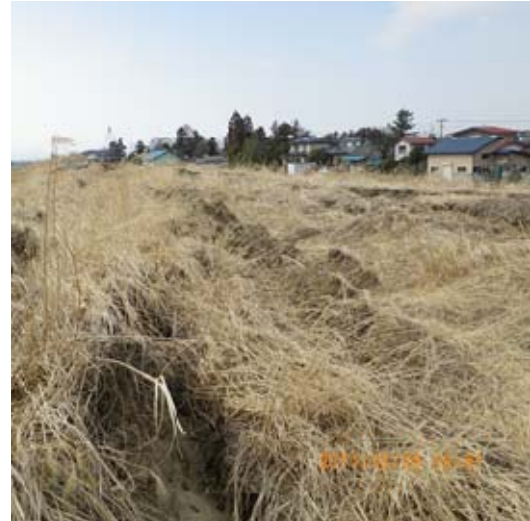
(a) Overall deformation

(b) 2-m subsidence at the top

Photo 5 Levee that was damaged by internal liquefaction during the 2011 East-Japan gigantic earthquake (Naruse River)

Traditionally liquefaction issues of river levees concerned the foundation soil under a levee body. However, one of the recent problems is the liquefaction inside a levee. This remark may sound strange because a levee is located above the ground surface and, therefore, above the ground water table and also because a levee is considered to be compacted. Photo 5 illustrates a typical damage caused by liquefaction inside a levee. Noteworthy is the profound distortion of the levee slope that is in The mechanism of the levee's internal liquefaction is discussed as what follows; good contrast with the intact shape of the unliquefied ground surface. Consolidation settlement is induced in the soft clayey subsoil under the weight of a constructed levee.

As a consequence, the lower part of a levee becomes submerged underground water table.

More water is supplied from the surface during rain and the levee body becomes more water-saturated.

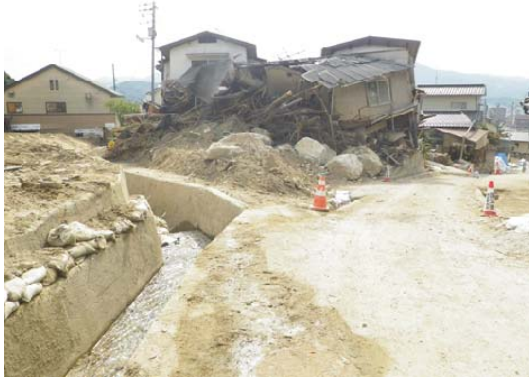
Photo 9 Consequence of debris flow caused by heavy rain (Hiroshima, 2014)

Earthquake is not the only one kind of natural disaster that produces a fatal damage to a private house. Photo 9 illustrates an area near Hiroshima where a heavy rain in August, 2014, caused debris flow in a residential area, destroyed many houses and killed 74 people during mid night. The problem was that a residential development took place on an alluvial fan that was formed by deposits of debris and that people did not pay attention to the risk of natural disasters. Similar to the aforementioned earthquake problems, it is very difficult to reduce the risk by reconstruction, soil improvement, relocation etc. after people have constructed houses and started living. Such a problem in existing structures is profoundly more difficult than that of new construction. Relocation requires people to purchase another land despite that their previous land and house are still under unfinished mortgage payment.

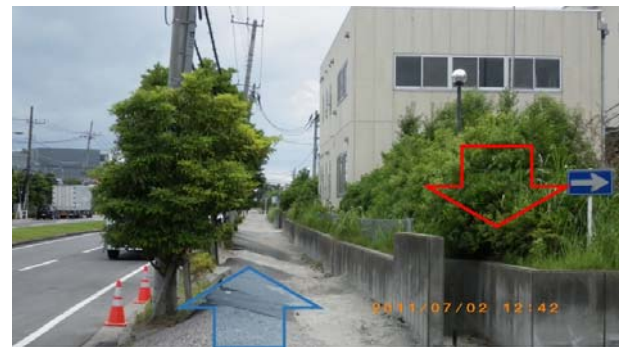
Photo 11 Uplift of public sidewalk as a consequence of liquefaction-induced subsidence of private building

In principle, soil improvement in a private residential land is a responsibility of house owners. However, the scale of house damage during the 2011 gigantic earthquake was extremely huge and the national government decided to provide a certain public aid to private properties, which is an integrated soil improvement package by which both public streets and private lands are worked on together. It was thought therein that the safety of streets and embedded lifelines against liquefaction is achieved by soil improvement not only under the public spaces but also in private lands; hence the public fund should be added to the personal money in order to improve private subsoil. Photo 11 shows a case in which liquefaction in a private land induced subsidence of the building and the subsided soil was pushed out to the public sidewalk where significant uplift happened. Note that pipelines are often embedded under sidewalk.
