Behaviour of Geogrid Reinforced Abutments on Soft Soil

E.M. Palmeira^{1*}, A.R.S. Fahel² and G.L.S. Araújo³

ABSTRACT: The behaviour of embankments on soft soils is a complex problem, particularly when the substitution of the soft material is not cost effective. In this case, the use of geosynthetics may be a feasible and economical solution for the stabilization of the embankment and reduction of the effects of differential settlements. This paper shows an investigation on the use of geogrid reinforcement in combination with pre-fabricated vertical drains (PVD) to accelerate soft soil consolidation in abutments for the duplication of the BR-101 highway, in Brazil. The instrumentation of bridge abutments included inclinometers, settlement and horizontal displacement plates, full-profile settlement gauges and piezometers, as well as strain gauges in the reinforcement layer. The results obtained showed that one of the abutments almost collapsed due to wrong construction practice and reinforcement specification. Insufficient reinforcement tensile force mobilization along the embankment transverse direction combined with wrong reinforcement orientation yielded to large embankment disp

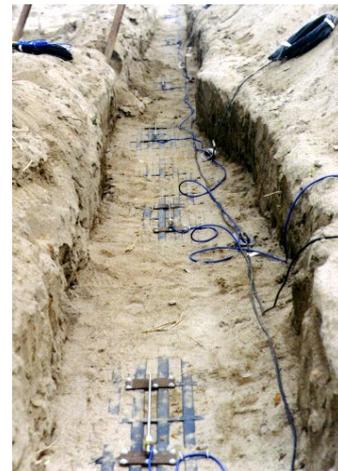
Figure 4 Strain gauges along the bottom reinforcement layer of the South abutment

probe at the base of the embankment, two electric piezometers (5.1 m and 8.0 m deep installed on the vertical passing by the interception of the diagonals formed by 4 neighbouring vertical drains) and strain gauges in the bottom reinforcement layer to measure reinforcement strains (Figure 4)

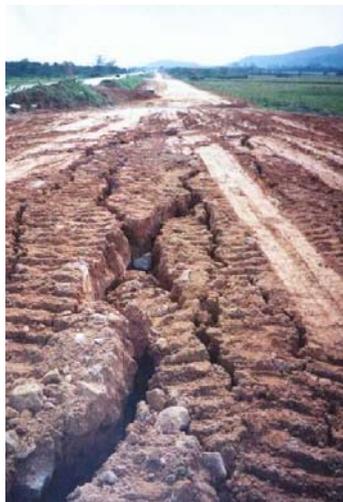
(a) Cracks along the embankment surface

Figure 6 Instability of the embankment of the North abutment

Figure 5 presents the variation of embankment height versus time for the North Abutment. The embankment was built at a rate of approximately 0.35 m/day. Large cracks (Figure 6a) along the embankment longitudinal direction were noticed at the embankment surface when it reached the height of 3.6 m. This was a consequence of the initiation of a failure mechanism of the embankment side slope due to insufficient reinforcement tensile force mobilization along this direction. Excavation of the embankment confirmed sliding of adjacent reinforcement panels along the overlapping length (Figure 6b). Because of the clear signs of instability of the embankment, construction was interrupted and the designers and contractor decided to reduce the embankment height in approximately 2.5 m and to use the excavated material to build a 30 m wide stabilizing berm (Figure 2a) ahead of the lateral slope

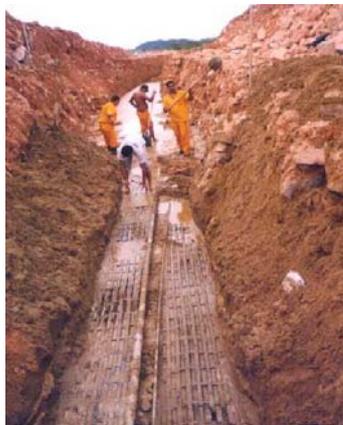
(b) Location of reinforcement slippage
