# Shear-Induced Geomembrane Damage due to Gravel in Underlying Compacted Clay

**ABSTRACT:** Lining systems for landfills and heap leach pads are often constructed with compacted clay liners (CCLs) containing significant amounts of gravel. Geomembranes placed against gravelly CCLs are vulnerable to damage due to high overburden stress and interface shear displacement. This invited paper reports results from the first experimental investigation of shear-induced damage to geomembranes placed in contact with gravelly compacted clay. A series of large-scale direct shear tests was conducted for the interface between smooth HDPE geomembranes and CCLs with 20 percent gravel. The tests were performed for normal stress levels ranging from 72 to 1658 kPa to simulate overburden stresses associated with bottom liner systems. Replicate interface shear tests were also performed for normal stresses up to 4145 kPa with a geosynthetic clay liner (GCL) placed in between the geomembrane and the CCL to evaluate protection provided by the GCL. Results indicate that shear displacement between a geomembrane and a gravelly CCL under high normal stress conditions can cause severe damage to the geomembrane.

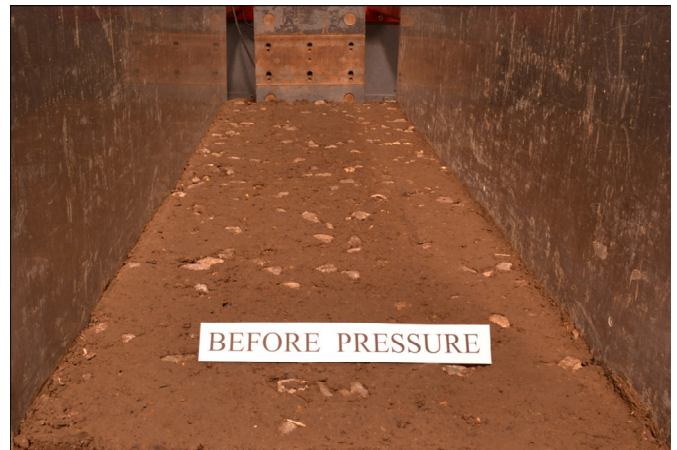
Figure 2 Typical view of CCL after compaction in the test chamber

Two types of multi-interface specimens, GM/CCL and GM/GCL/CCL, were tested for the experimental program. From bottom to top, the GM/CCL specimens consisted of gravelly CCL, GM, and sand. The CCL subgrade was compacted in two lifts using a large hand tamper to a final thickness of approximately 75 mm. The target water content for compaction was 22%. New subgrade soil was used for each test. Figure 2 shows a typical view of the CCL subgrade immediately after compaction in the test chamber. The gravel particles are lighter in color than the surrounding clay matrix and level with the clay surface (i.e., no protrusions). After compaction, the top of the CCL was sprayed with 100 mL of water to wet the shearing surface. The GM specimen was then placed on the CCL with the smooth side facing down to facilitate the observation of damage features (e.g., scratches, gouges, holes) and to ensure that failure occurred at the GM/CCL interface. Each GM specimen was cut longer than 1067 mm to allow additional material to enter the rear of the test chamber during shear and thus maintain

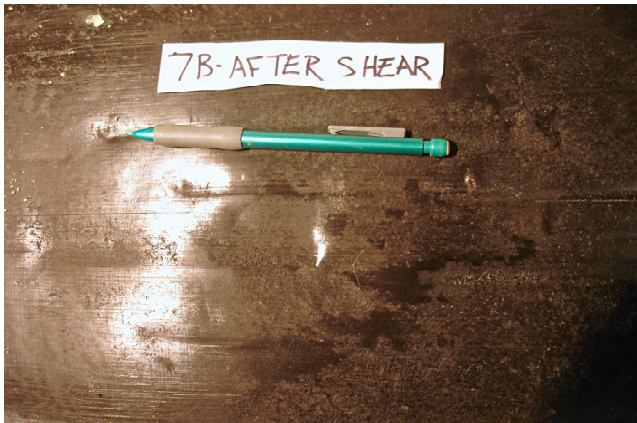
Figure 6 Photograph of geomembrane specimen 7B after shearing under  $\sigma_n = 4145$  kPa for GM/GCL/CCL test

Post-shear visual inspections of the geomembrane specimens sheared directly against the gravelly CCL revealed minor to moderate damage (i.e., indentations, scratching) under low normal stress ( $\sigma_n \leq 348$  kPa) and severe damage (i.e., holes, gouges, tears) under higher normal stress ( $\sigma_n \geq 693$  kPa). Tests performed with a GCL in between the geomembrane and CCL resulted in far less damage to the geomembrane. Photographs comparing the post-shear condition of the geomembrane following the GM/CCL and GM/GCL/CCL tests at  $\sigma_n = 1658$  kPa are shown in the Figure 5. The geomembrane from GM/CCL test 5A shows severe damage, with several deep scratches, gouges, and holes with an maximum size of nearly 25 mm. The bottom photograph, from GM/GCL/CCL test 5B, shows no holes and only minor scratches and indentations on the geomembrane. The potential cushioning effect of the GCL was further evaluated by performing two additional GM/GCL/CCL tests at  $\sigma_n = 2146$  and 4145 kPa. Figure 6 shows a photograph of geomembrane specimen 7B at  $\sigma_n = 4145$  kPa. Although some dimpling was noted, there were no holes in the geomembrane specimens for any of the GM/GCL/CCL tests, even for normal stresses as high as 4145 kPa.
