Concept and Design Methodology of Redundancy in Braced Excavations

G. Zheng^{1,2}, X. S. Cheng^{1,2}, Y. Diao^{1,2}, H. X. Wang^{1,2}

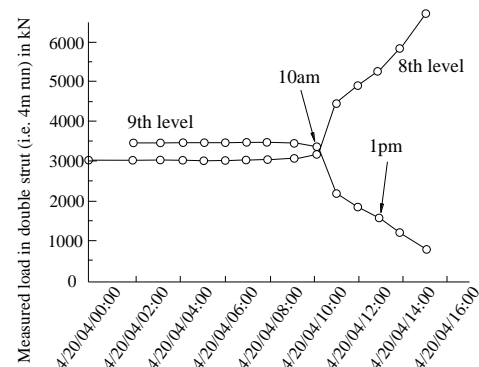
Figure 7 Change in measured load at strut 335 (Davies 2007)

This collapse proceeded as domino effect. It began from the yield of the strut waler connections at the 9th level, then the 9th level struts failed, following that, the 8th level struts were broken, at last, other levels struts and the whole support system collapsed (Davies 2007). The changes of axial forces of the 8th and 9th level struts could demonstrate the process, as shown in Figure 7 (Davies 2007).

The suddenly decrease of the axial load of the 9th level strut in Figure 7 was exactly caused by the brittle response of the C-channel connection beyond peak strength (COI 2005). If the more ductile plate stiffeners were used in all the connections, the collapse would probably have been localized and slower. On this occasion, there would be more time to carry out the emergency measures which could prevent the failure. It can be concluded that improving the ductility of the elements or connections of the system is an effective and crucial way to increase the redundancy of a system.

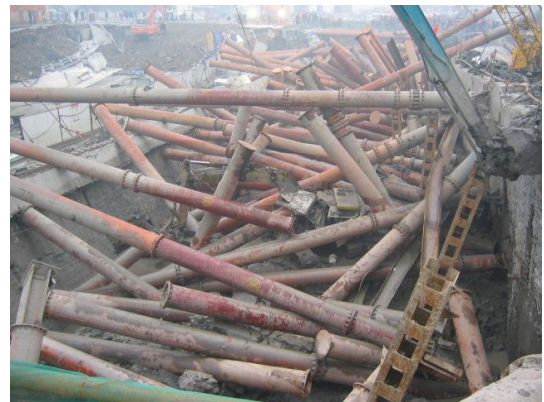
Figure 14 The messy struts after the collapse

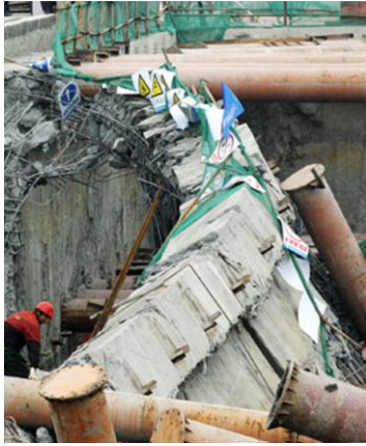
Figure 15 shows that the bracket was two short steel angles welded on the embedded steel plate of the diaphragm. The pipe struts were just put on the brackets without welding or riveting to the diaphragm. When the diaphragm was broken, the load acting upon the struts increased, and what's more, the excessive deformation of the diaphragm wall also made the struts suffer the axial load and transverse load at the same time. But the connections of the struts and the diaphragm could not provide adequate transverse restraint to the struts. Then, the struts at one end slipped away and the other end fell down. This unstable behaviour made the whole system brittle and caused the collapse to happen so suddenly. On the contrary, if the struts were well connected to the diaphragm walls at the both end of strut, the two diaphragm walls, struts and the vertical columns would possibly act as an integral frame in the vertical section of the support system, as shown in Figure 13, therefore, the collapse would be probably mitigated or be more progressive.

Figure 15 Brackets of pipe struts

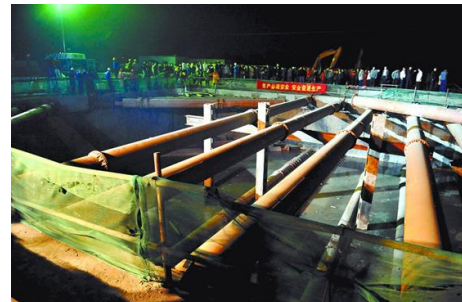
The redundancy of the vertical support system is vital to maintain the stability of the horizontal struts. Figure 19 shows part of the survived retaining structure. It could be seen that the integrity of the vertical support system of the horizontal struts are not very good. The pipe struts were laid on rather than fixed to the H-beam. This situation could also result in the struts to be more susceptible to fall down. The vertical supporting structure was also not reinforced by the diagonal bracing, which could have made the system to have higher redundancy. Figure 20 illustrates a relative appropriate configuration of the vertical support structure of struts.

Figure 19 Pipe struts and their vertical support structure
