Reinforced embankment constructed along irrigation canal

Kritsada Teerachavalvong, Surasak Kaipinit,
Taweephong Suksawat* and Kawin Saiprasertkij
Department of Rural Roads, Ministry of Transport, Thailand
*Corresponding author: Taweephong2727@gmail.com

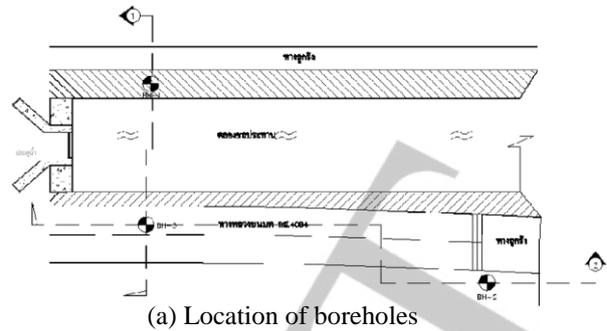
Fig. 3 Locations of soil boring and test pit

Three boreholes were conducted soon after failure occurred as shown in Fig.3. The BH-1 and BH-3 are tested on the opposite side of the first failure spot while BH-2 is tested on the stable slope out of the construction area (Sta 21+100). In addition, a test pit of 4.0 m depth was performed nearby BH-3 in order to collect undisturbed samples for direct shear and pinhole tests.

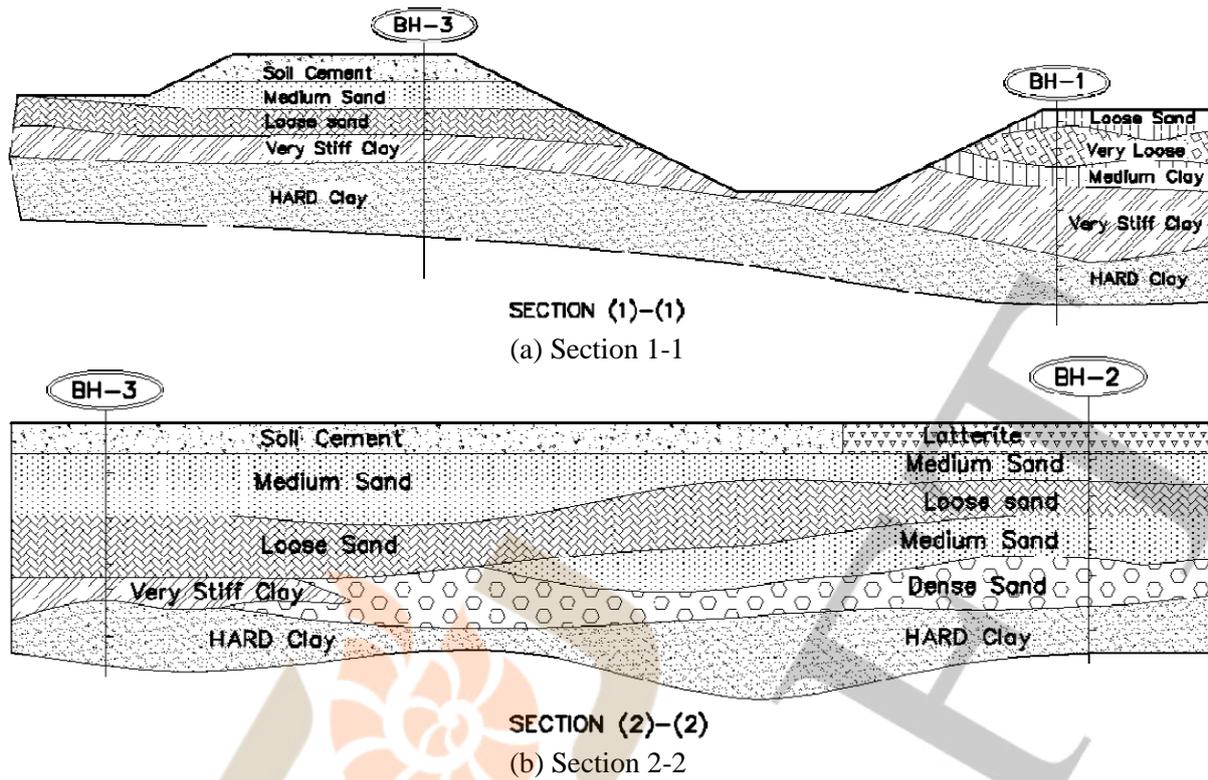
Fig. 4 Soil profile of Section 1-1 and Section 2-2

Section 1-1 and Section 2-2 (BH-1 to BH-3 and BH-3 to BH-2, respectively) show the soil profiles as illustrated in Fig 4. The first layer is soil-cement base and fill material having a thickness of 0.5 m to 1.0 m and underlain by loose to medium dense silty sand which extends down to about 3.0 m depth approximately. The shear strength parameters obtained from the direct shear test are cohesion vary from 7.0 to 12.0 kPa and internal friction angle around 25^{o}

to 28^{o}. The very stiff to hard clay layer was found to underlie the loose to medium dense silty sand at 3.0 m onward having Standard Penetration test (SPT) more than 30 blows/foot.

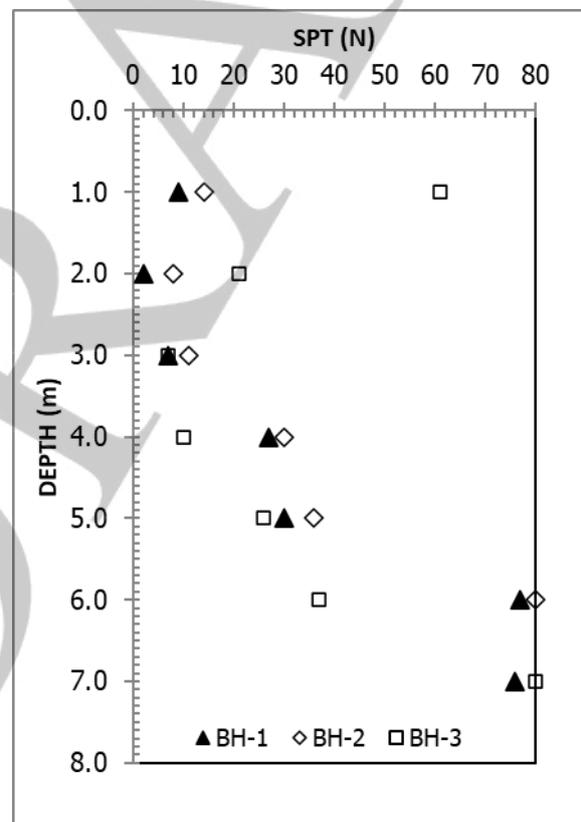
Fig. 5 SPT with Depth

Fig 5 demonstrates the SPT with depth of the three boreholes. The SPT with Depth indicated the weak zone locates from 1.0 to 3.0 m then the SPT gradually increases with depth. After 6 meters depth, the SPT is greater than 30 Blow/foot. It implies that the failure surface should not be lower than 3.0 to 4.0 m from the surface. Finally, the BH-1 (located on the opposite site of the failure spot) is used as the representative Geotechnical parameters because it is the lowest SPT values. In addition, the pinhole testing results indicate ND1 class which indicates that Non- dispersive soil.

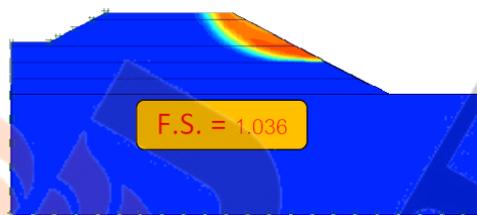
Fig. 6 The slip surface of the back analysis model of Sta 21+500.

The appropriate material parameters obtained from back analysis as well as laboratory testing are tabulated in Table 2. The Factor of Safety is 1.036 which is compatible to the fail slope at Sta 21+500 for instability slope as shown in Fig 6.

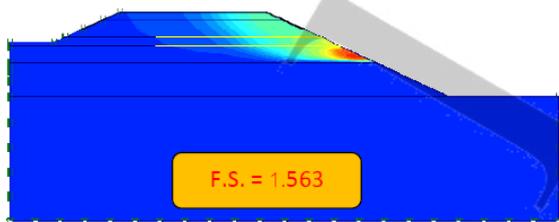
Fig. 7 The Factor of Safety results

The results from simulations demonstrated 1.563 and 1.640 for geogrid reinforcement and soil replacement methods, respectively as shown in Fig 7. Even though, the first method illustrated lower Factor of Safety, however, the displacement is lesser since higher stiffness than the soil replacement method.

Several solutions are proposed, for example, bearing unit, gabion wall, geosynthetic reinforcement, concrete pile wall and so on (Gu, 2011). However, two solutions are adopted which are geogrid reinforcement and soil replacement methods for 100 m and 300 m, respectively because budget is limited. The excavation depth of 3.0 m and 2.0 m for geogrid reinforcement method and soil replacement method, respectively, are requested to remove the existing soil and replace with the suitable materials. The advantages of Geogrid reinforcement method are lower excavation depth, faster construction time and less effect to agriculturists since it is not necessary to reduce the water level in the canals. However, Geogrid reinforcement is very expensive and it is not widely used in rural areas. On the other hand, the soil replacement method requires a greater volume of fill material as well as longer construction time but cheaper and easier for quality control during construction. The pros and cons of both methods are tabulated as shown in Table 1. The selected material type A (following DRR.204-2002) is applied as the filled material for the soil replacement method while the sub-base material (following DRR.202-2014) is used as the embankment material for the geogrid reinforcement method.
