CORROSION BEHAVIOR OF FRICTION PLATE SURFACES CONNECTED BY HIGH-STRENGTH BOLTS

S. YAMASHITA¹, T. SHIMOZATO², Y. ARIZUMI², M. TAI³, and T. YABUKI²

¹ Production Planning Group, Miyaji Engineering Co., Ltd, Ichihara, Japan

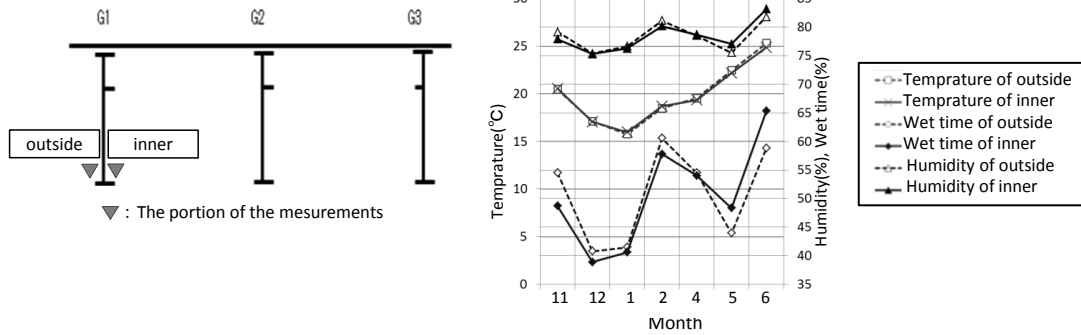
Figure 2. The portion of the measurements. Figure 3. Temperature, wet periods, and humidity.

The monitoring test was conducted to research the corrosive environment around this bridge. Atmospheric temperature and humidity around the bridge are shown in Fig. 3. The figure also shows the rate of wet periods calculated from measuring temperature and humidity. A wet period is defined as a continuous time in a state of humidity of 80% and higher with a temperature of 0°C and higher (ISO 9223). The average monthly temperature is 26.2°C and the humidity is 78.5%. The rate of the wet periods around the bridge was over 60% between February and June.

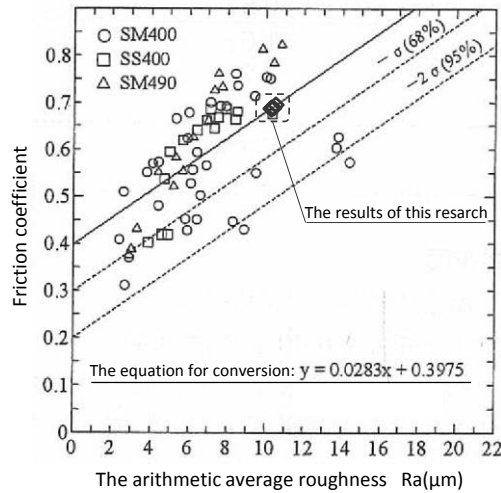
Figure 11. The relationship between Ra and the friction coefficient.

The friction coefficients of the inner faces of test specimens were evaluated with their arithmetic average roughness measured. The edge of the inner surfaces had intense rust. Therefore, the arithmetic average roughness of the inner surface of specimen at a distance 30mm away from the bolt hole was used for the evaluation. The evaluation was performed using an established transformation method (Minami et al. 2004.). The previous transformation data and equation for the evaluation are shown in Fig. 11.

Table 1 shows the evaluated friction coefficients and the used arithmetic average roughness for the test specimens. These data are also shown in Fig. 11 for comparison purposes. All values of the coefficients show high friction coefficients over 0.6. In terms of arithmetic average roughnesses, there was a dispersion in the measured data. However, it seems that the friction coefficient of the corroded high-strength grip bolted joint parts satisfies the design value, which is 0.4, sufficiently.
