ANALYSIS OF DETERIORATION IN REINFORCED CONCRETE BRIDGE GIRDERS DAMAGED BY CHLORIDE DETERIORATION AND FATIGUE

H. HONDA, T. SHIMOZATO, and Y. ARIZUMI

Dept of Engineering, Ryukyu University, Okinawa, Japan

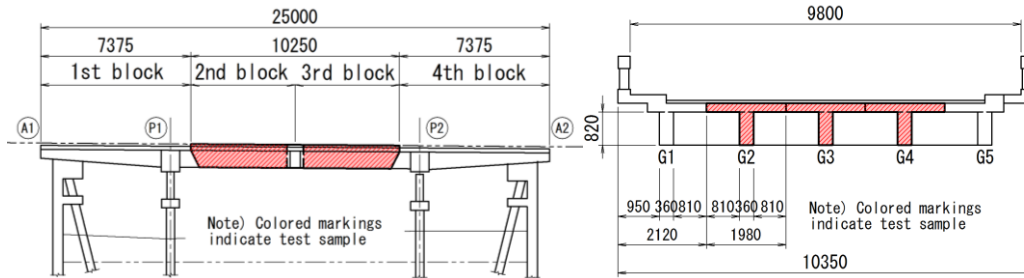
Figure 1 is a structural summary of the removed bridge. The bridge was 25.0 m long, with five main girders and sidewalks on both sides. The steel used was deformed reinforcing bar, and the design standard strength of the concrete, judging by the period of construction, is thought to have been 21 N/mm². The bridge remained in use as a bridge for the old road, after a new bridge was built in 1987 to carry a bypass. In 2001, an investigation and tests, including external visual inspection and compression strength tests, were conducted to find the state of chloride-induced deterioration. Since that time, there have been reports of severe damage to the bridge, including reinforcing bar corrosion, and concrete scaling and spalling. The bridge was taken out of service from that time, and the decision was taken in 2011 to remove it.

Figure 1. Structural summary of the removed bridge.
