BASAL STUDY ON SIMPLE THICKNESS EVALUATION FOR ROAD-LIGHTING POLES WITH LOCAL CORROSION NEAR THE BASEPLATE

TOMOHIRO MITSUNAGA¹, TATSUMASA KAITA¹, and KATASHI FUJII²

In this study, a simple thickness evaluation method was proposed for corroded road-lighting poles based on thickness measurement results of a dismantled road-lighting pole which had been used for about 40 years. The remaining thickness in cross-section of this specimen was measured by using both of Ultrasonic Thickness Gauge (UTG) and 3D portable laser scanner in order to investigate the accuracy of average thickness which could be obtained from only 4 measuring points at intervals of 90 degrees in circular cross-section. In this UTG measurement, the smoothing process, which will be carried out ordinarily by using electric grinder around measuring points, was abbreviated from the considering of labor-saving and additional thickness loss. From the measurement results, UTG measurement under the condition of no smoothing process will overestimate the actual remaining average thickness depending on surface roughness due to corrosion. Finally, an example of simple thickness evaluation, which uses average thickness and stan

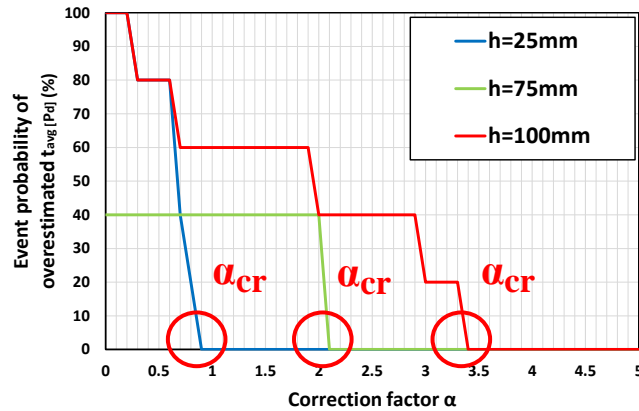
Figure 4. Event probability of overestimated P_d .

Figure 4 shows the relationship between the event probabilities of overestimated average thickness P_d and the thickness correction factor α . Event probabilities P_d can be calculated by counting the number of overestimated cases in all combinations of measuring unit, as shown in Figure 5.

These overestimated cases mean the modified average thickness t_m , which was obtained from Equation (1), was greater than the actual average thickness (obtained from 3D scanner). Correction factor α was changed numerically at the intervals of 0.1, after counting the number of overestimated cases. From Figure 4, it will be found that the event probabilities P_d will decrease with an increase in correction factor α . From this calculation, the critical correction factors α_{cr} when P_d reached 0% were decided in the case of $h = 25\text{ mm}, 75\text{ mm}, 100\text{ mm}$. Figure 6 shows the relationship between α_{cr} and σ_t . In this figure, σ_t was obtained from 20 measuring points cross-section at $h = 25$

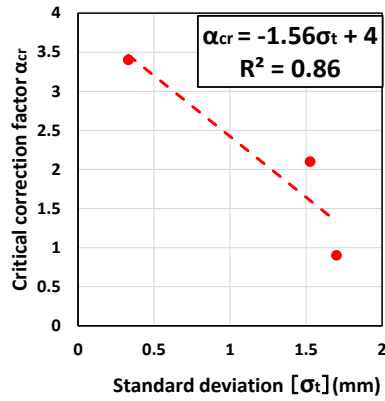
Figure 6. α_{cr} - σ_t relationship.

mm, 75 mm, 100 mm, respectively. If the correction factor α was decided from relationship such as Figure 6 by using the measurement result of only four measuring points, the average thickness will be modified easily from Equation (1) toward the safe side with consideration of the roughness condition (σ_t) of corroded surface. However, it should be noted that the α_{cr} - σ_t relationship will requires the investigation for more cases of other corroded road-lighting poles in order to enhance reliability and generality.
