# An Expanded Polystyrene Foam (EPS) Road Robust to Successive Great Kumamoto Earthquakes in 2016

**ABSTRACT:** This paper describes a case in which no complete demolition was observed in a geofam (expanded polystyrene foam EPS) embankment. Used for local roads situated over active faults at a mountainous site in Mashiki Town, Kumamoto, Japan, the EPS withstood two successive strong earthquakes that struck Kumamoto and Oita prefectures in 2015. The EPS blocks of this EPS embankment were markedly shifted sideways both horizontally and vertically because earthquake-caused landslides occurred behind the EPS fills. Nevertheless, only a part of the EPS embankment collapsed, causing no damage to the temple nearby. Thereafter, the road surface was remediated temporarily immediately after the earthquakes and was maintained for the opening of traffic. This case demonstrates that EPS presents great benefits: most importantly, the partly collapsed EPS road was put into practical use as a temporary road supporting the daily life of local residents. This report describes an engineering perspective of why the road was not collapsed completely. Future issues to be considered by local governments

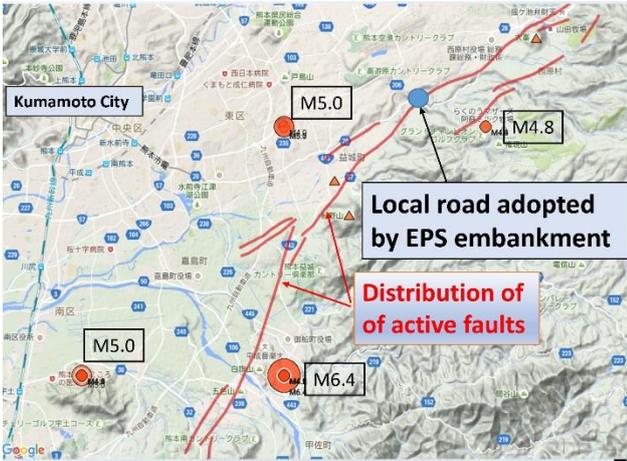
Figure 2 Location of EPS embankment for a local road (Prefectural road called “Route 28”) on active faults

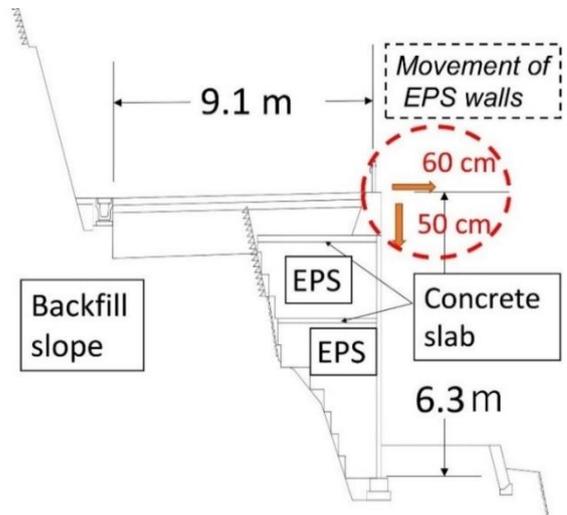
Figure 6 Original configuration of EPS embankment in 1998

- i) maintaining safety against fallen stones from steep slopes
- ii) saving excavation
- iii) avoiding usage of large construction machinery at the steep mountainous site

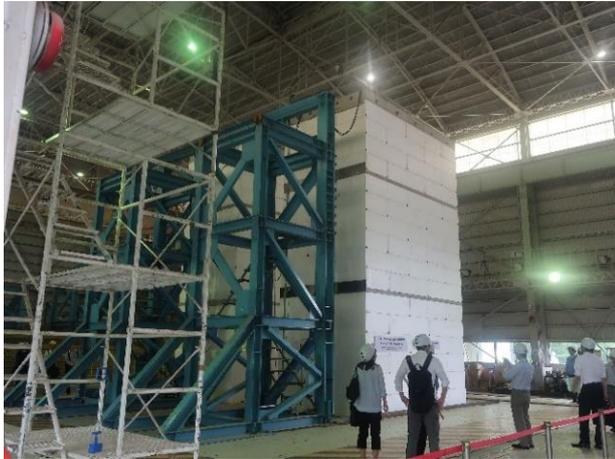
EPS model embankment of 8 m height, 5 m length, and 3 m width (Figure 15) were conducted in 2018 at a large facility under the auspices of National Research Institute for Earth Science and Disaster Resilience (NIED), Japan.

Figure 15 Scene of full-scale model tests of an EPS embankment

Although EDO is planning to present details of the tests within 2019, a characteristic aspect of this new full-scale test was to investigate the effects of new JMBs for improving EPS embankment stability. The following are newly devised points that differ from the earlier experience in 1997.

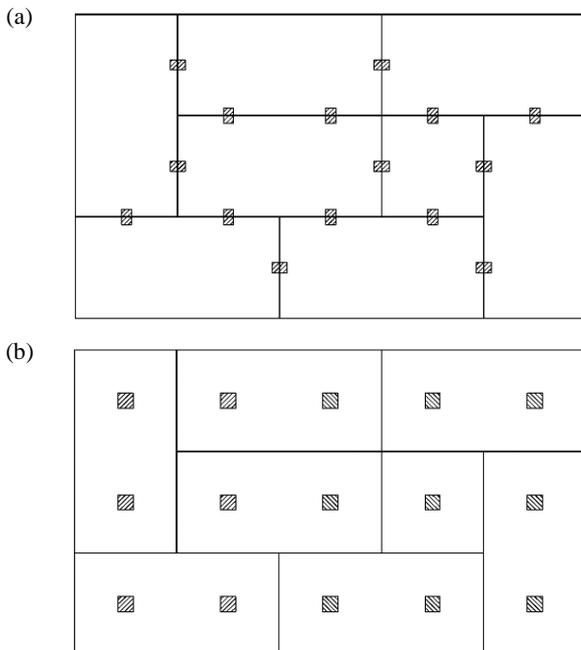
Figure 16 Two JMB layouts: (a) Conventional layout and (b) New layout

Unfortunately, the laboratory model tests (Taneichi et al., 2018b) revealed greater deformation in the case of the new layout than in the case of the conventional one, as shown in Figure 18.

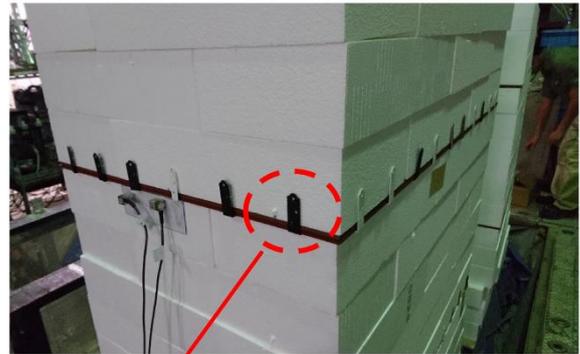
Hooks were placed at the edge of bottom slabs between each EPS block.

Figure 17 Metal hook placement

- i) The hybrid layout shown in Figure 19 was adopted.
- ii) Metal L-hooks were set between EPS blocks.

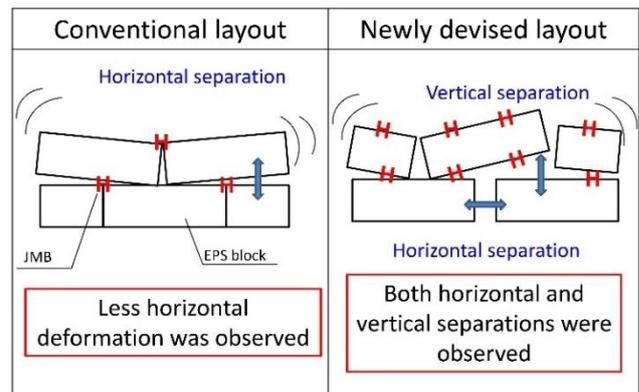
Figure 18 Rocking motions of conventional and new layouts

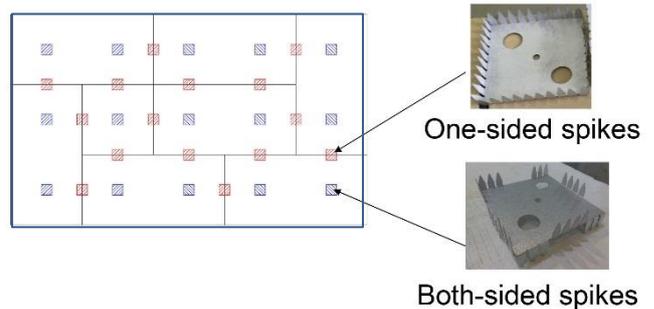
Figure 19 Hybrid layout of JMB

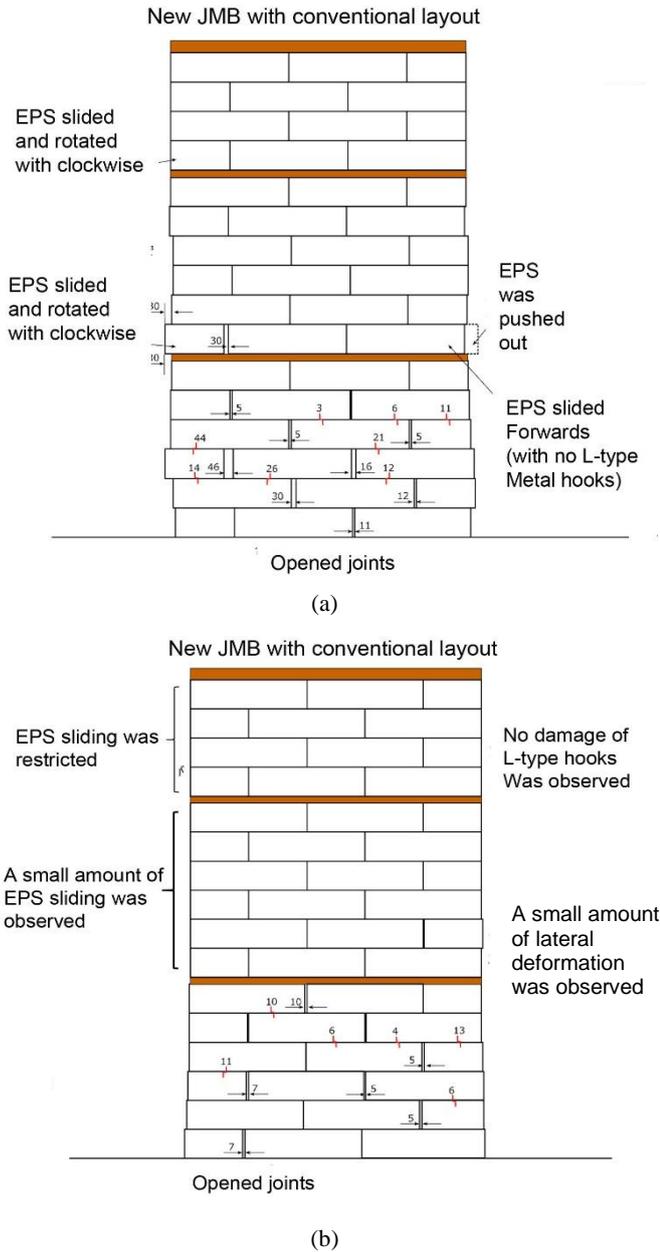
Figure 20 Typical results of full-scale shaking table tests for EPS embankment: (a) Conventional layout and (b) Hybrid layout

Test results were obtained with and without L-hooks installed for increasing stability against earthquakes having the acceleration waves depicted in Figure 21. It might be readily apparent from Figure 20 that using metal L-hooks in the hybrid layout of JMB is useful for maintaining EPS embankment stability during earthquakes.

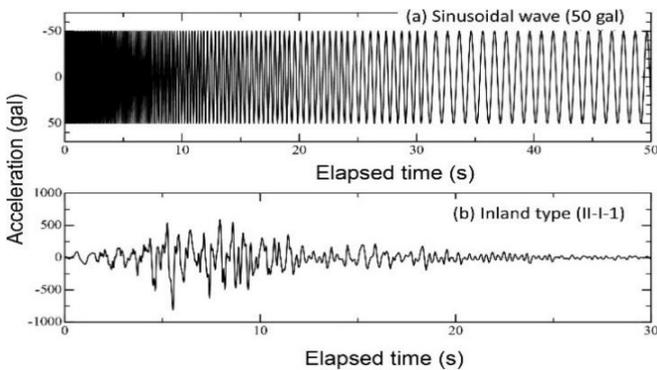
Figure 21 Acceleration records used for full-scale shaking table tests
