Anchors of Anchored Slopes in Taiwan

Hung-Jiun Liao¹, Shih-Hao Cheng² and Chun-Chung Chen³

ABSTRACT: A catastrophic failure of an anchored cut slope at the national expressway in 2010 uncovered the status quo of tie-back anchors in Taiwan. Serious corrosion of anchor components due to poor corrosion protection was found to be the most obvious factor contributing to this landslide among other factors. After an extensive island-wide investigation on the existing anchored slopes, similar corrosion problem was found in many other anchored slopes. After the investigation, the construction and maintenance practice of anchored slopes had been fundamentally changed in Taiwan. This paper covers the inspection results on anchored slopes and also the measures taken to improve the corrosion protection of existing anchors and new anchors. Based on the problems found from the existing anchored slopes, some modifications on anchor tendon assembly and cement grouting practice had been developed to upgrade the corrosion protection of the new anchors and to monitor the long-term anchor load change as well.

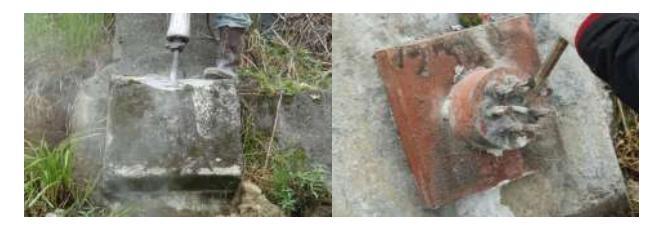
Figure 8 Remove the concrete protection cap of anchor head

(2) Remove the concrete cap and inspect the steel strands and wedges on the anchor head (Figure 8): If the integrity of concrete cap is good, normally the appearance of steel strands and wedges also look good. Otherwise, a clear sign of corrosion can be observed on the strands and wedges.

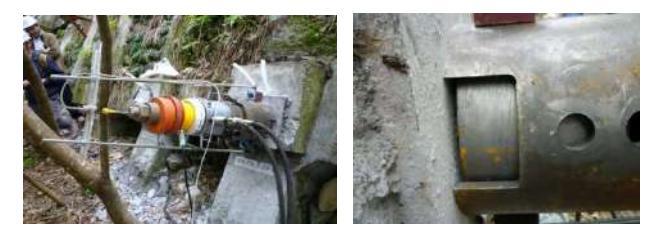
Figure 10 Lift off test for determining the residual anchor load

(4) Carry out the lift off test to determine the residual anchor load (Figure 10): It is normal to have a residual anchor load varied within ± 20% range of design load. For those anchors suffering serious strands corrosion problem, extra caution must be exercised to avoid breaking the rusty steel strands during lift off test. If the residual anchor load goes beyond 130% of design load, it is an indication of slope displacement. Immediate measures must be taken to resume the stability of slope. If the anchor load falls below 80% of design load, it may be resulted by problems associated with fixed end, free end, and anchor head; or simply a load redistribution of the anchored slope. The real causes should be observed and verified from the timely slope inspection work carried out afterward.
