Geological Investigation and Sliding Mitigation in Jiufen Area

Lee-Ping Shi¹, Jen-Cheng Liao², Sheng-Hsiung Hung³ and Chien-Shui Huang⁴ ^{1,2}Taiwan Construction Research Institute, New Taipei City, Taiwan ³Agriculture Department, New Taipei City Government, New Taipei City, Taiwan ⁴P.E. of Applied Geotechnical Engineering, New Taipei City, Taiwan E-mail: lepnhsu@tcri.org.tw

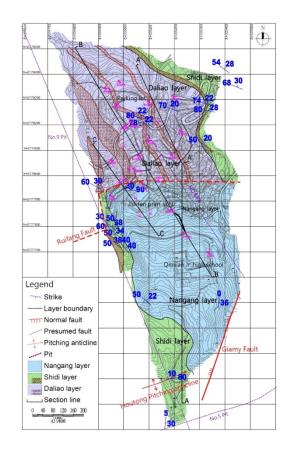
Figure 2 Site topographic and geological map

The area of supplementary topographic survey was enlarged from 20 hectares to 56 hectares. The site topographic and geological map is shown in Figure 2.

Using the orthophotos base maps of Taiwan area (Ruibin and Jiufen, 1/5000) provided by Aerial Survey Office, Forestry Bureau and the map from supplementary topographic survey, the surface geological surveys were conducted. The surveying centre was at Jiufen, the eastern boundary extended to Giamy fault, the northern to the southern part of Keelung Mountain, the western to the entrance of Yuansantze Flood Diversion Project and the southern to the district of Houtong and Xiaojingua. The survey results are plotted to geological map as shown in Figure 2 and the sectional diagram (B-B cross-section) is shown as Figure 3.

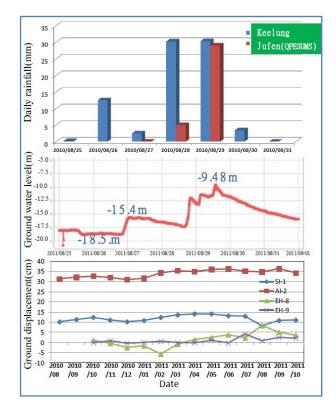
Figure 5 The relationship between rainfall and ground water level during Nanmadol typhoon

ground displacement recorded more than one year. It can be seen that the ground displacement increased with the heavy rainfall quantity. Comparing to the monitoring rainfall results in Juifen area and the nearby Keelung rainfall station data of Central Weather Bureau during the Nanmadol typhoon, it is noted that the groundwater level rose about 9.02m and the increasing groundwater volume not only from the rainfall in Juifen area but also from the underground flow of surrounding area as shown in Figure 5. Since the groundwater associated with the stability of Juifen landslide area, it was very important to investigate the underground flow distribution and constructed the drainage well.

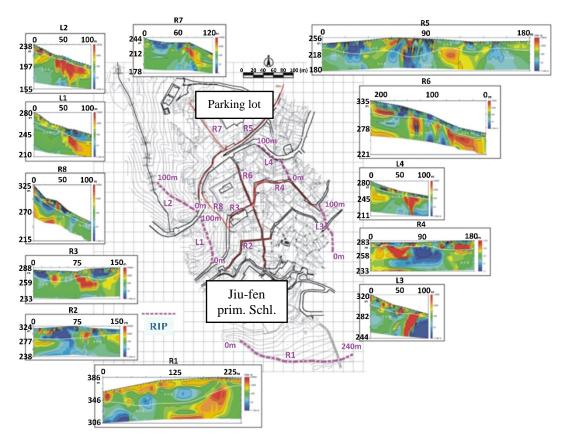
Figure 6 The RIP results from 12 profiles and their resistivity distribution zones with different colors

Both RIP(Resistivity Image Profiling) and self-potential (SP) survey were used to investigate the distribution of the underground flow. Figure 6 shows the RIP results from 12 profiles and their resistivity distribution zones with different colors. Base on RIP results, there was one main line of the underground water flow passing through

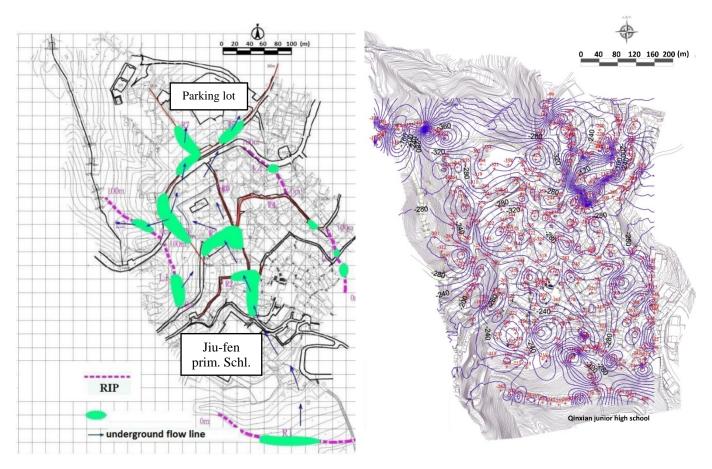
Figure 7 The underground flow line located by RIP

the area as shown in Figure 7. The relative voltage contours from SP surveys are shown in Figure 8. Figure 9 shows that the underground flow lines were located both from the RIP and SP survey results. There are four underground flow lines and the main line passed through the middle part of the area. The direction was from the south to the north.
