Characteristics of Slope Failures During Natural Disasters Considering Geographical Features and Groundwater Level: Case Study of the Chuetsu Region of Niigata, Japan

H. Toyota¹

¹Department of Civil and Environmental Engineering, Nagaoka University of Technology, Niigata, Japan E-mail: toyota@vos.nagaokaut.ac.jp

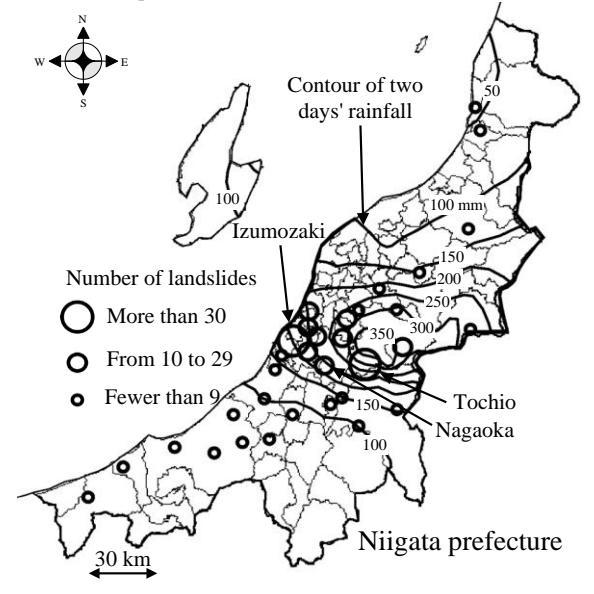
Figure 3 Number of landslides during the 7.13 Niigata flood disaster

In Fig. 3, based on data of the Niigata Prefectural Government, the numbers of landslides are shown on a map of Niigata with contour lines representing rain precipitation. A tendency exists for landslides to be numerous in heavy rain areas, except in Izumozaki town, which is at the west end of an area of rain concentration. The east end of the rain concentration is geologically composed of older and harder strata. The most damaged area is in the East Hill area (Fig. 2), which almost agrees with the centre of rain precipitation. Regarding landslides in Izumozaki, it can be pointed out that more landslides have taken place in the West Hill areas despite of the smaller amount of rain; those hill areas are folded mountains of the same geological age with the East Hill area. The main reason for this

difference in landslide frequency is probably that many surface collapses occur on steep hills extending close to the coastline of Izumozaki town (Toyota et al., 2006a). Vegetation on that hill is mainly grass and shrubbery. A weathered soft rock layer is buried several tens of centimetres under the surface soil. Topography and geology are also important determinants of the degree of earth disasters because this type of slope is apparently vulnerable to heavy rainfall and earthquakes.

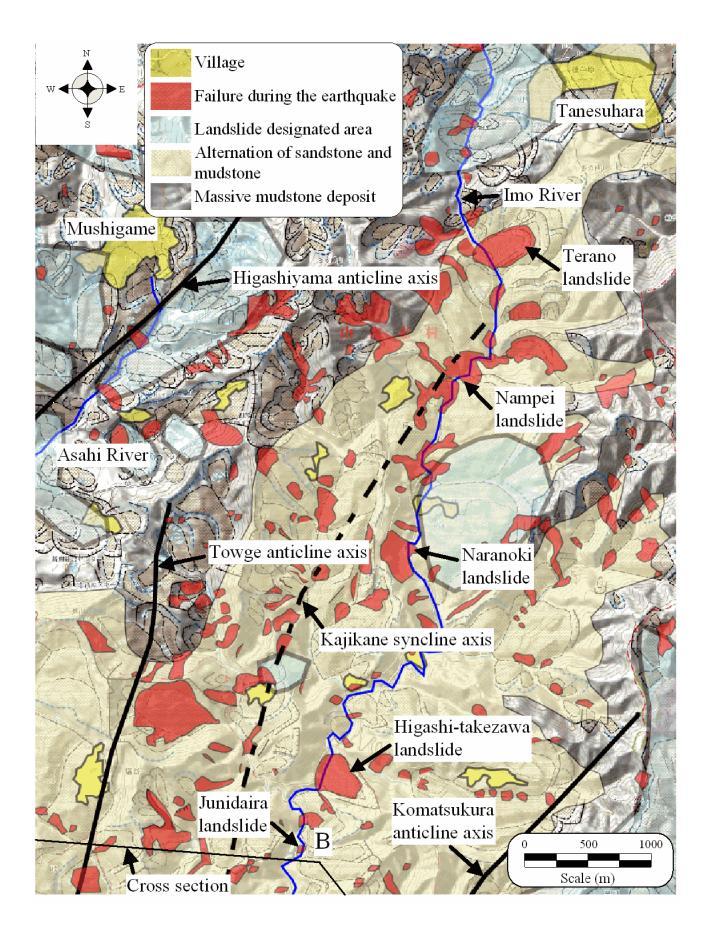
Figure 4 Landslide distribution during the Chuetsu Earthquake and geological map of Yamakoshi (Based on Takeuchi et al. (2004))

Figure 4 was prepared by overlaying a map of the locations of landslides occurring during the earthquake in the Yamakoshi area (Fig. 1) on a simplified geological map provided by Takeuchi et al. (2003). Landslide designated areas obtained from a conservation map of Niigata prefecture (1982) are also shown in the figure. Many designated landslide areas are located in the East Hill area. River-clogging landslides along the Imo River during earthquakes are known as the "Terano", "Naranoki" and "Higashi-takezawa" landslides. Large-scale landslides such as those of Terano and Higashi-takezawa, which required urgent actions to alleviate river clogging, might be of a reactivated type because they coincide completely with the old landslide topography (Towhata and Toyota, 2010).

The west side (brown colour) of the map, which is classified as the Asahi River Basin (Fig. 4), is geologically an Araya deposit of massive dark grey mudstone. At the downward side (ochre colour) of the map, which is classified as the Imo River Basin (Fig. 4), the deposits are alternating sandstone and mudstone, named the Kawaguchi and Wanatsu deposits. This alternation of sandstone and mudstone is distributed mainly along the Imo River, except in its upper course. As presented in Fig. 4, numerous landslides occurred during earthquakes more frequently in areas with alternated layers of sandstone and mudstone than in areas with massive mudstone deposits. This finding implies that sandy natural slopes (alternating sandstone and mudstone) are more fragile than clayey natural slopes (massive mudstone) during earthquakes. However, landslidedesignated areas, indicating that snowmelt waters have induced landslides, are distributed mainly in the massive mudstone deposits. Moreover, the notable geological features of this region are syncline and anticline structures. A peculiarly cuesta-like topography is apparent in this region because of its complex topography: synclinal axes and anticlinal axes are arranged with a short interval (Fig. 4). Fragile and weak slopes are therefore easily formed. In addition, the river scours the riverbed and the slope toe. Then the slope becomes u unstable. For those reasons, it is considered that numerous landslides occurred during the earthquake.

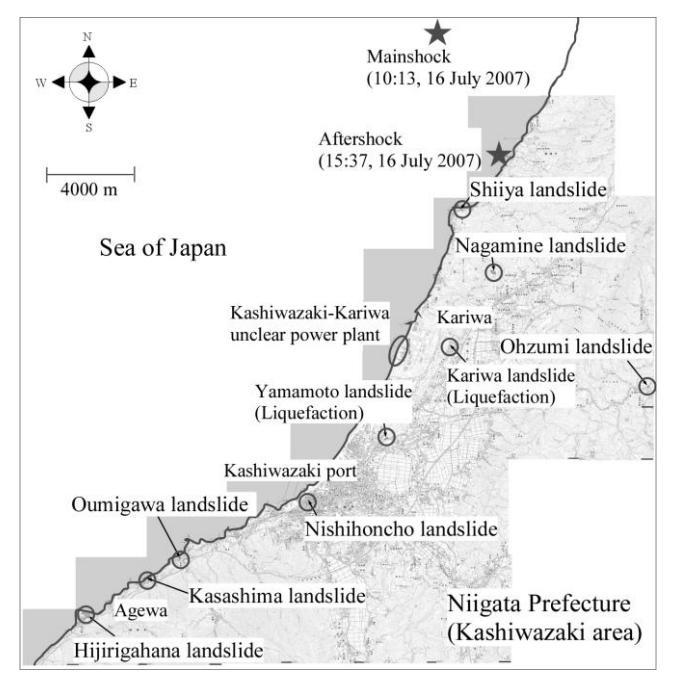
Figure 5 Main landslide distribution during the Chuetsu-oki Earthquake

According to a report of the Ministry of Land, Infrastructure, Transport and Tourism (MLIT) issued on 6 Aug. 2007, 108 slope failures occurred during the Chuetsu-oki Earthquake. Figure 5 depicts the main slope failure sites including those caused by liquefaction during the earthquake. The main slope failures are concentrated in the steep slope of coastal terrace from Shiiya to Hijirigahana, which is about 25 km distant, because the earthquake occurred not under a mountainous area but under an offshore area and the fault moved from the epicentre to the south. Large mass movements rarely occurred in inland areas except for the case described by Ohzumi (Toyota and Onoue, 2008). Although the epicentre location is important to ascertain potential damage to an area, results show that the slopes of coastal terrace are weak during the earthquake, just as in the case of the 7.13 Niigata flood disaster.

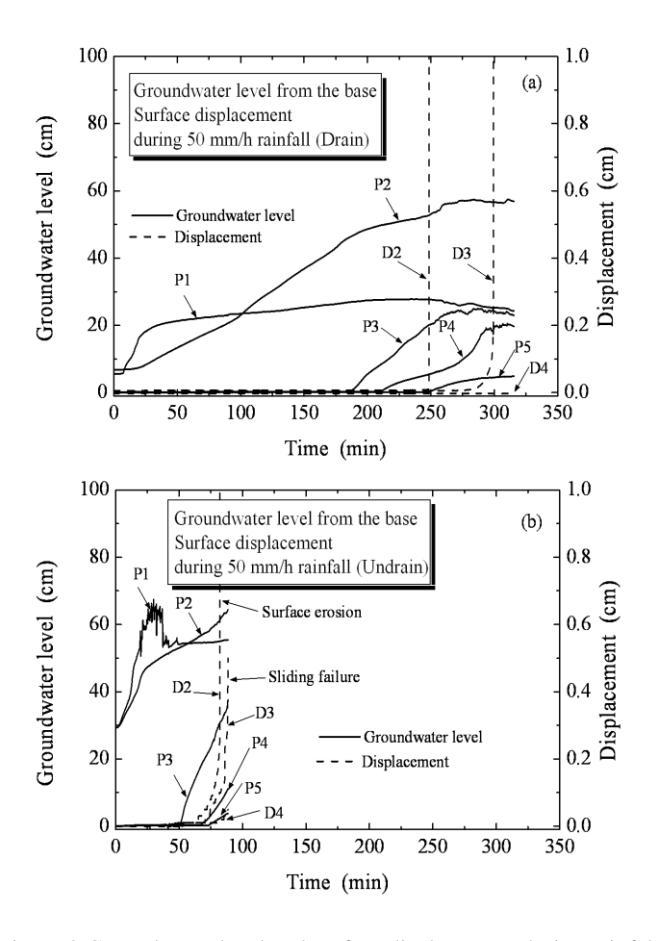
Figure 8 Groundwater level and surface displacement during rainfall: (a) Drained condition, (b) Undrained condition

Two test cases were conducted to compare the relation between the increase of groundwater level and the failure time. The first case is designated as the drained condition (Case 1), in which groundwater accumulated by rainfall is drained from the front vertical surface using the drain sheet as shown in Fig. 6. The second case is designated as the undrained condition (Case 2), in which groundwater is accumulated in the container without draining. It overflows from the container during rainfall, as shown in Photo 1 and 2. Figure 8 shows the groundwater level from the base estimated using pore water pressure meters and surface displacement during the main rainfall. The groundwater levels of about 6 cm and 30 cm, which are induced by the initial rainfall, respectively remain in the flat parts of the model slopes in Case 1 and Case 2. Groundwater level measured by P1 and P2 sometimes exceeds 50cm, which is 43/48 depth of model ground. The reasons are that depth of the container is 60cm and that surface soil partly flows down by surface erosion. When the groundwater level of P5 increased, large deformation occurred near the toe of the slope (D2) in both cases. Especially in Case 2, the deformation behaviour showed a sign of failure that gradually developed to about 10 cm before P5 increased. The deformation of D2 was triggered by surface erosion, as shown in Photos 1(a) and 2(a). In Case 1 (Fig. 8(a)), the surface erosion gradually extended to D3, as presented in Photo 1(b). However, the displacement of D3 in Case 2 (Fig. 8(b)) was generated by the sliding failure, as depicted in Photo 2(b). The difference of groundwater level is that the increase of P3 is limited in Case 1, whereas P3 is increasing in Case 2 until sliding failure is generated. A large difference is also apparent in the failure time between Case 1 and Case 2. It is inferred that the rise of groundwater level in a slope is a key factor for slope stability because of the relation between the groundwater level and failure time. The failure type and triggering time are closely related with the groundwater level of the slope. Therefore, it is useful to monitor groundwater levels to discuss slope stability problems.

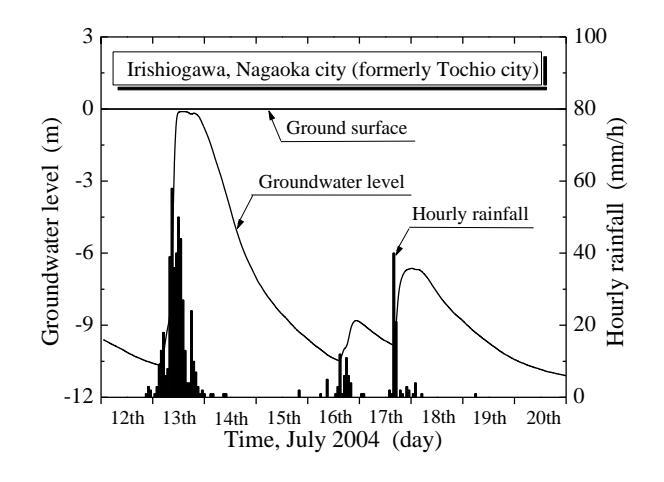
Figure 11 Groundwater level during the 7.13 Niigata flood disaster

First, fluctuation of the groundwater level during the 7.13 Niigata flood disaster is demonstrated with hourly rainfall data in Fig. 11. The rainfall data of the nearest areas from the measuring point were selected from among data provided by the JMA. The measuring point of Irishiogawa is about 4 km distant from the rainfall-recorded points. The groundwater level rises immediately by about 11 m with rainfall. From this quick rise, a permeable layer might exist in the slope. However, the groundwater level descends gradually over a few days, meaning that groundwater flowed into this catchment area after the rainfall. Although the mass movement induced by this rainfall is not obvious because the slope deformation has not been measured, deformation was not confirmed by visual observation. It is clear that an unstable state having a high groundwater level was generated in the slope during heavy rainfall.

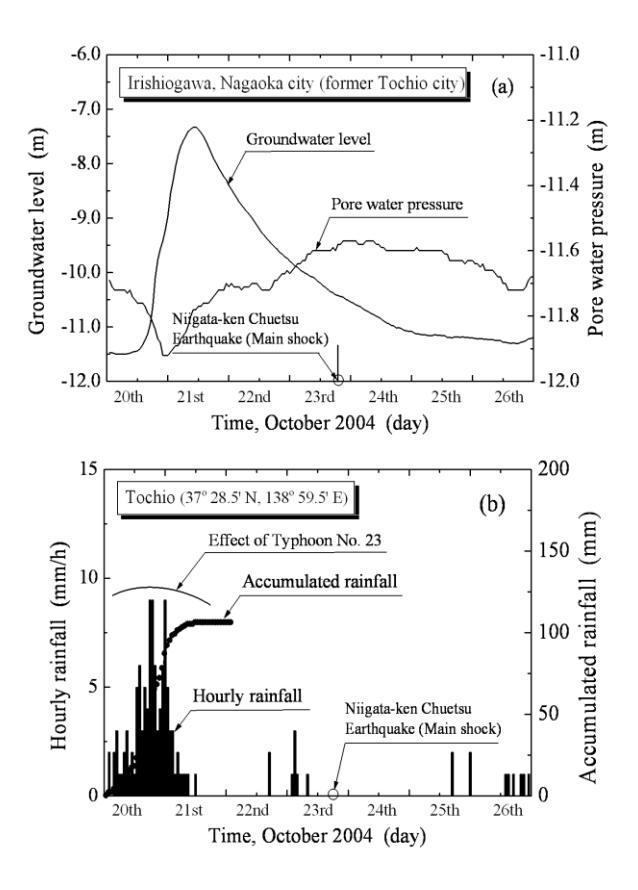
Figure 12 Groundwater level during the Chuetsu Earthquake

Figure 12 presents records of the groundwater level and hourly rainfall at Irishiogawa during the Chuetsu Earthquake. The pore water pressure was also measured in this term. Rainfall of typhoon No. 23 was precipitated on 20 Oct. 2004. The rainfall accumulation reached 100 mm in this area (Fig. 12). The groundwater level rose quickly, about 4 m, with the rainfall and descended gradually over a few days. The rise in the groundwater table induced by the typhoon had dropped by about 3 m in Irishiogawa by the time of the Chuetsu Earthquake. It is apparent that this area contained more water during the Chuetsu Earthquake than it does under ordinary conditions.

The pore water pressure dropped on 20 Oct. 2004 with low atmospheric pressure; it then increased gradually. Although the pore water pressure reached a peak at the time of the Chuetsu Earthquake, its increase of about 20 cm in the water head is too small to affect slope stability. The pore water pressure sensors might not have been installed near the unstable slip surface where pore water pressure will change highly during disaster events.

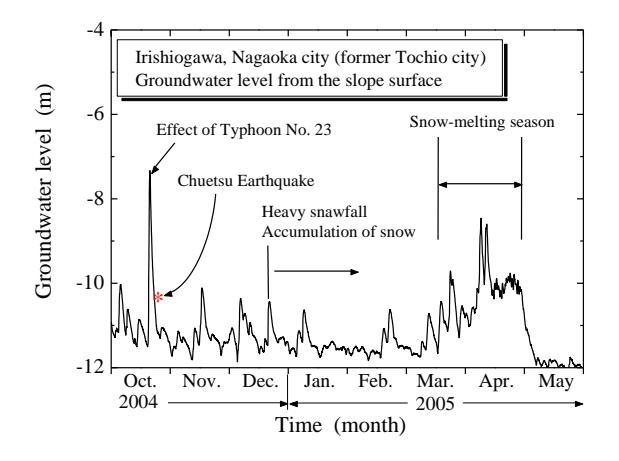
Figure 13 Groundwater level fluctuation: Oct. 2004 - May 2005

Fluctuation of the groundwater level during October 2004 - May 2005 is presented in Fig. 13. It is understood that groundwater level at three days before the Chuetsu Earthquake was the highest during the displayed period of time. The snow season starts from mid-December. The total amount of snowfall reached 699 cm at Nagaoka during that winter. Snow melting accelerates from March with the coming of spring. The groundwater level increases during

the snow-melting season because of soaking of snow water. Then it drops suddenly after snow melting (in May) as presented in Fig. 13. It is noteworthy that tertiary type landslides in this area have frequently occurred in April and May, which are months of the snow-melting season. Therefore, the slope damaged by the Chuetsu Earthquake was feared to begin moving again, but no large mass movement occurred during the snow-melting season. The Northern Nagano Earthquake occurred in a mountainous area on 12 March 2011. Only limited slope failures were observed during the earthquake. From estimation using Fig. 13, although the year differs, there is a possibility that the groundwater level had not increased at the time of the earthquake.

Landslides have occurred frequently during the snow-melting season in this area because of high groundwater levels (Fig. 13). Therefore, a slope damaged by the Chuetsu Earthquake was feared to begin moving again, causing a secondary disaster. After the snow had melted, follow-up investigations were conducted to observe the damaged slope sites. However, it is reported by Toyota (2010) that no large mass movement occurred during the snow-melting season, although surface erosion and small surface failures were observed during snow-melting and rainy seasons. These sliding masses induced by the Chuetsu Earthquake were therefore stable except for erosion from rain and snow-melt.

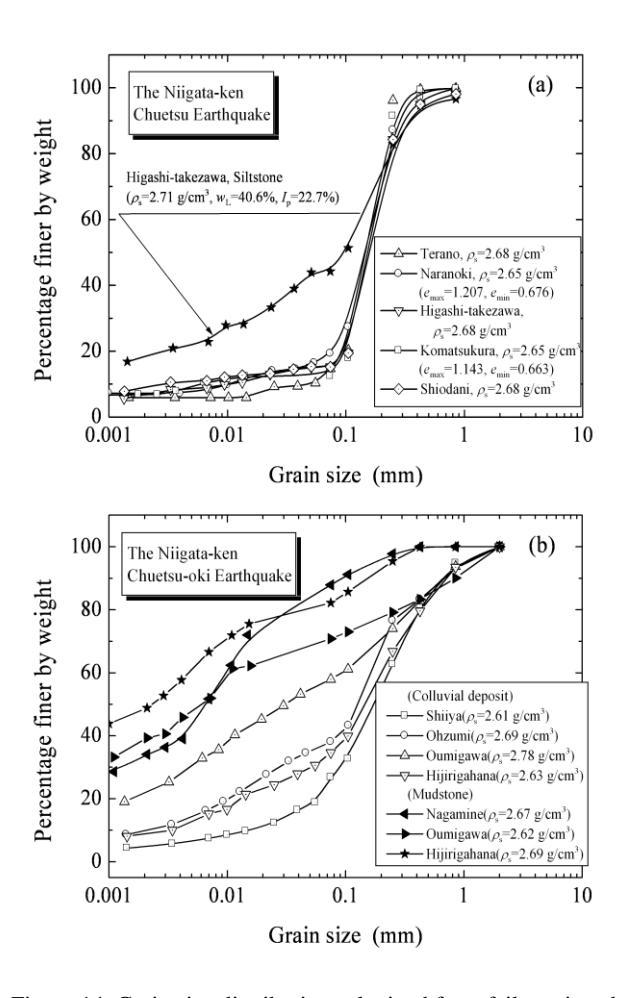
Figure 14 Grain size distributions obtained from failure sites that were (a) damaged by the Chuetsu Earthquake and (b) damaged by the Chuetsu-oki Earthquake

Figures 14(a) and 14(b) show grain size distributions of soil samples taken from slope failure sites of the Chuetsu and the Chuetsu-oki Earthquakes. All samples portrayed in Fig. 14(a) were obtained from the main scarps of the slope failures along the Imo River (except Shiodani) during the Chuetsu Earthquake. They are sands including less than 10% fines. Therefore, sandy natural slopes collapsed mainly during the earthquake, not clayey natural slopes. The mudstone that lay exposed after the slope failures at Higashi-takezawa is composed mainly of silt: siltstone. These results agree with information shown in the geological map: alternating sandstone and mudstone strata. Figure 14(b) portrays the grain size distribution of colluvial deposits and mudstones exposed after the slope failures during the Chuetsu-oki Earthquake. Mudstone contains much more

fines than colluvial deposits do. Furthermore, the colluvial deposits have higher fines contents than those shown Fig. 14(a). Therefore, silty and clayey deposits were more predominant in natural slope failure sites during the Chuetsu-oki Earthquake than in the Chuetsu Earthquake in spite of their roughly equivalent geological age in East Hill, West Hill, and coastal areas of Kashiwazaki (Fig. 2). This aspect might explain the lower number of failure sites associated with the Chuetsu-oki Earthquake than with the Chuetsu Earthquake.
