Overview of the Geotechnical Damages and the Technical Problems Posed after the 2011 Off the Pacific Coast of Tohoku Earthquake

M. Kazama¹, T. Noda², T. Mori¹ and J. Kim¹

ABSTRACT: The 2011 Off the Pacific Coast of Tohoku Earthquake which occurred on March 11, caused serious damage to the infrastructural facilities in Tohoku and Kanto districts due to the strong motion of the earthquake and the subsequent tsunami. This paper includes a brief outline of the earthquake, the earthquake damage to various facilities, and the main geotechnical engineering problems which have emerged after this disaster

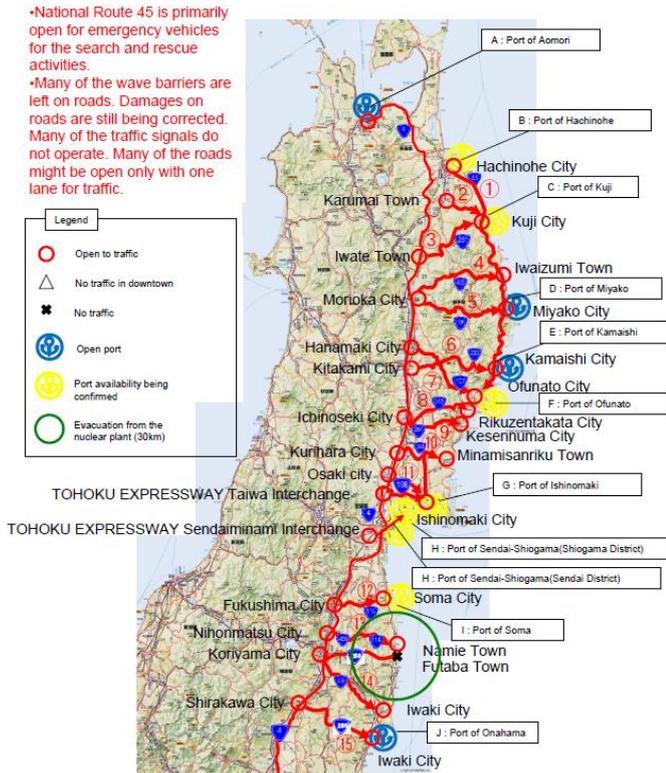
The tsunami caused damage to road facilities, in particular to National Route 45, which connects the Pacific coastal part of Tohoku Region running north-south. Because the main north-south route along the coast was closed, the Ministry of Land, Infrastructure, Transport (MLIT) Tohoku Regional Development Bureau adopted a road-opening strategy that was referred to as the "teeth of a comb strategy." The strategy was to first open the inland National Route 4, in the backbone of the Tohoku Region, and then to secure road transport to the disaster-stricken areas along the coast, like the teeth of a comb (see Figure 5).

Figure 5 Road opening strategy taken by the national government

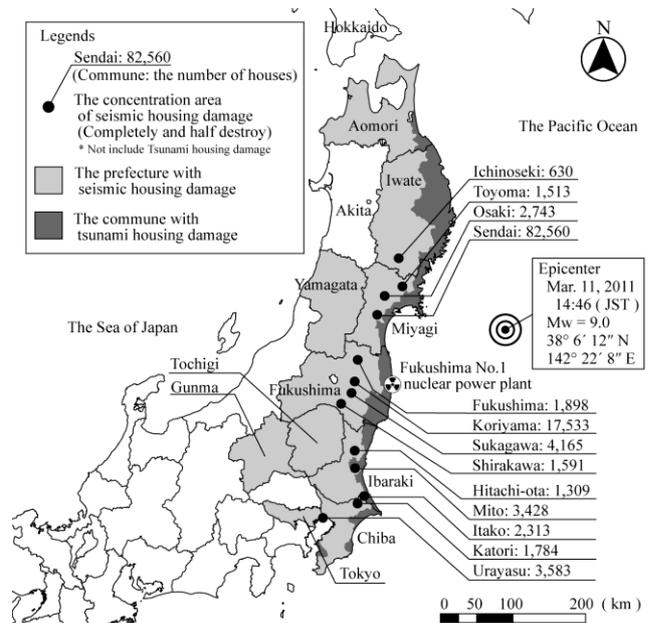
In the eastern areas along the coast, most of the damage to housing structures can be attributed to the tsunami. In contrast, in the hilly areas within cities with large-scale areas of developed residential land, restoration of damaged housing had still not been achieved even after 9 months. Figure 11 shows the damage map of private dwellings. Detailed information about this matter will be available in Japanese Geotechnical Society articles to be published soon.

Figure 11 The damaged area and the number of dwellings damaged by seismic activity in a representative community
