## Advance in Geogrid Reinforced Slopes in Malaysia

T.A. Ooi<sup>1\*</sup> and C.H. Tee<sup>2</sup>

**ABSTRACT:** Geogrid product was formally introduced into and developed in Malaysia after Pilecon Holdings Sdn Bhd signed a distributorship agreement with Netlon Ltd (now Tensar International Ltd) United Kingdom in 1985. Prior to that Star Art Sdn Bhd was the distributor of Netlon product in Malaysia. Ooi & Tee (2004) examines the various case histories of slope repair and the role of geosynthetic reinforcement used in slope reconstruction and their performances for the last twenty years since the introduction of geogrids to Malaysia. Slope failure is not uncommon in many parts of Malaysia. Asahari (2009) reported more than 100 landslide incidences a year in Malaysia at a seminar on safe hill-site development in Kuala Lumpur. The frequency of occurrence of slope failure increases during the monsoon seasons where incessant rain extended over long period of time caused the slope to fail despite the fact that it may be stable for a long time. The infiltration of rainwater causes the reduction of soil suction, rise in water table and reduction of the shear strength of soil. In the cas

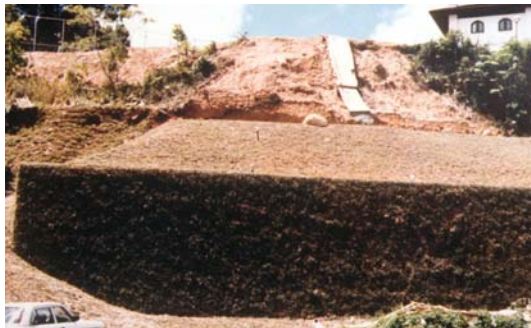
Figure 2d Rehabilitation in progress with upper slope, 1987

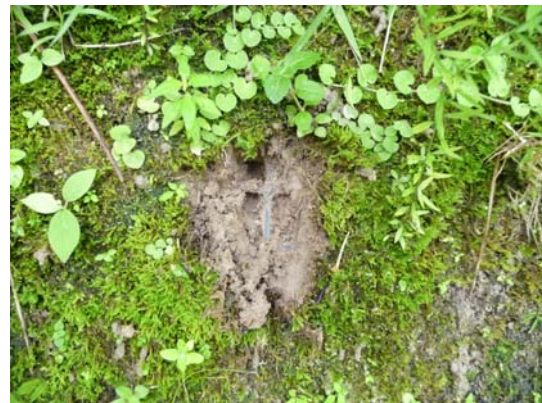
Figure 2i Petronas bungalow slope failure rehabilitation 2010

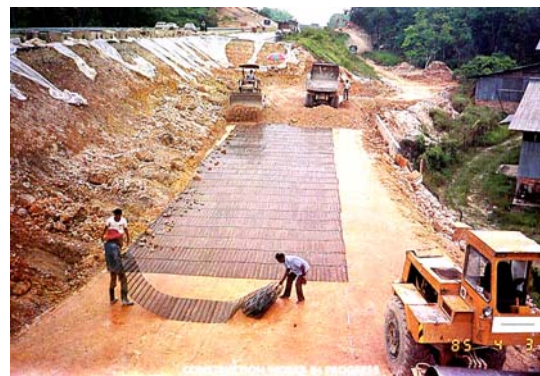
Figure 3b Rehabilitation in progress; laying of geogrid

In Malaysia, the use of geosynthetics for reinforcement of road embankment was introduced into JKR in early 1985 in the Temerloh – Mentakab bypass. In this instant, it was not possible to use stabilizing berm technique due to the limited width of the road reserve and the embankment had failed. In order not to encroach into private land, a 45° slope with 8.5m high embankment was reconstructed and reinforced with 6m length of SR2 uniaxial geogrid at 1.2m. The material used was residual soil of sandstone / shale compacted to wet of optimum moisture content at 90% degree of compaction using B. S. heavy compaction. An internal drainage system using sand drainage layer was provided at the back of the cut back slope and the base of the embankment with suitable drainage outfall as shown in Figure 3. This embankment has remained stable for 25 years.

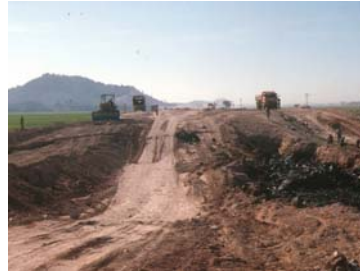
Figure 4b Excavation in embankment

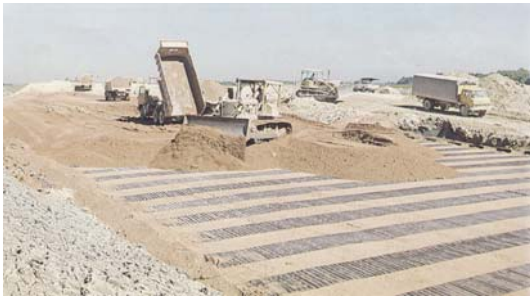
Figure 4d Laying of SR2 uniaxial geogrid

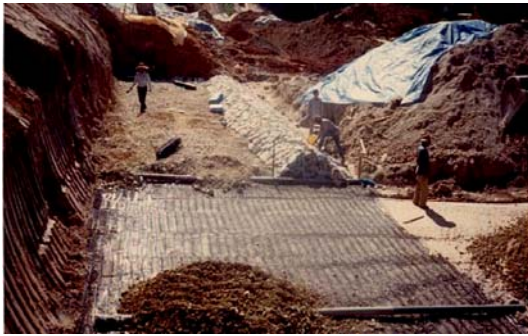
centres. A rock fill toe and toe drain was also provided to avoid toe softening due to poor drainage. Figure 10d shows rehabilitation in progress. Figure 10e shows picture of rehabilitated slope.

Figure 10d Rehabilitation in progress, 1989

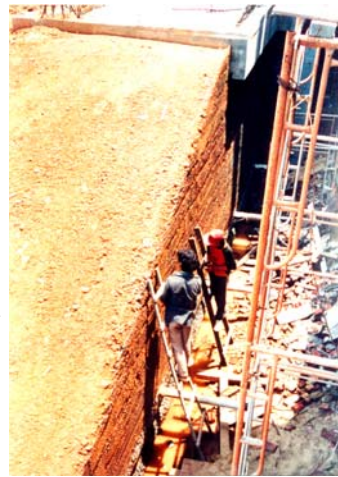
Figure 13b Completed wall

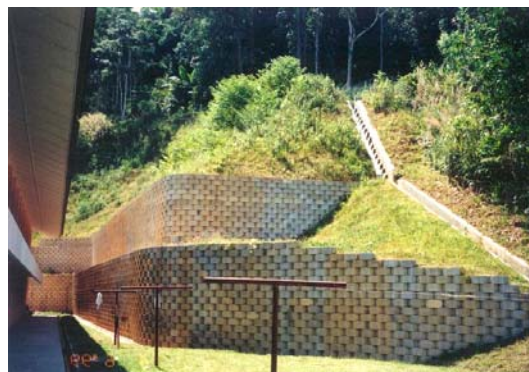
Figure 14c View of Rehabilitated Slope

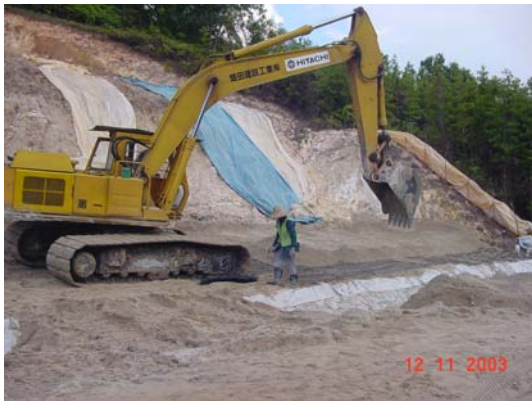
Figure15c Rehabilitation in progress

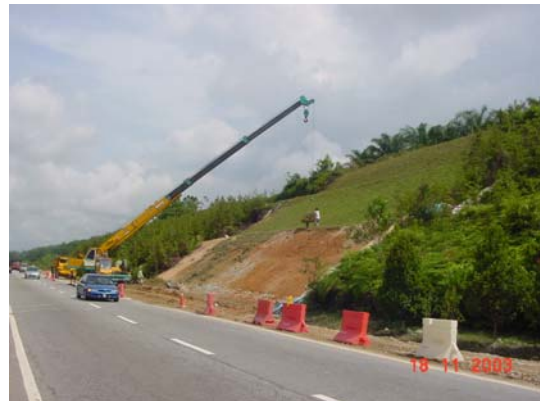
Figure15d Rehabilitated slope

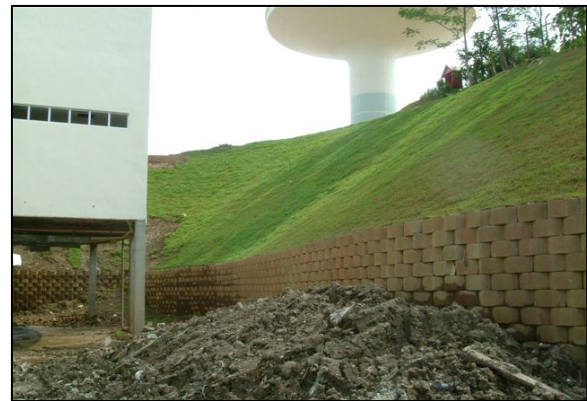
Figure16d Rehabilitated slope

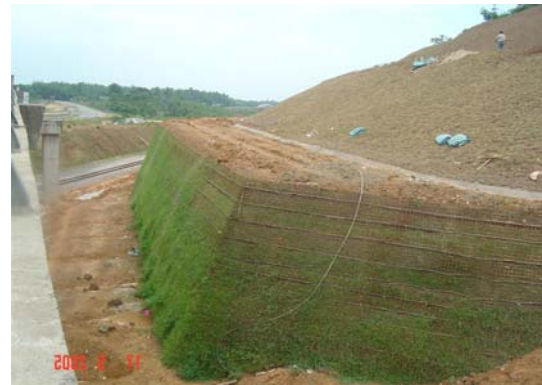
Figure 18e Turfing of geogrid block

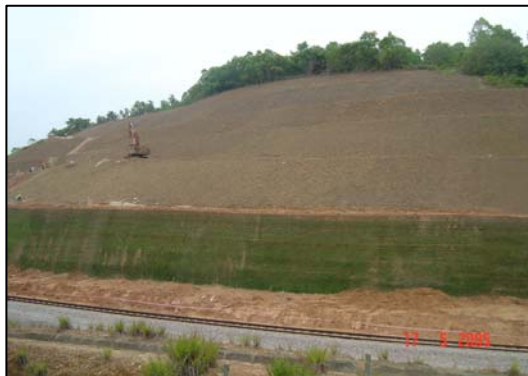
Figure 18f View of rehabilitated slope

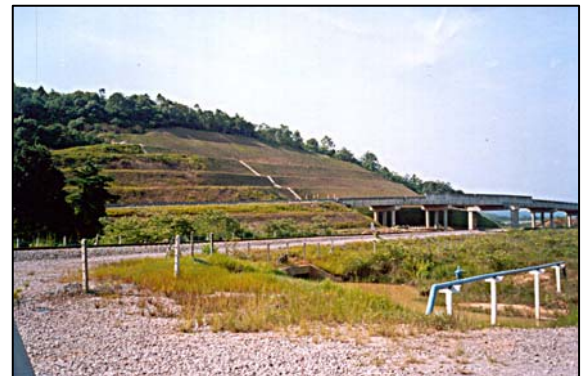
Figure 18g Overall view of rehabilitated slope

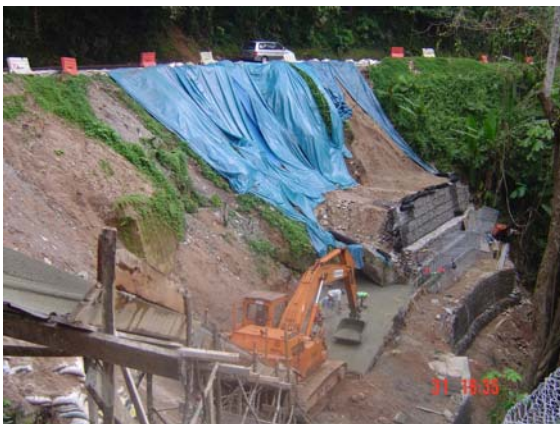
Figure 19c View of slope on rehabilitation

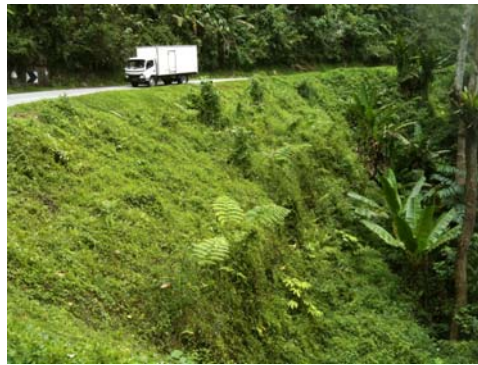
Figure 19e Recent view of rehabilitated slope

Figure 19 Collapse of Tapah-Ringlet Road embankment, Tapah, Cameron Highland.

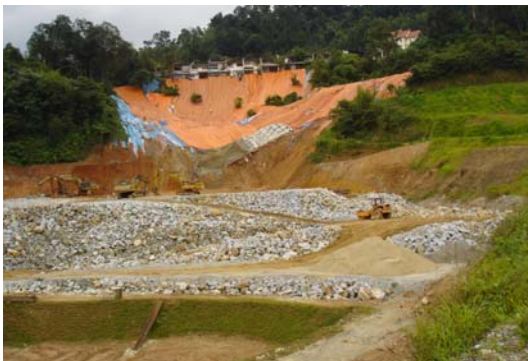
Figure 20h Construction of lower rock fill embankment

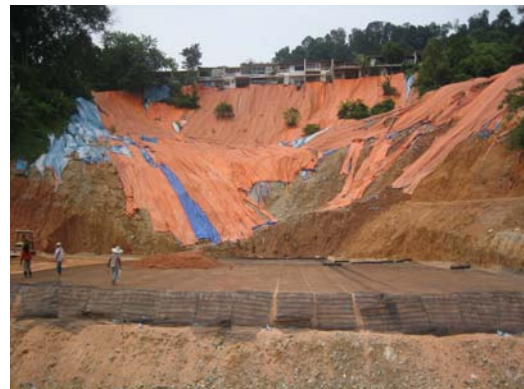
Figure 20i Construction of upper geogrid embankment

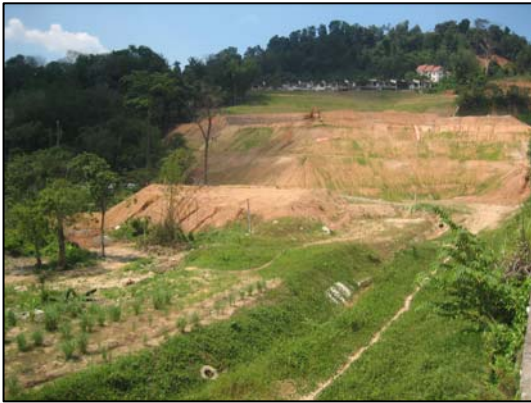
Figure 20n Rehabilitated slope on completion.

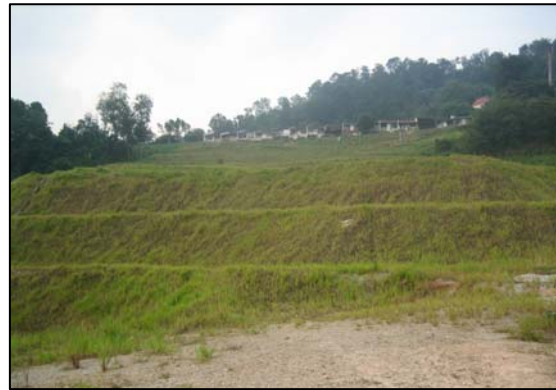
Figure 20p Rehabilitated slope with turf established
