SEISMIC BEHAVIOR OF FRAMES WITH UNEVEN LARGE SECTION BEAMS OF TRADITIONAL WOODEN STRUCTURE

NORIKO TAKIYAMA and NAOTO IDATE

Div. of Architecture and Urban Studies, Tokyo Metropolitan Univ., Tokyo, Japan

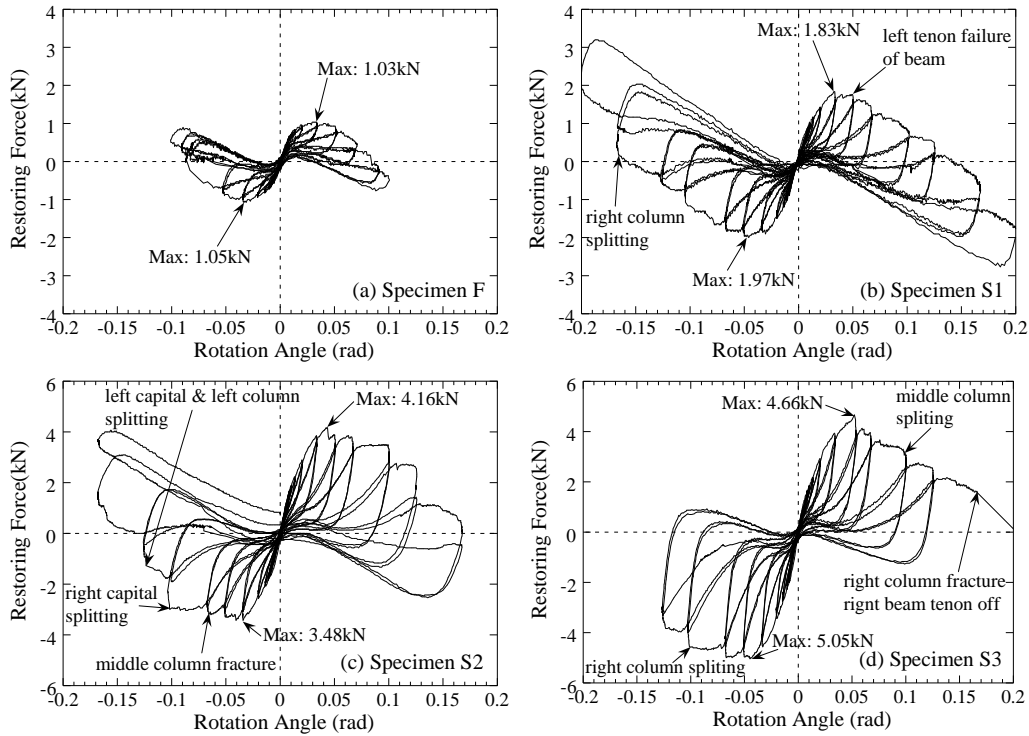
Figure 4. Restoring force.

The restoring force and skeleton curves of the shear force are shown in Figures 4 and 5, respectively. Figure 5 compares the skeleton curves for both loading directions and the shear force with a “manual” limit-strength calculation.

For Specimen F and S1, the restoring force reached maximum values of 1.03 and 1.83 kN, respectively, at +1/30 rad. For both specimens, the shear forces in both loading directions were approximately the same as the manual value.

For Specimens S2 and S3, the restoring force reached maximum values of 4.16 and 4.66 kN, respectively, at +1/20 rad. These values are larger than the deformation of one span frame. For both specimens, the shear forces in both loading directions did not differ significantly from the manual value, but the shear forces had directional dependence. In Specimen S2, the frame was symmetrical, but the middle column-beam joint was not. On the other hand, in Specimen S3, the middle column-beam joint was symmetrical, but the frame was not.

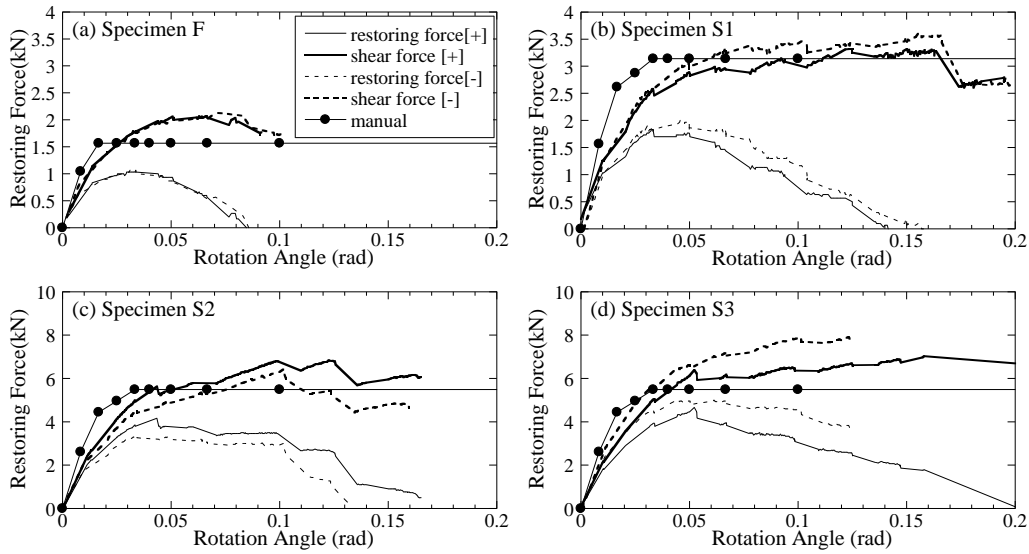
Figure 5. Skeleton curve of shear force.
