Corrosion of neutron/gamma-irradiated aluminium alloy 6061

Kotchaphan Kanjana* and Jatechan Channuie

*Division of Research and Development, Thailand Institute of Nuclear Technology,
Ongkharak, Nakhon Nayok, 26120 Thailand*

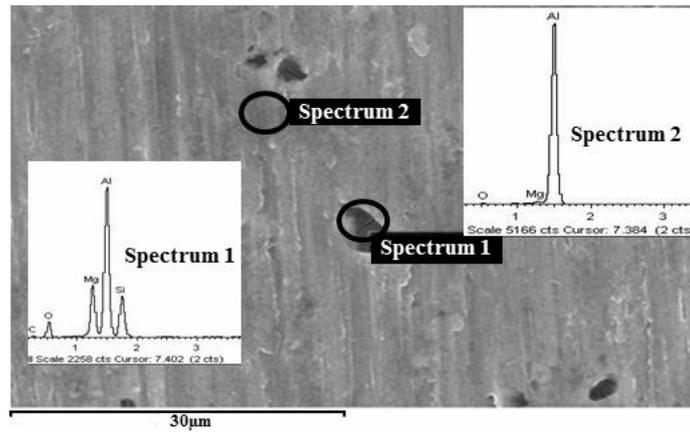
Figure 1. Surface morphology of the blank AA6061 sample taken by SEM-EDAX.

The surface morphology of the blank sample was also investigated using SEM-EDX technique. As shown in Figure 1, all over the sample surface was found to be non-uniform with two distinct features. One was expectedly smooth surface mainly composed of Al (Spectrum 2) and the other was darker areas (Spectrum 1) containing Si and Mg in addition to Al. Si and Mg are known to be added during alloy precipitation for strengthening purpose. The carbon component detected was a contaminant from the sample preparation process.

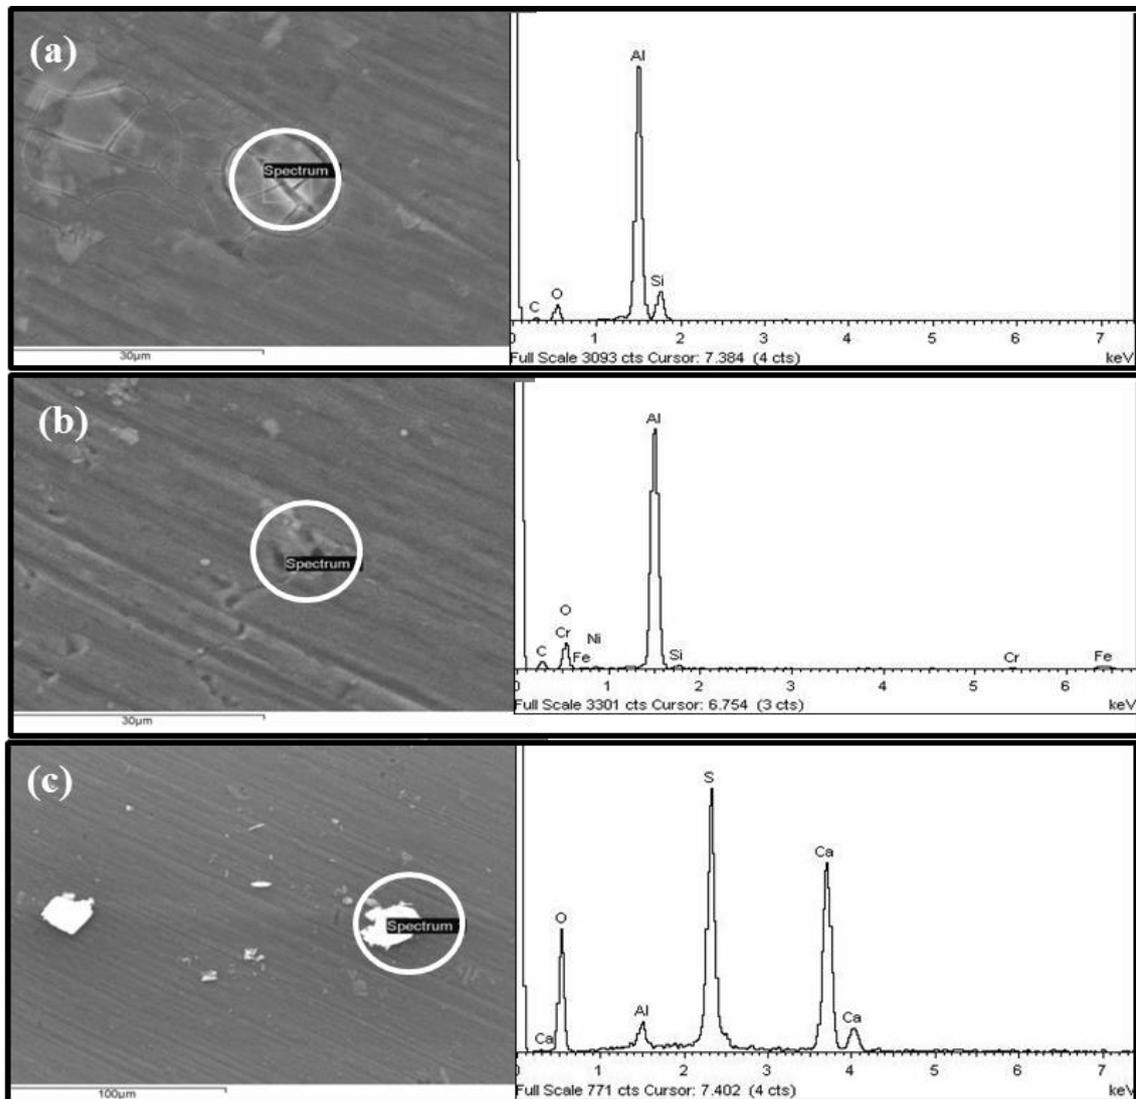
Figure 2. Surface morphology of AA6061 samples exposed to mixed neutron/gamma (26 hrs): (a) exposed to 1.7×10^{18} n/cm², (b) exposed to 3.9×10^{18} n/cm² and (c) corrosion product after exposing to 3.9×10^{18} n/cm².

The morphology of the AA6061 samples exposed to mixed neutron/gamma radiation is illustrated in Figure 2. It can be clearly seen in Figure 2a that after exposing to low fluence (1.7×10^{18} n/cm²) there is no evidence of corrosion product on the sample surface. However, it appears to have crack-like features on the surface of the samples which was not found in the samples exposed to high fluence (3.9×10^{18} n/cm²) (see Figure 2b). These non-corresponding results indicate that the phenomenon may not be relevant to irradiation.

This challenging issue is left for our future investigation. In addition, the evidence of corrosion products was found in the sample exposed to higher neutron fluence (Figure 2c.) The corrosion products observed contains O, S and Ca in addition to Al matrix element. The O component implicates oxide formation on the sample surface. At room temperature the corrosion products generated from oxidation of Al in water are commonly found in the form of amorphous alumina (Vargel, 2004; IAEA, 2003) or a crystalline aluminum hydroxide AlO(OH), boehmite (Farrell, 2012). With continued immersion in water, the latter product may eventually transform in to a crystalline aluminum hydroxide (Al(OH)₃), so-called bayerite. However, considering our experimental conditions (temperature and pH) in conjunction with the features of the corrosion products virtually observed in Figure 2c, the products in this experiment are presumably amorphous alumina. The traces of S and Ca detected were likely to come from demineralized water.

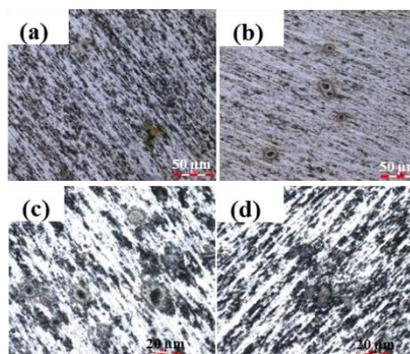
Figure 3. Surface morphology of AA6061 samples from gamma radiation experiments taken by a confocal microscope: (a) 100 hrs of immersion in demineralized water without exposing to gamma radiation, (b) 100 hrs of immersion in demineralized water while exposing to 300 kGy of gamma radiation, (c) 200 hrs of immersion in demineralized water without exposing to gamma radiation and (d) 200 hrs of immersion in demineralized water while exposing to 600 kGy of gamma radiation.

In order to study separate effect from gamma radiation, AA6061 samples were irradiated with gamma radiation for 100 hrs (300 kGy) and 200 hrs (600 kGy) while immersing in demineralized water. The sample morphology from the gamma experiments taken by a confocal microscope can be seen in Figure 3. After immersing in demineralized water for 100 hrs without exposing to radiation, some brown spots were observed on the sample surface (Figure 3a). When the sample was allowed to expose to 300 kGy of gamma radiation, a number of dark spots were detected (Figure 3b.). The dark spots seem to develop from the brown spots shown in Figure 3a. It was reported previously pitting corrosion is the major corrosion type found in AA in contact with water (Davis, 1999; Farrell, 2012; Zaid, Saidi, Benzaid, & Hadji, 2008). Therefore, it is reasonable to believe that with higher gamma radiation dose, the dark spots will evolve into pitting corrosion. To verify this assumption, 600 kGy of gamma radiation was used to perform an additional experiment, the results of which are demonstrated in Figure 3d. Unfortunately, the morphology taken by the confocal microscope did not give a good comparison between the results from the control (Figure 3c.) and the experimental (Figure 3d.) sets. Therefore, the sample exposed to 600 kGy of gamma radiation and the control set were later characterized by SEM-EDX as shown in Figure 4. The SEM micrographs shown in Figures 4a and 4b clearly show the effect of gamma radiation on pitting corrosion of the AA6061 sample. More pits were developed in the sample exposed to 600 kGy of gamma radiation compared to the controlled sample in Figure 4a. It is implicit that with higher gamma dose the sample surface is more corroded producing corrosion products with higher density. The EDX spectra of the corrosion products appearing around and on the pits can be seen in Figures 5a and 5b. The results reveal that the %wt ratios of Al:O of the products around and on the pits are approximately 64:36 and 53:47 indicating the formation of bayerite (Al(OH)₃) and boehmite (AlO(OH)), respectively. Both aluminum hydroxides have been proven to stabilize in the crystal structure (Farrell, 2012).

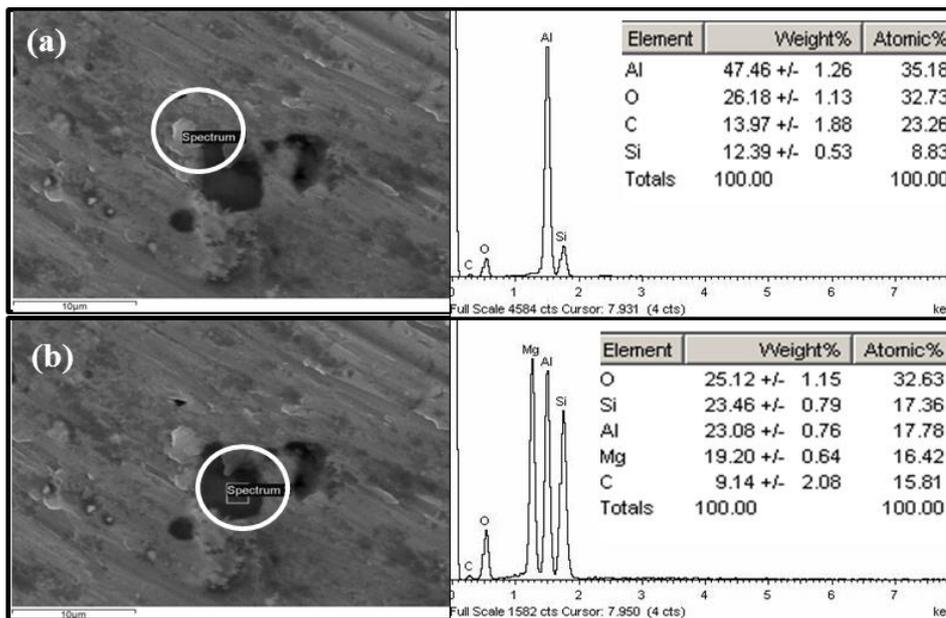
Figure 5. Surface morphology of AA6061 samples after 200 hrs of immersion in demineralized water while exposing to 600 kGy of gamma radiation taken by SEM: (a) with EDX spectrum of the corrosion product around the pit (b) with EDX spectrum of the corrosion product covering the pit.
