Ancient Service Systems in Historic Houses and Their

Contribution to Sustainable Urban Development: The Case of Architect Sinan's House

Gülşen Dişli⁺ & Gül Gediri-Gökçen⁺⁺ (Turkey)

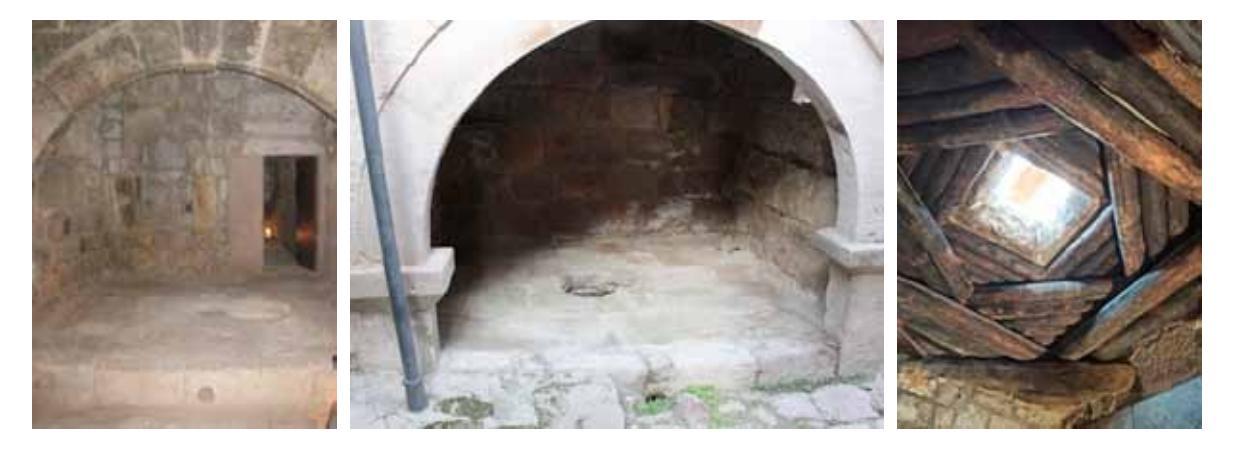
Figure 3. Tandoor pits (left & center) with their ash-discharge holes and stone sliding cover (*duvak*) & wooden lantern-roof/tüteklikli örtü. (right) Above the tandoor room in the stone masonry section. (Source: Photos by author).

The case study building is located in a region where winters are cold and severe and summers are quite hot. Therefore, the outdoor temperature directly affects indoor conditions and user comfort, requiring appropriate solutions compatible with the regional climate. The part of the house carved in rock meets this requirement to a great extent so that it is warm in winter and cool in summer. The proper orientation of the living spaces, the window openings, and the local volcanic tuff material of the main walls in the upper part of the building also contributes to heating the spaces. The sun is the main source of natural heating in the upper parts of the house. Shallow or splayed window openings are used for this purpose. Furnaces and built-in fireplaces, on the other hand, were the direct heating elements located in different parts of the house. There were three types of heating devices: Tandoors for cooking and heating, built-in fireplaces with chimney pots in the rooms of the upper part for heating the rooms, and cast-iron furnaces for mining in the part of the house cut into the rock. The tandoor room, which opens onto the courtyard just outside the kitchen, was used during the day in summer as a semi-open extension of the kitchen for cooking. It was also used to heat the room and the body, especially at night. When it was used as a heater, a sliding cover made of metal or stone with a diameter of about 0,50-0,60m and a thickness of 0,10m, called duvak in the local language, covered its top

(Figure 3). A thick blanket was then spread over this cover, and people sat around the edge, using the indirect heat of the remaining embers (Cömert, 2005). In the case study house, a lantern-like roof/tüteklikli örtü covers this space above (Figure 3). In the traditional houses of Kayseri, braziers were another means of indirect heating. They were prepared either with pieces from the fire that turned into a fire from the oven or with charcoal that was specially prepared and burned in the courtyard. Then they were generally placed in the center to heat the living quarters. In some other cases, similar to the night use of tandoors, a wooden table was placed over the braziers and covered with a thick blanket so that users could warm their bodies. This mechanism is called isgembi (Imamoglu, 1992). Therefore, it is clear that in the building, the priority was to heat the body rather than the entire room in an effective manner, as in a traditional Anatolian house (Küçükerman, 1995). In the part of the house carved into the rock, there are casting furnaces with ash removal drains, which were used for mining purposes (Cömert, 2005). Therefore, it is assumed that this part might be used as an iron foundry (Anonymous, 2017). In the living rooms of the masonry part, there are also built-in furnaces located along the walls, with chimney extensions at the roof. The ovens, on the other hand, are located in the part of the house that is carved in stone, on the floor level, and are bordered with stone pieces. They were used either for heating the rooms or mainly for cooking. A ventilation hole can also be seen on the top cover, directly above these ovens (Figure 4, Figure 5). Another indirect source of heat for the rooms above the carved stables was the animals, so the small holes in the stone arches used to tether the animals support the animal husbandry in the rock-cut part of the building (Figure 6).

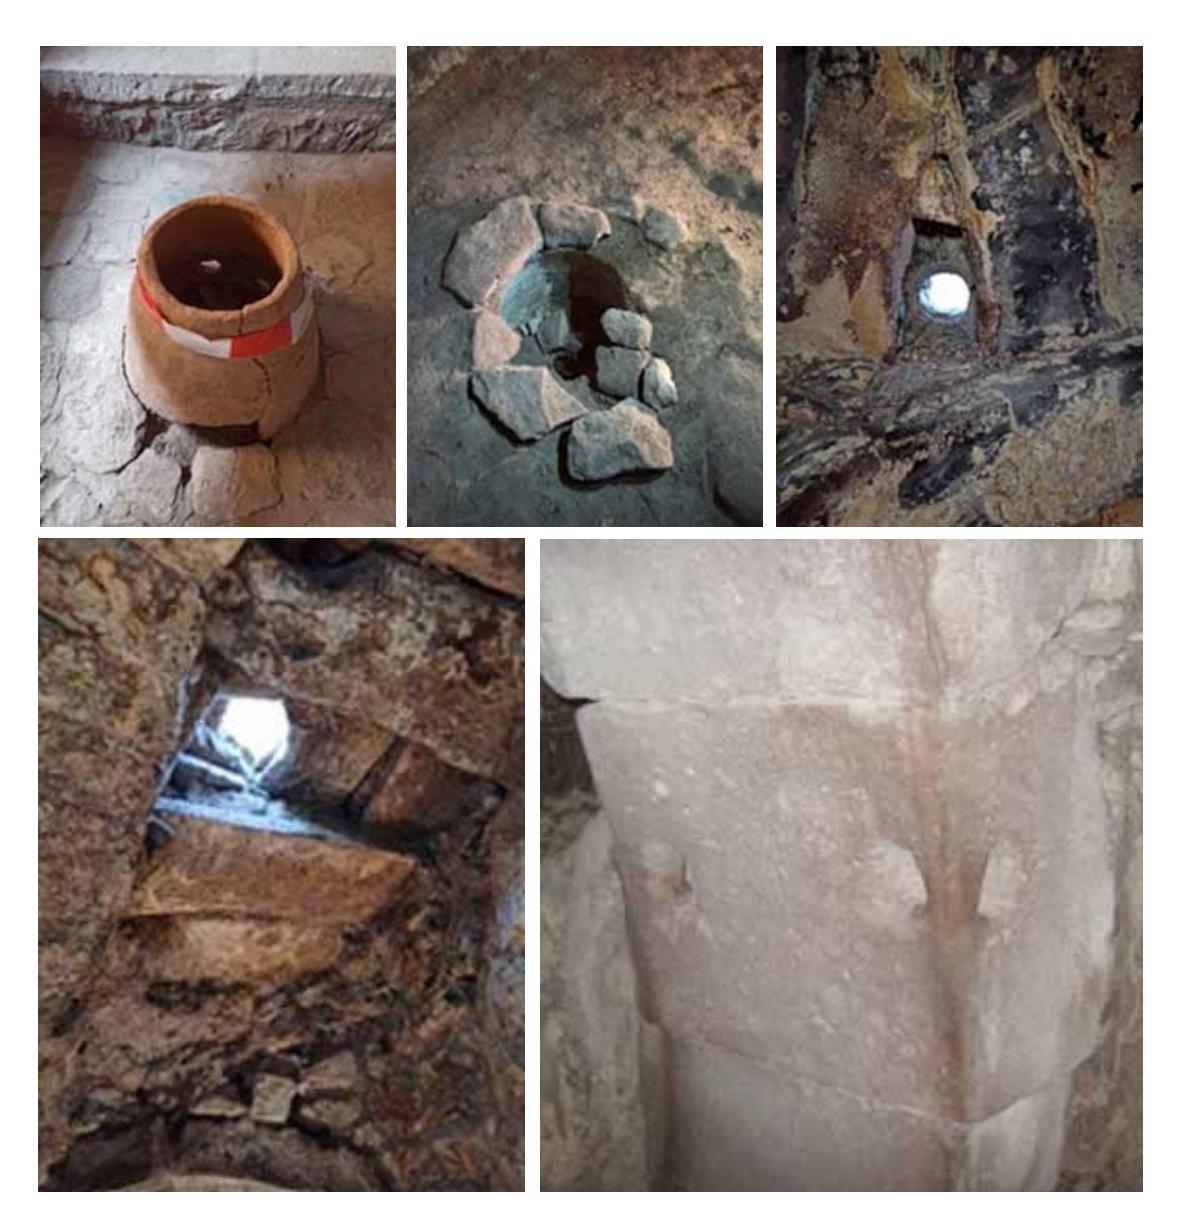
Figure 4. Views of the tandoor (top left) and the oven (top center) with their ventilation holes (top right & lower left) on the ceiling and stone arches with small holes for tethering the animals, in the carved rock-carved (lower right). (Source: Photo by authors).

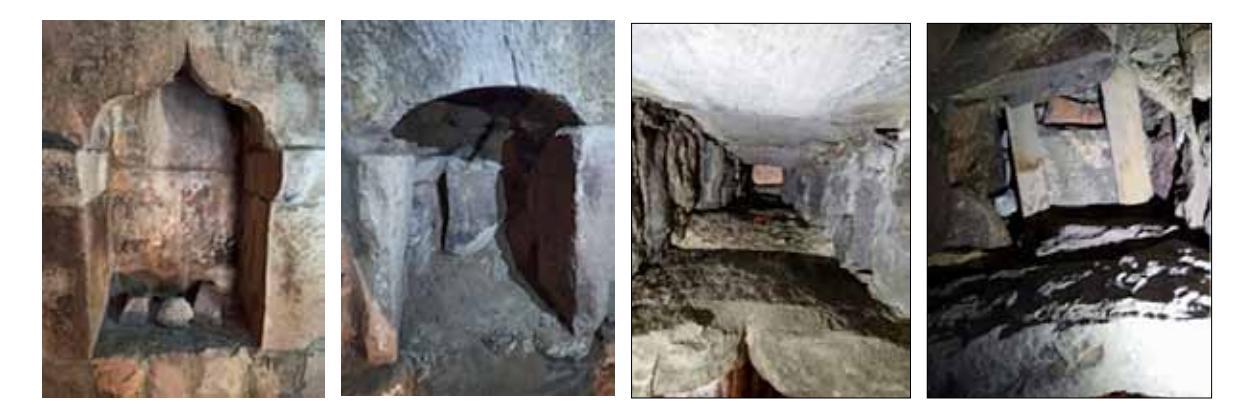
Figure 5. Built-in fireplaces (left) and interior views of their chimney extensions (right). (Source: Photos by authors).

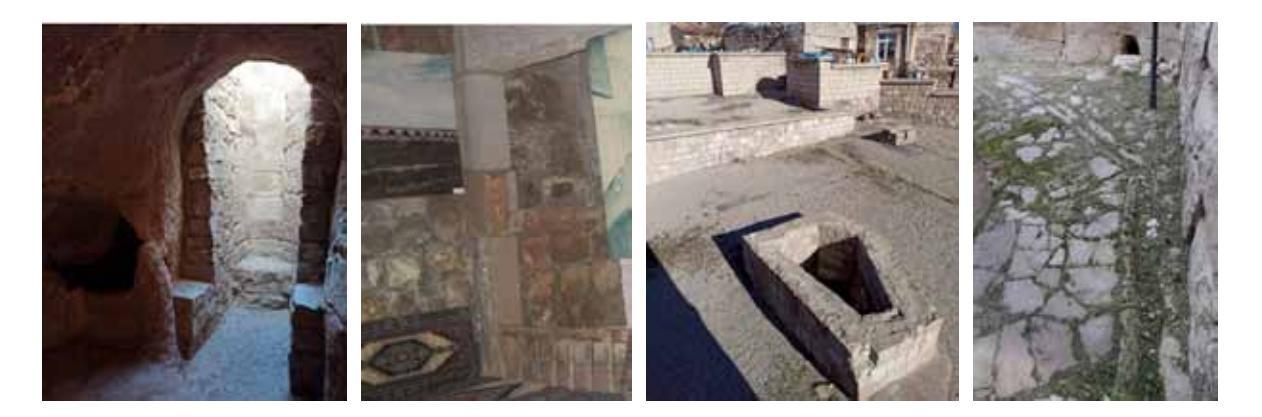
Figure 7. Left & 2nd from left, bathing areas. Third from left, lighting and ventilation shaft above the bathing area with its extension on the flat roof and (right) open gutters in the courtyard for surface drainage. (Source: Photos by authors).

The information on waste and clean water systems is based largely on on-site surveys. In the case study building, wastewater was discharged through floor drains, open channels for surface water drainage, sewers, bathing areas, latrines, and washrooms. The surface slope in these areas was also the primary means of surface drainage. The original latrine of the building was located in the courtyard, but nothing remains of this unit except for some traces. In this courtyard, there are also traces of a pool, a well, and its channels that were connected to the main fountain of the area. There is also a stone basin of a fountain in the courtyard. The bathing room was built as a small niche, closed with a wooden door, inside the living area. In this small niche, there is a stone pedestal in the center where you can sit while bathing. A ceiling vent at the top ventilates this space (Figure 7). The original wastewater drain is no longer visible today. In another example, the bathing room opens to the main living area/hall/sofa and is separated from the sofa by wooden grilles. In this room is a *cag tas*, a rectangular or elliptical stone pedestal with small holes and drains, and/or in some cases with a raised central section used for bathing and ablution (Figure 7, Figure 8) (Çelebi, 2017).

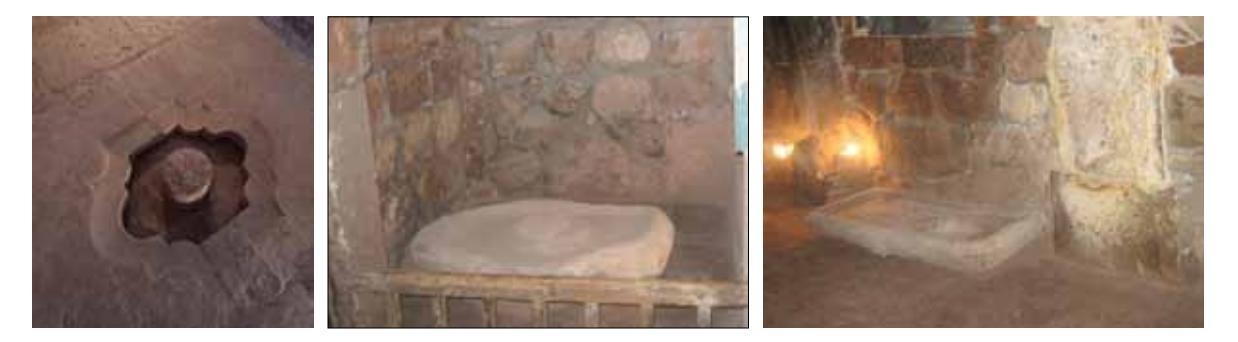
Figure 8. Left, Ablution space with its stone base and cag tası for bathing and ablution purposes center & left. (Source: Photo by authors).

In the building, there is also a sunken ablution space made of stone, located in the entrance area within the living area. The sewage is drained into the earth below with the help of the porous nature of the stone material. The central part of this washing stone is elevated, as in the bathing cabins, so that the splashing of the wastewater during washing does not disturb the users (Figure 8). In addition to these above-ground washing and bathing devices, there is another special solution for washing and cleaning facilities. In this case, the first step of the staircase connecting the ground floor with the upper floor was converted into a lavatory and ablution area. The drain is connected to the courtyard and is clearly visible on the facade of the building (Figure 9). There is also a lavatory on the wall of the cellar room behind the stairs. Its drain could not be discovered, but it could be hidden in the wall and located under the floor of the room. Kayseri was a region with a high potential for water sources throughout the centuries, but wells and cisterns were also used as alternative water sources both for providing clean water and for storing snow in winter, especially in the areas where water from rivers could not be used. Until recently, these alternative water sources could be observed in the courtyards of traditional houses in Kayseri (Karakus, 2000). Neither a well nor a cistern could be discovered in the case study building (Figure 10).

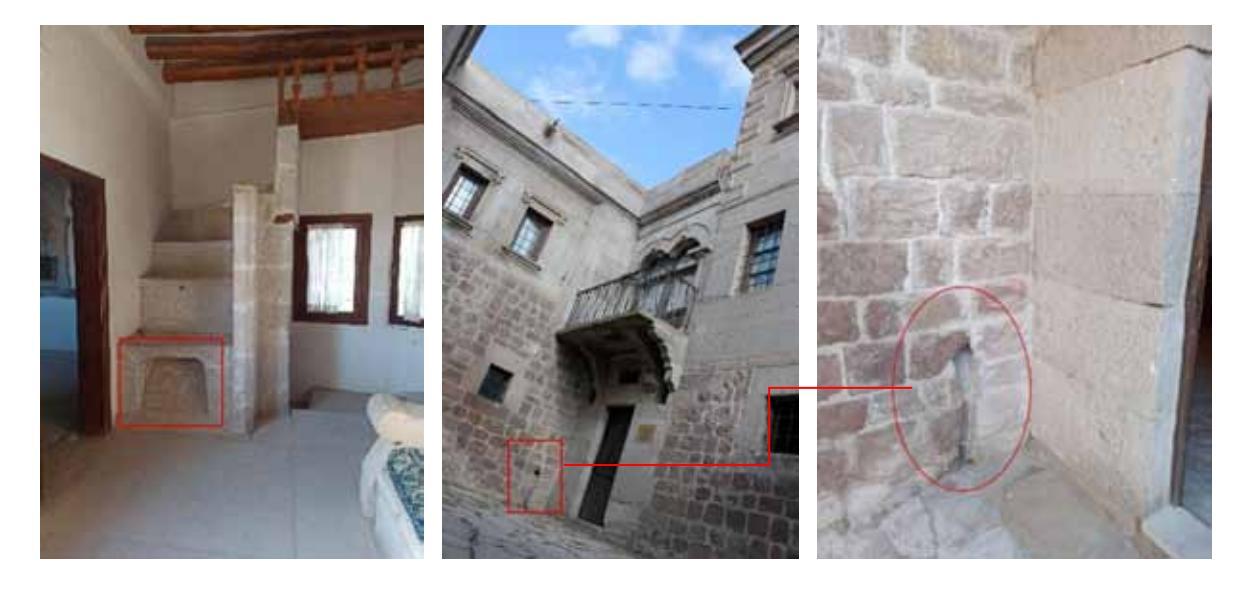
Figure 9. The staircase step also used as a sink and ablution space (a), and its drain in the wall (b-c) (Source: Photo by authors).

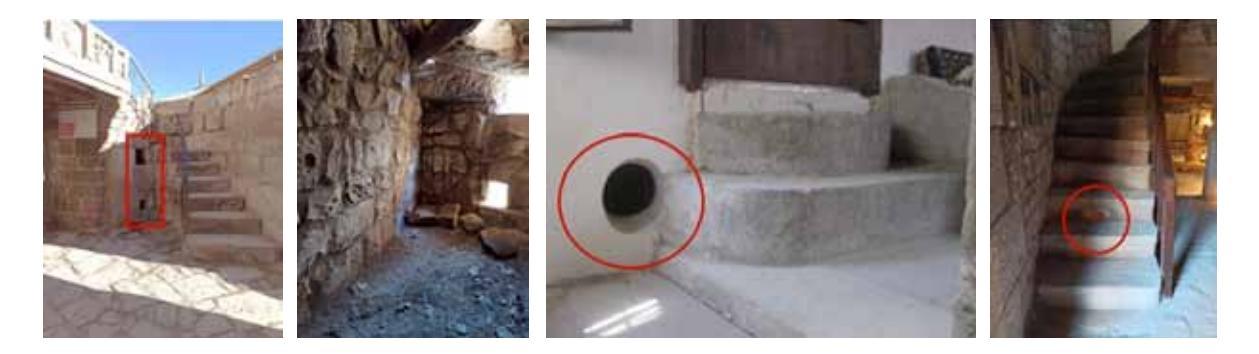
Figure 11. Ventilation holes on the walls and steps specially built for ventilation of cellar spaces. (Source: Photos by authors).

Traditional Ventilation and Lighting Solutions and Techniques in Case Study Building In the case study building, both natural solutions and artificial elements were used for ventilation and lighting of the rooms. During the day, the sun was the main source of light. After sunset, indirect sources of lighting such as oil lamps, candles, or candlesticks were used, as well as fire in the fireplaces/furnaces and ovens on winter nights. Window and door openings, as well as ceiling openings, were the main architectural solutions for letting natural light into living spaces. Their dimensions, shapes, and numbers vary depending on the characteristics and location of the rooms. On the ground floor of the stone masonry, intended mainly for service spaces, almost all the windows have the form of small embrasures/splayed openings. On the upper floors, on the other hand, there are large rectangular windows for ventilation and lighting in the living rooms. In the stone masonry part of the building, there are built-in cellars under the stone staircase for food/grain storage. For their ventilation, there are some small holes in the steps of the staircase or some ornamented openings in the walls of the cellar rooms (Figure 11). In the rock-cut part, the ceiling holes/ openings were the main means of ventilation and lighting. There are also some small-decorated niches on the wall surfaces called serbetlik to place the artificial lighting elements such as candles, candlesticks, or oil lamps. In some examples, there are even small holes at the bottom of these niches to place and fix these artificial lighting elements. Small holes in the walls, called *tembel delikleri*, served the same purpose, but also to place small objects such as matches, kindling, and firelighters (Figure 12). The case study building also had a light well that was used for both lighting and ventilation of the bathing rooms. There are no mechanical systems to ventilate the building; instead, natural ventilation and lighting are provided through architectural construction solutions. Chimney extensions of the builtin stoves also contribute to the ventilation of the rooms, especially on hot summer days (Figure 13). The chimneys are made of stone with a three-layer conical cap. On four sides of the chimneys, there are small square openings on the top level, so that cross ventilation is possible and wind can be caught from all sides on hot summer days, reminiscent of the principle of operation of Iranian *badgirs* (see Figure 2). In addition, there is a lantern-like roof/tüteklikli örtü above the tandoor room to ventilate the space and dissipate smoke and odors from the food during the cooking process (see Figure 3). In this type of roof, wooden beams are placed diagonally on top of each other to form a kind of dome with a small opening (about 0,50m) at the very top for smoke dissipation and lighting of the room (Akın, 1991).

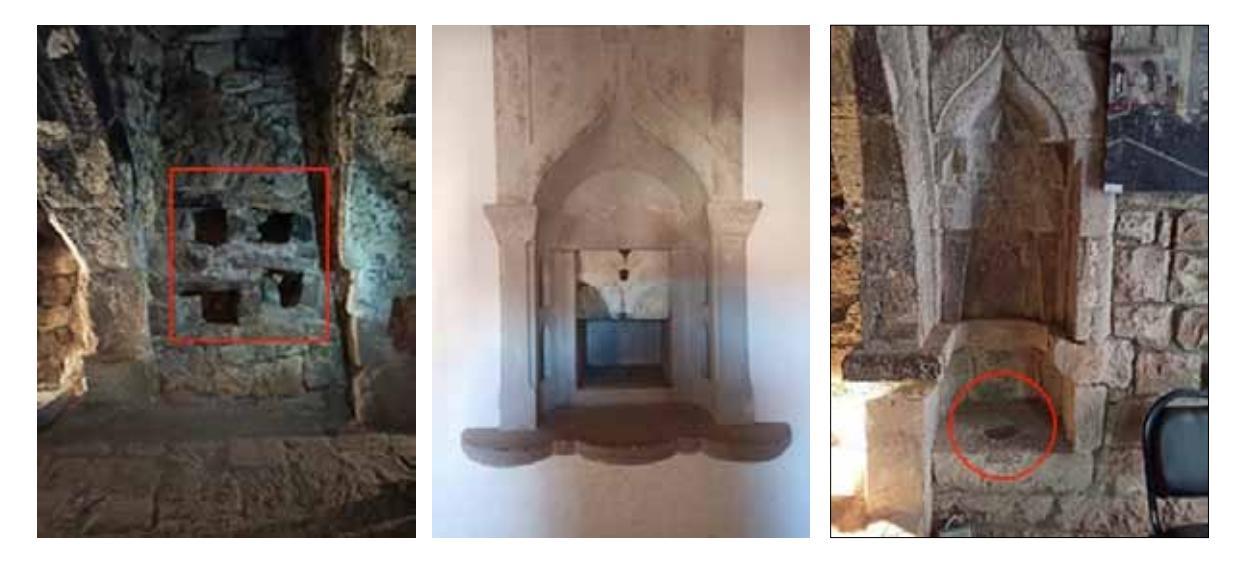
Figure 12. Left wall niches, called tembel delikleri and center & right serbetlik. (Source: Photo by authors).

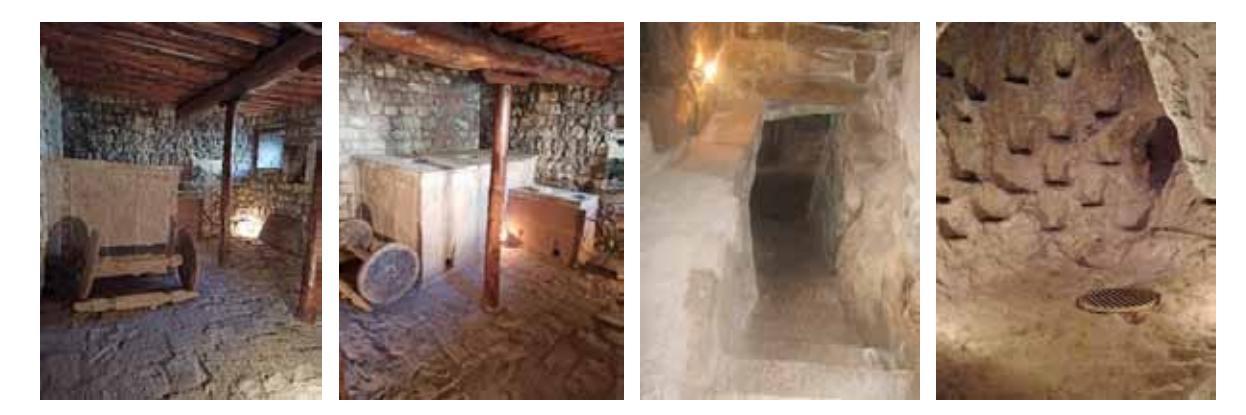
Figure 15. Left 2 pics, cellar room and storage room with connection passageway with the rock-cut areas and far right the pigeon lofts in the rock-cut area. (Source: Photos by authors).

two wheat storage units of different sizes, made of local volcanic tuff. This room is made of stone masonry with a wooden ceiling supported by wooden beams and posts (Figure 15). There are only small embrasures/splayed openings in the wall for ventilation. The floor of the cellar is covered with stones. Small niches on the walls of the cellar and the other living spaces, as well as under the lavatory, are the other storage options. Thanks to the cooling effect of the earth and the rock, the part of the house carved into the rock were mainly used over time as an underground storage room with special cellar solutions, including pits carved into the ground and terracotta jars of various sizes used to store food. In this area, there is a special storage solution called cardak in the local language (Figure 16). A staircase from the original masonry part of the house reaches this part. In the çardak storage technique, a small pit was dug into the earthen/stone soil and food was stored in these underground pits for long-term use. The upper part of the pit was closed with tight iron grates so that some kind of protection and ventilation was provided. Below the stone staircase, there were also closed cellars, which were used for storage purposes. Terracotta jars, either buried in the ground or standing on the surface, were the other portable storage containers.

Dovecotes, carved into the tufa, were also seen in the parts of the house carved into the rock. They have the shape of small holes about 0,25*0,25m in size on the rock surfaces and were used to collect and store pigeon manure. At the very top, there is a small hole called hazne çatısı through which the pigeons can enter. However, it was originally believed to be columbarium that was used to store the ashes and personal belongings of the dead (Figure 15) (Kaya, 2005). Pigeon lofts similar to dovecotes were built to support agricultural trade in Kayseri. By the mid-nineteenth century, Kayseri and the surrounding periphery were an important center for the trade of cehri plants, which were an important source of income for local people. Pigeon manure, collected from pigeon lofts or dovecotes, was an indispensable part of this trade, which ensured the efficient and rapid growth of the cehri (Büyükmıhçı, 2006).

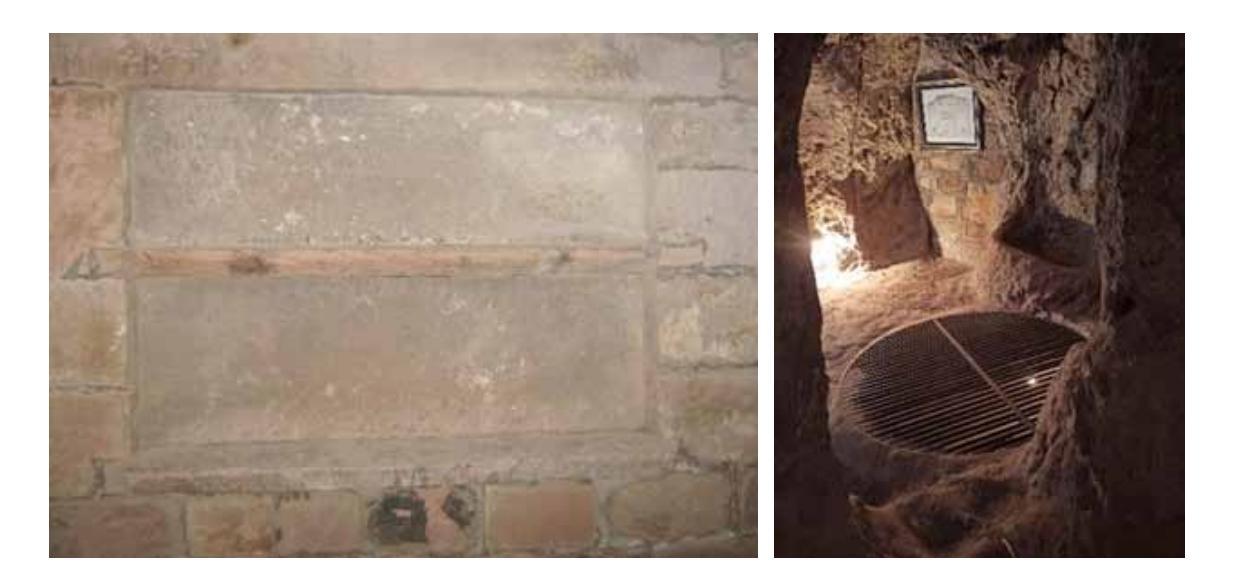
Figure 16. A rectangular niche on the wall in the tandoor room (a) and food storage containers buried in the ground (b), called çardak in the local language, in a rock-carved part of the house. (Source: Photo by authors).

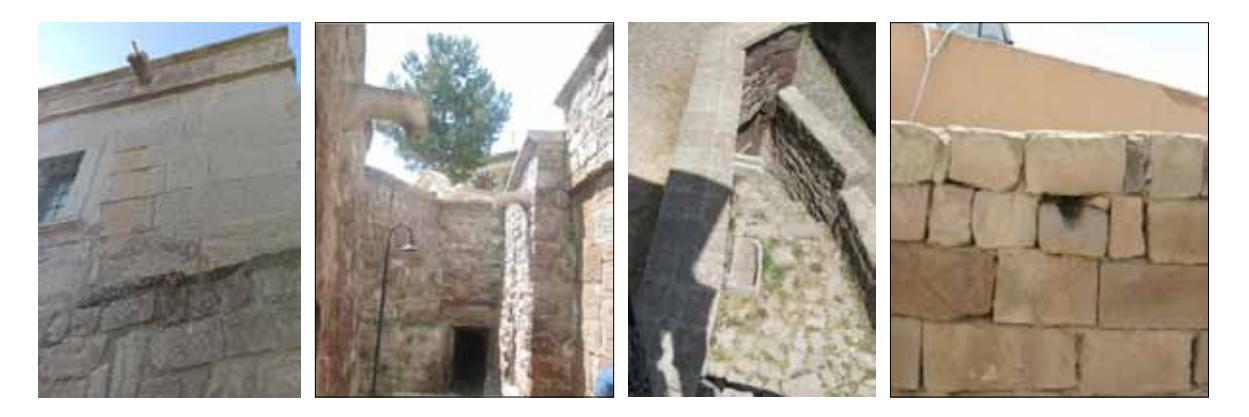
Figure 17. Left 2 pics, roof waterspouts and center right courtyard walls to drain rainwater. (Source: Photos by authors).

The building originally had a flat roof covered with a layer of earth, characteristic of traditional houses in Agırnas in the fifteenth and sixteenth centuries (Yaslıca and Çalısır, 2002). At present, however, most parts of the roof are covered with pebbles mixed with earth. The stone waterspouts located at certain intervals on the parapet level of the roof are the primary drainage elements used to drain rain and snow water accumulated on the roof surfaces (Figure 17). They protrude from the main walls at the parapet level and have a gutter in the center through which the water is drained directly to the street or courtyard. In this way, the main stonewalls of the building are protected from wetness and humidity on rainy days. Rain and snow water is directed to these water spouts made of volcanic tufa, through muddy surfaces formed in the earth layer of the roof, towards these drainage elements. The earth layer of the original earthen roof was compacted after the rainy and snowy days with log tası, a special type of oval stone with an iron handle. The waterspouts are used both as functional and decorative elements, some of them with special shapes. In some cases, the waterspouts do not protrude but are located on the same surface as the courtyard wall itself, and in another case, the waterspout is located directly above the fountain basin in the courtyard, serving a dual purpose (Figure 17). Parapet walls with copings sloping in two directions, stone cornices at the parapet level, and on the facades between floors are the other architectural elements of the building that serve to drain water and protect the wall surfaces (Figures 17-18).
