The Application of the Environmental Adaptation Concept to A Collector Road in KKU, Thailand

Abstract

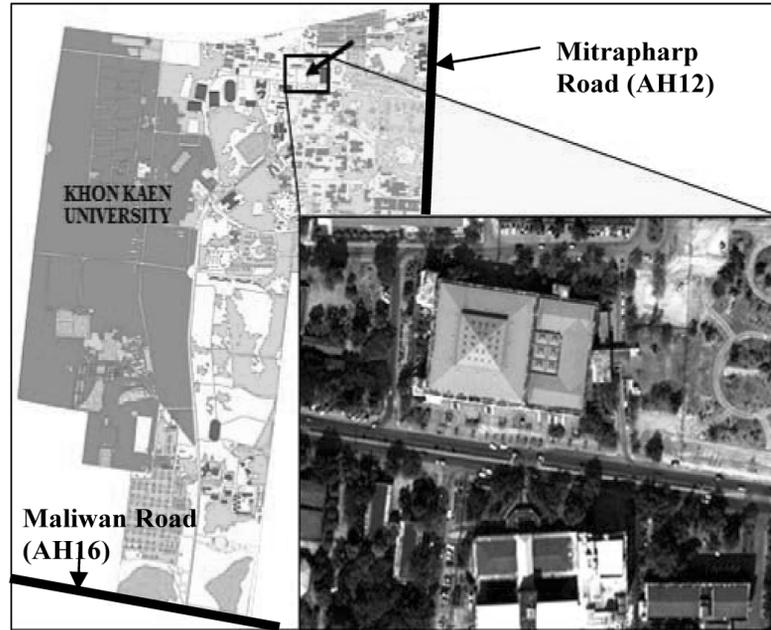
Figure 1 A collector road adjacent to the complex building in Khon Kaen University

(ii) study area specification: a collector road, a divided four-lane road with 1.5 meters median width and narrow footpath as shown in (Figure 1 and 3) in front of the complex building is functioning as the main street in KKU. In addition, the adjacent road network and surrounding land use on both sides of the road were also taken into account; **(iii) objectives and strategies identification:** the main objectives of this research is to improve road and land use physical characteristics to reduce conflicts between pedestrian maneuverings and vehicles movements (therefore pedestrian accident risk) and to improve the environmental and amenity quality; **(iv) performance criteria identification:** prior to conducting a detailed investigation of the project. The performance criteria must be identified and selected to assess and evaluate the outcome of proposed alternatives; **(v) data collection and analysis:** the collected data include physical road and land use characteristics of a collector road, adjacent road network and surrounding land use such as mid-block and intersection traffic volume, Origin and Destination (O-D) traffic data, operating speed, pedestrian crossing maneuvering and others; **(vi) developing alternatives of measure schemes:** alternatives will be developed in an integrated fashion. Therefore, different control, design and construction measures as suggested in¹ will be properly selected and incorporated as set of different alternatives to be proposed for implementation; **(vii) selection of the appropriate alternative:** the different alternative were proposed and compared in correspondence to the specified objectives. Then, the appropriate alternative was selected for actual implementation.

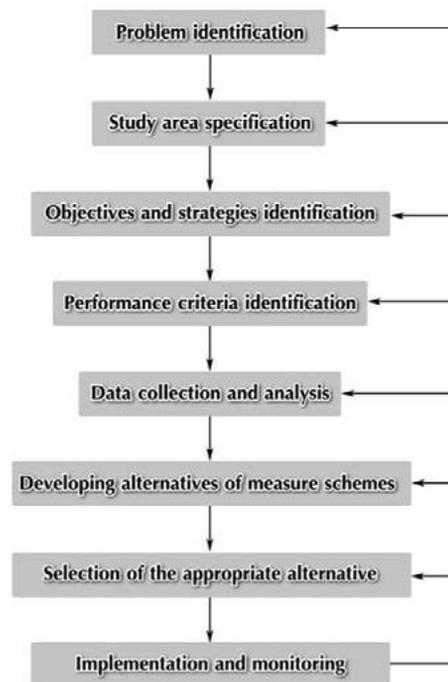
Figure 2 Flow chart diagram of the application process of the EAM concept

KKU collector road⁶ and (Figure 2) also shows flow chart diagram of the process. The EAM application processes are as follows: **(i) problem identification:** based on comprehensive field surveys and data collections of traffic and land use characteristics along a collector road in front of the KKU complex building has been suffered from pedestrian accident risk, traffic environmental impacts, amenity and esthetic and land scape problems;

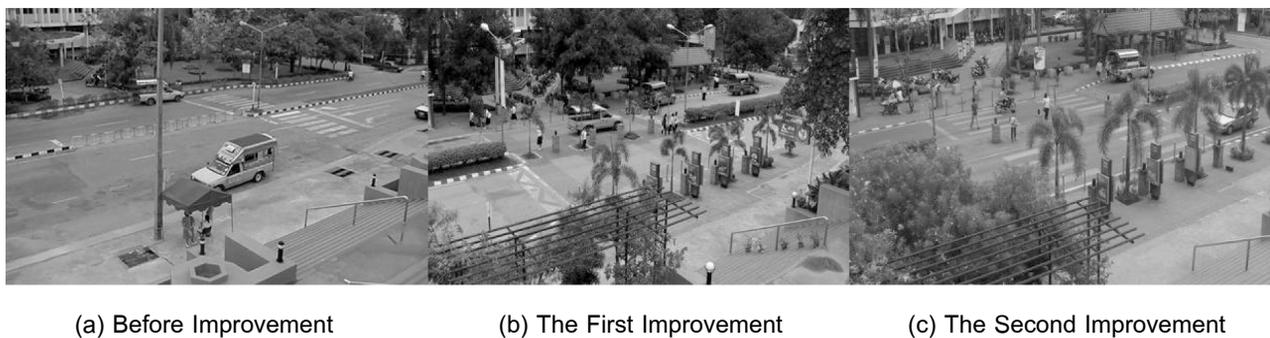
Figure 3 The road and land use physical characteristics of the study area during before and after applying the EA concept

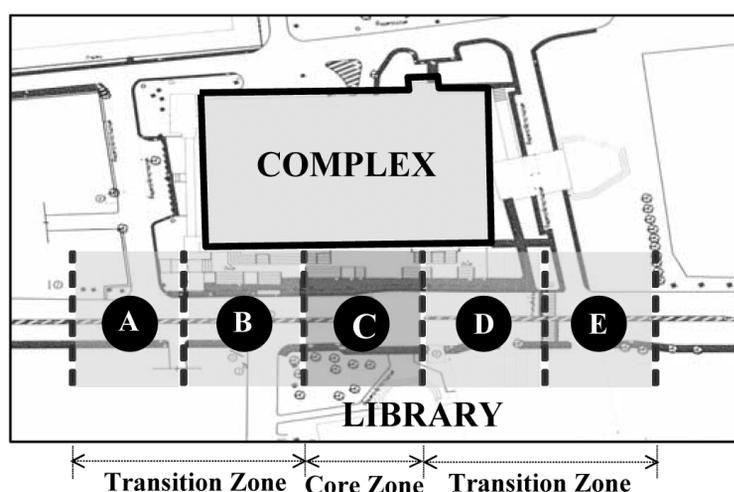
Figure 4 Five zones of pedestrian crossing data collection

As indicate in (Figure 4) in the before-improvement period at the core zone (C), the traffic flows (collected during 7:30 and 8:30 AM) in the east-bound, west-bound and combined both directions were 577, 610 and 1,187 passenger cars per hour, respectively, while in the first improvement period, the traffic volumes the east-bound, west-bound and combined both directions were 790, 812 and 1,602, respectively. In the second improvement period, the traffic volumes in the east-bound, west-bound and combined both directions were 833, 921 and 1,754, respectively. In the first and second improvement periods, the morning peak hourly (combined both directions) volumes were considerably greater than that in the before improvement period. This was possibly because during the first and the second improvement periods, the certain amount of through traffic attempted to avoid traffic congestion on the existing road network and use the collector road as the short-cut route.

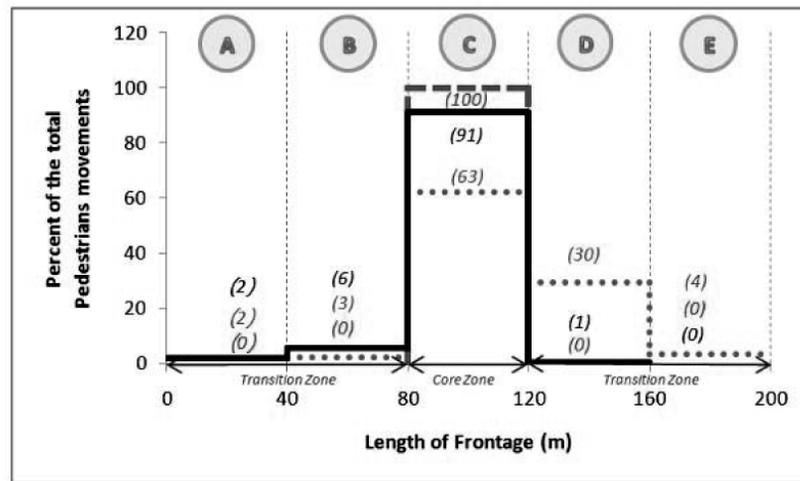
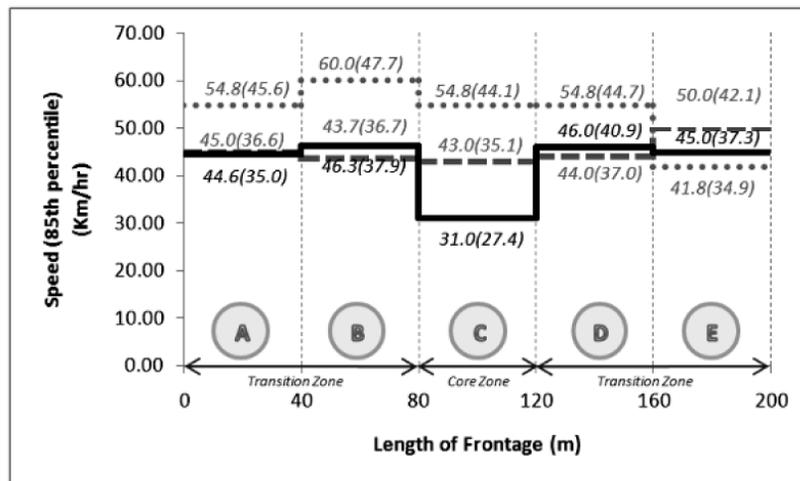
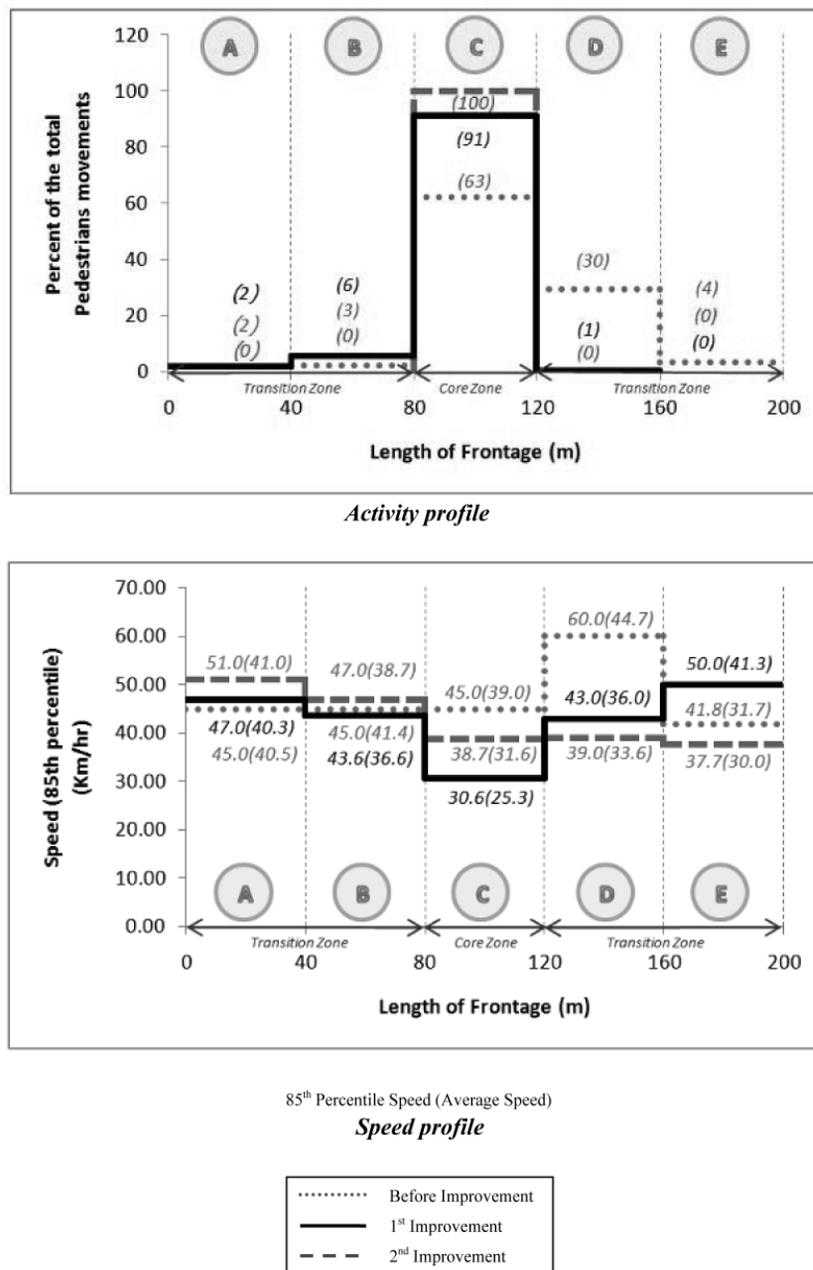
Figure 5 Activity profiles and speed profiles by traffic directions during the before-, the first, and the second-improvement periods

(Figure 5) illustrated the speed profile collected during 7:30 and 8:30 AM in the core zone (C) and the

transition zones (A, B, D and E) during the before-, the first- and the second- improvement periods. In the before-improvement period, the 85th percentile speeds in the core zone were 54.8 km/h and 45.0 km/h in the east- and west-bound directions, respectively, while in the first-improvement period, the 85th percentile speeds in the core zone were reduce to 31.0 km/h and 30.6 km/h in the east- and west-bound directions, respectively. Interestingly, in the second-improvement period, the 85th percentile speeds in the core zone were become 43.0 km/h and 38.7 km/h in the east- and west-bound directions, respectively. It could be concluded that based on the 85th percentile speeds (in both directions) in the core zone, the first- and the second- improvements could potentially reduce traffic speeds dramatically. The results indicated that the installation of a speed hump (in the first-improvement period) can effectively reduce the hazardous speed (in the before- improvement period) to the safer target speed interval (25-35 km/h). McLean et al⁷ implicitly noted that if a car hit a pedestrian at the impact speed of 50 km/h, the probability of survival is only 7%. However, if the impact speed is reduced to 31 km/h, the probability of survival is greatly raised to 99 %. However, the effectiveness of the improvement in the second-improvement period was lesser than that of the first-improvement period, because of the construction of speed humps during the two improvement periods were physically different in terms of the type of road surface and their physical characteristics (side slopes and heights).

(Figure 5) also illustrated that the pedestrian crossings maneuverings (activity profile) collected during 7:30 and 8:30 AM in the core zone (C) and the transition zones (A, B, D and E) during the before-, the first- and the second-improvement periods. These pedestrian crossings were classified into walking and running maneuvering. As shown in (Figure 7), the percentage of the pedestrian crossings in core zone (C) was increased from 63% (in the before- improvement period) to 91% and approximately 100% in the first- and the second-improvement periods, respectively. In the transition zone (D), the

percentage of the pedestrian crossings was reduced from 30% (in the before-improvement period) to only 1% and 0% in the first- and the second-improvement periods, respectively. In other remaining zones, the percentages of the pedestrian crossings were very low and relatively unchanged during those periods. The results clearly show that the principal achievement of the applications of the EAM concept in gathering as many as pedestrian crossings in core zone (with lower target speeds) and minimizing such crossings in transition zone (with high traffic speeds).
