# Carbonation depth and compressive strength of pedestrian bridge concrete structures in Mueang Nakhon Pathom environment

This study is an investigation on the carbonation of pedestrian bridge structures in community area Nakhon Pathom province by nondestructive testing methods. Compressive strength and carbonation depth of pedestrian bridge structures in 16 projects were measured. The results indicated that the compressive strength of pedestrian bridge structures was larger than the design specification. The rate of carbonation of pedestrian bridge structures in community area Nakhon Pathom province was higher than that of the pedestrian bridge structures in the suburb area. The carbonation depth of concrete having higher compressive strength was lower than of concrete having lower compressive strength. The suggest that it is necessary to limit the carbonation depth of concrete to an acceptable level in the severe environmental conditions prevailing in Mueang Nakhon Pathom. Finally, the results of the survey have yielded realistic values of a carbonation coefficient which can be used to predict the carbonation depth of structures built with compressive strength different concrete

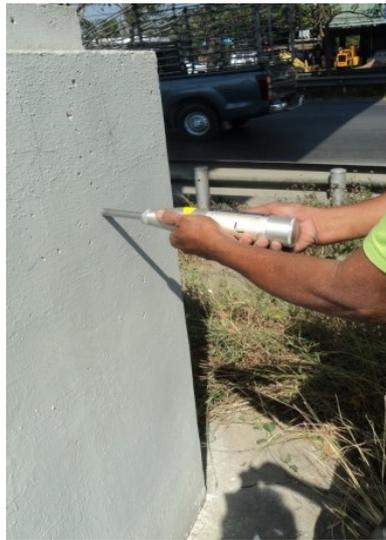
**Figure 2** Measurement the reflectance of concrete with Schmidt hammer

In the study the carbonation of pedestrian bridge structures in the community Nakhon Pathom. It measures the total reflection of the concrete with a Schmidt hammer. The compressive strength of concrete was determined according to ASTM C805-02 [7]. By used to measure the compressive strength and consistency of the compressive strength of the structure position close to the coring sample (see Figure 2). By one position

keep the reflection of the concrete 36 values. The measurement reflects the time required is approximately 25 millimeters. The one pedestrian bridge keep six positions. The total values equal to 216 values.

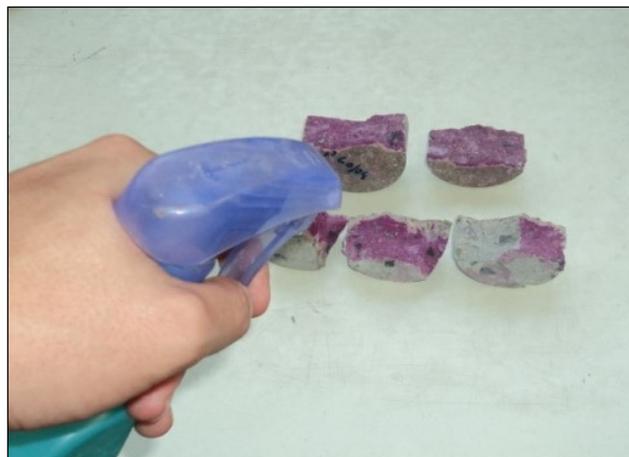
**Figure 3** Spraying with a phenolphthalein solution to concrete sample

For the carbonation tests of the pedestrian bridge is located in Nakhon Pathom province, carbonation depth was measured in the laboratory. The carbonation depth was assessed by split the concrete coring and spraying the split specimens uniformly with 1% of phenolphthalein in solution is colorless and used as an acid-base indicator [8] (see Figure 3). The color of the solution changes into purple when pH is higher than the range of approximately nine. The carbonation portion is uncolored and non-carbonation portion is purple. The carbonation depth was measured with a vernier caliper to the nearest 1 millimeter in Figure 4. The results are included in Tables 2-5.

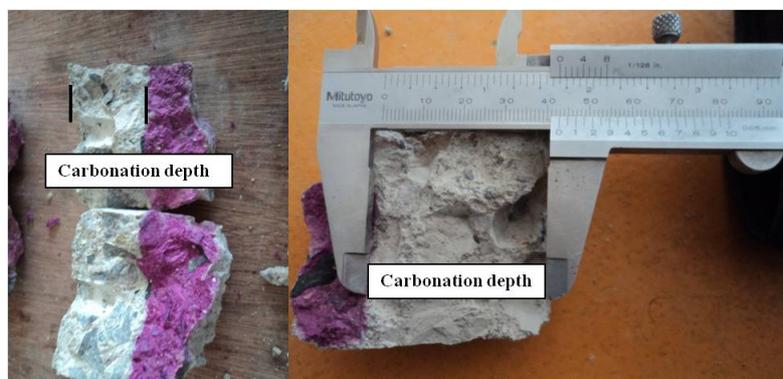
**Figure 4** Carbonation depth

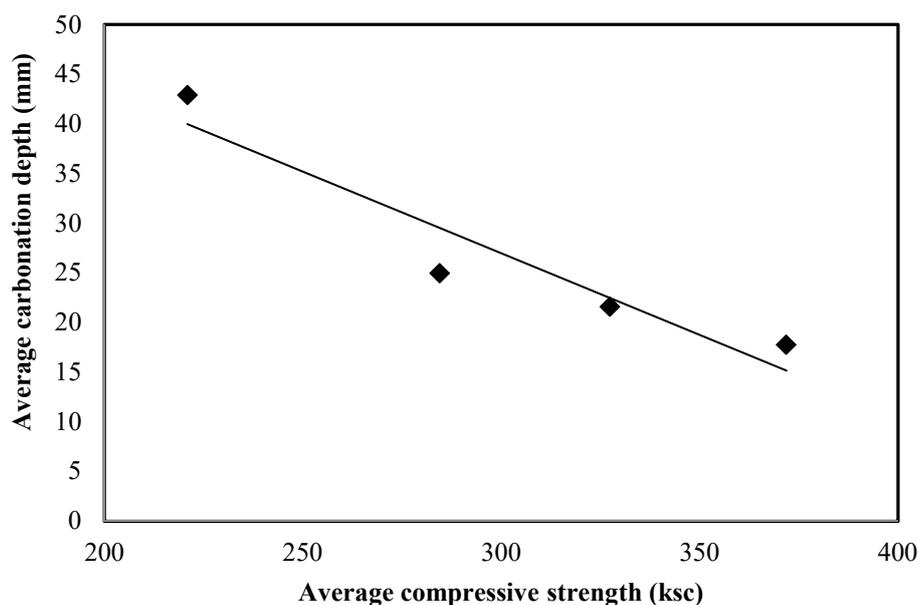
**Figure 5** Variation of carbonation depth for concretes structures

As mentioned earlier, the 16 pedestrian bridges surveyed have been constructed using 200-250 ksc, 250-300 ksc, 300-350 ksc and 350-400 ksc concretes. The average values of the compressive strength of these four grades of concrete of 221, 284, 327 and 372 ksc, respectively, have been plotted against the corresponding average depth of carbonation of 42.90, 24.95, 21.56 and 17.74 mm in Figure 5. The figure suggests, amongst other factors, that the carbonation depth of concrete structures is a linear function of the compressive strength of the concrete. Accordingly, the best safeguard against the passivation of reinforcement, where rate and total carbonation depth is expected to be high, is to use higher strength and better quality concrete. The maximum carbonation depth of 60 mm observed in this investigation occurred in a column of a pedestrian bridges which was only 14-years-old (see St. no. 2, Table 2). The compressive strength of the concrete used was only 213 ksc in this Mueang Nakhon Pathom pedestrian bridges. A compressive strength of 213 ksc is simply inadequate for a Mueang Nakhon

Pathom pedestrian bridges which are exposed to the ingress of another carbon dioxide as well. In addition, there are two other pedestrian bridges (see St. no. 2 and 8), where even lower compressive strength concrete of about 217 and 219 ksc have been utilized. The carbonation depth, however, in both of these pedestrian bridges is only 37.80 and 39.30 mm after 12 and 11 years of exposure, respectively. Although the compressive strength of 217 and 219 MPa is undesirably low, the possible reason for the much lower depth of carbonation of these pedestrian bridges is their distance from the Mueang Nakhon Pathom, of 8 and 11 km, respectively.

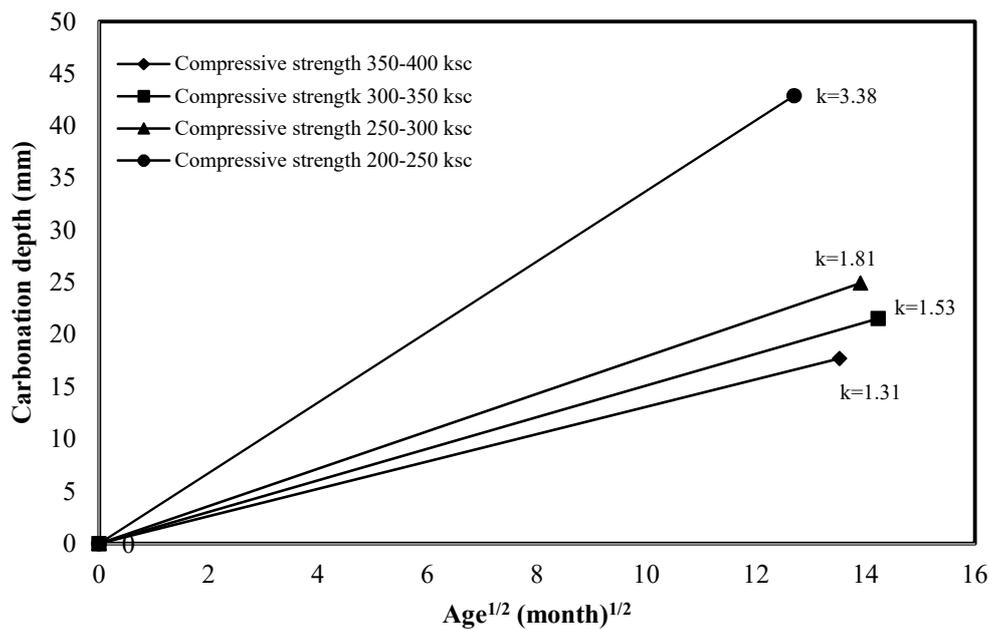
Figure 6 Variation of carbonation coefficient for concretes structures

As mentioned earlier, the structures surveyed were grouped in the (350-400 ksc), (300-350 ksc), (250-300) and (200-250 ksc) ranges. The average values of the compressive strength of the structures falling in these categories and the corresponding average of the  $k$  values calculated are included in Table 7. These  $k$  values have then been used to predict the 25 year carbonation depth of the structures built using the compressive strength of between 350-400 ksc, 300-350 ksc, 250-300 and 200-250 ksc concrete (see Table 7). These predicted values suggest, correctly, that the

lower the concrete strength the higher the depth of carbonation. Finally, the  $k$  values which are more realistic for the Mueang Nakhon Pathom exposure conditions of Thailand (Figure 6).
