Low income housing adaptation strategies to flood hazard in Chiang Mai, Thailand

Faculty of Architecture and Environmental Design, Maejo University, Chiang Mai, Thailand

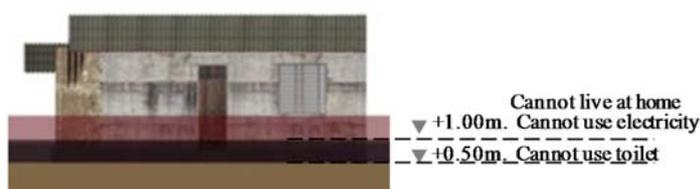
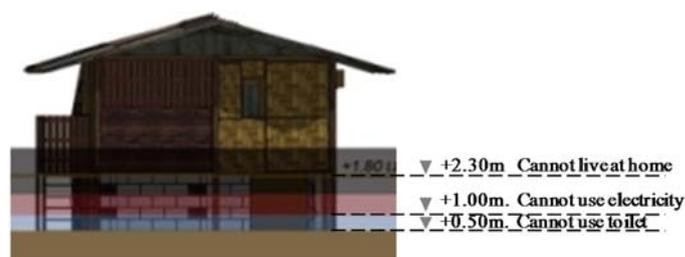
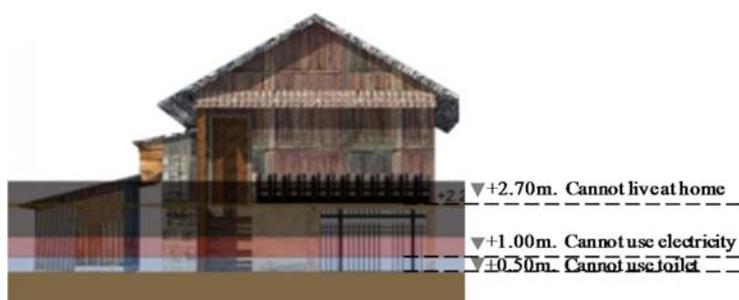
Figure 2 (A)-(C) Living problems on difference housing styles

It can be seen that living problems during floods before people have to be evacuated vary with the flood depth. The housing style i.e. 1-story house, 1-story elevated house, and 2-story house is also a factor which affects the living problems as shown in Figure 2. Most of the toilets have problems after 0.5 m. of flood depth, and electricity cannot be used after flood depth reaches 1.0 m. These problems are caused by the location of toilet, which is usually built on the ground floor, and electrical outlets or light switches, which are 1.2 m above finished floor level so all electrical power must be shut down off. However, flood depth does not directly affect housing damage, a flood depth of 0.9 m for 6 days caused less housing damage than a flood depth of 0.7 m for 10 days. Shortage of food and resources rarely occurs during floods there since it is in the city and residents can walk out to get assistance.

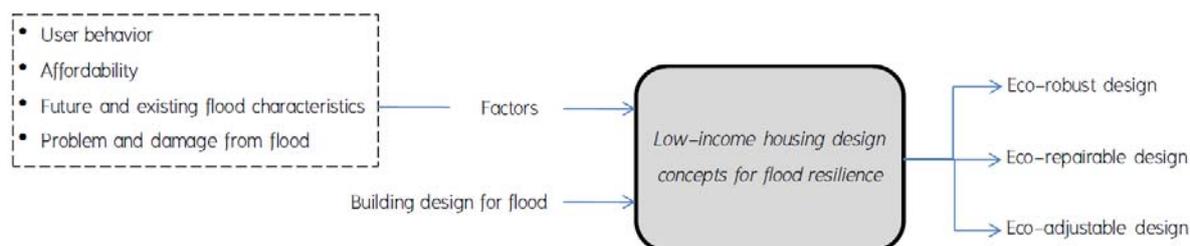
**Figure 4** Framework for conceptual analysis

From the study, many factors were found related to housing design against flooding, i.e. flood characteristics, affordability, household problems during floods and residents' behavior. Residents must try to find a suitable design for resisting current and future floods as effectively as possible. They should start by understanding flood characteristics which affect them, since residents in the same village can be affected differently. Therefore, low-income housing design for flood resilience cannot be a fixed model, but can be shown as conceptual design principle which emphasizes key points of being able to accept and live with flooding without significant housing damage. The residents will be able to live during flood and recover by themselves after the situation returns to normal. The design principles can be divided into 3 concepts (Figure 4) which can be integrated for more effectiveness and efficiency.

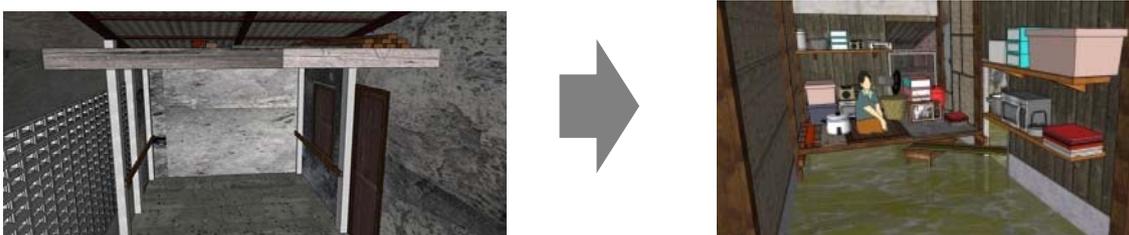
Figure 9 Hanging beam on the column for future flooring (door panel or window panel)

For a permanent house with a strong structure, hanging a beam on the column for laying panels such as door and window panels can increase living space

during flood and the house would not be cluttered in a normal situation. This is one example applied from this concept as shown in Figure 9. The columns should be steel, concrete or hard wood and the minimum size of the column should not be less than 0.15×0.15 m., however, the strength of structure has to be checked for safety load. The distance between two columns should not be more than 3m center to center of the columns.
