Ergonomic Risk Level Assessment in Building Process at An Automobile Tire Manufacturing

Keywords: Ergonomic; Tires; Building process; REBA method

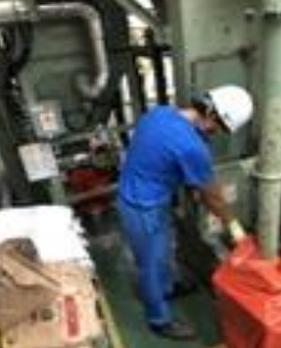
8	4
<i>No. 6</i> Filling the steel grid with metal powder	Standing and bowing head to fill the steel grid with metal powder.

4	3

A posture of work in the task or process of filling the steel grid with metal powder was found in having an ergonomic risk level 3 which was required future investigation and improvement. While the posture in task or process on bending and reaching out to place the rubber sheet on shin-gane was needed the action level 2 which was needed more attention.

We recommend the prevention measures to reduce the ergonomic risk in the tire building process as follows: i) use lifting equipment to raise heavy objects which will reduce exertion to within the body capabilities and eliminate work postures that violate natural muscle use, especially when pulling the raw cover out of the tire-forming machine and changing the bead ring during the task; ii) redesign the workstation to be high and appropriate for staff physique to prevent the need for bending over while working, especially during peeling the tread and filling the steel grid with metal powder; iii) apply a rubber mat to reduce fatigue from standing for long periods; iv) Adequate rest time should be provided to reduce fatigue during work;
